# **Pavement Quality Indicators Study**

## **Five Year Report**

**Construction Management Department  
University of Nebraska  
Lincoln, NE 68588-0500**

**Researcher: Cody Kluver  
Advisor: Wayne Jensen**

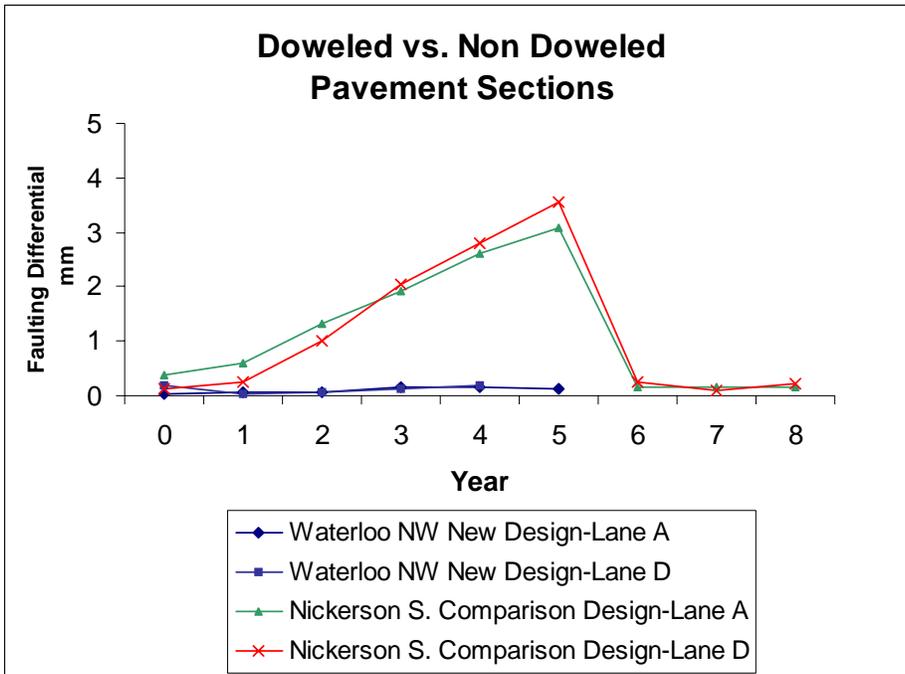
Figure 1.1: Faulting Differential, Waterloo NW and Nickerson South

This graph shows how the dowel bars used in the Waterloo NW section have limited the amount of faulting over the past five years.

The graph also shows the benefits of dowel bar retrofits. Nickerson South experienced a dowel bar retrofit in year 6 as is visible by the significant decrease in the level of faulting. Its important to notice the initial trend over the first five years (prior to the retrofit) as that trend shows a steady increase in faulting to nearly 3 mm (half the allowable maximum) by year five.

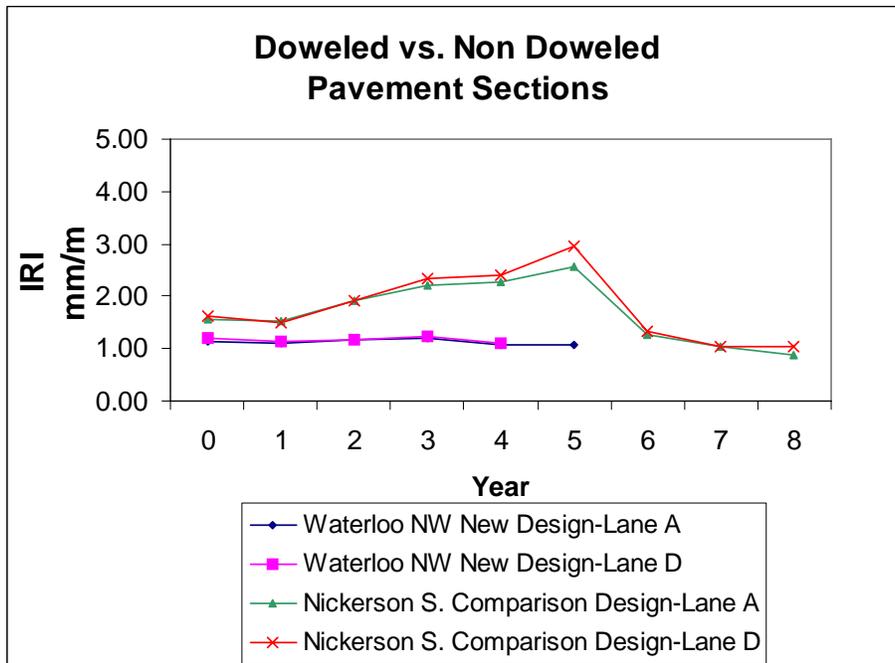
Figure 1.2: IRI, Waterloo NW and Nickerson South

Similar to the previous graph, the doweled Waterloo NW section is smoother than the traditional Nickerson South section.

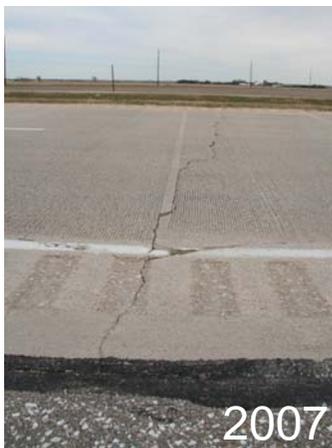
**Location:** MM 158

- High structural cracking with visible displacement, caused by undermining of pavement for utilities.

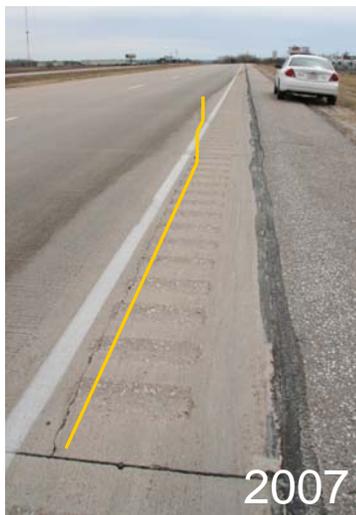
**Location:** MM 165.5

- Longitudinal crack starting along edge of rumble strips.
- Crack extends four pavement panels in length.
- Located along a gentle curve.

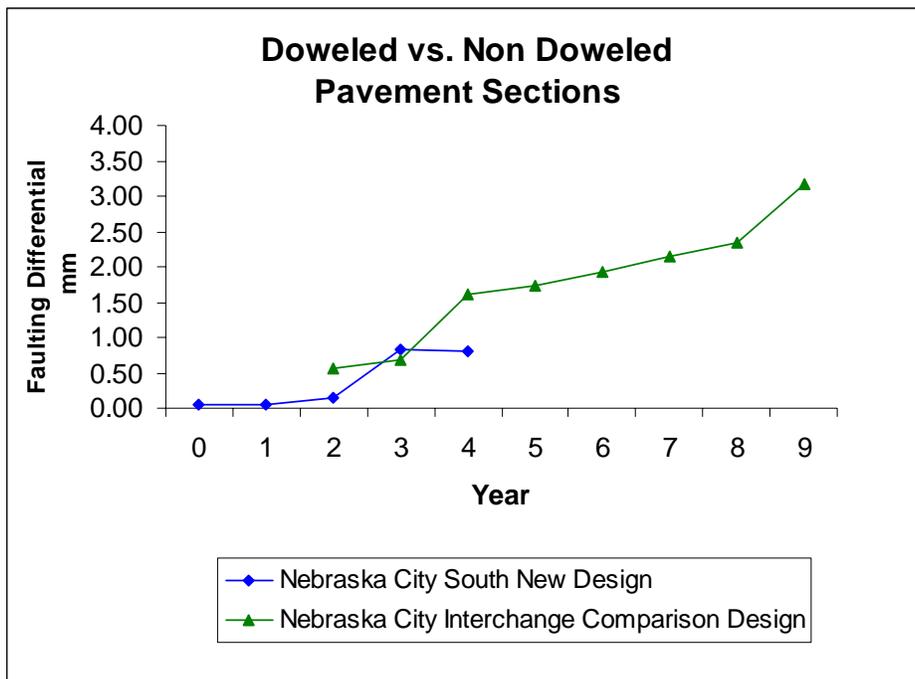
Figure 2.1: Faulting Differential, Neb. City South and Neb. City Int.

The doweled pavement (Nebraska City South) has outperformed the non-doweled section for most indicators.

At the end of year nine, the non-doweled pavement exhibits faulting of about 3 mm. The doweled pavement is experiencing less severe faulting, averaging about 1 mm after four years.

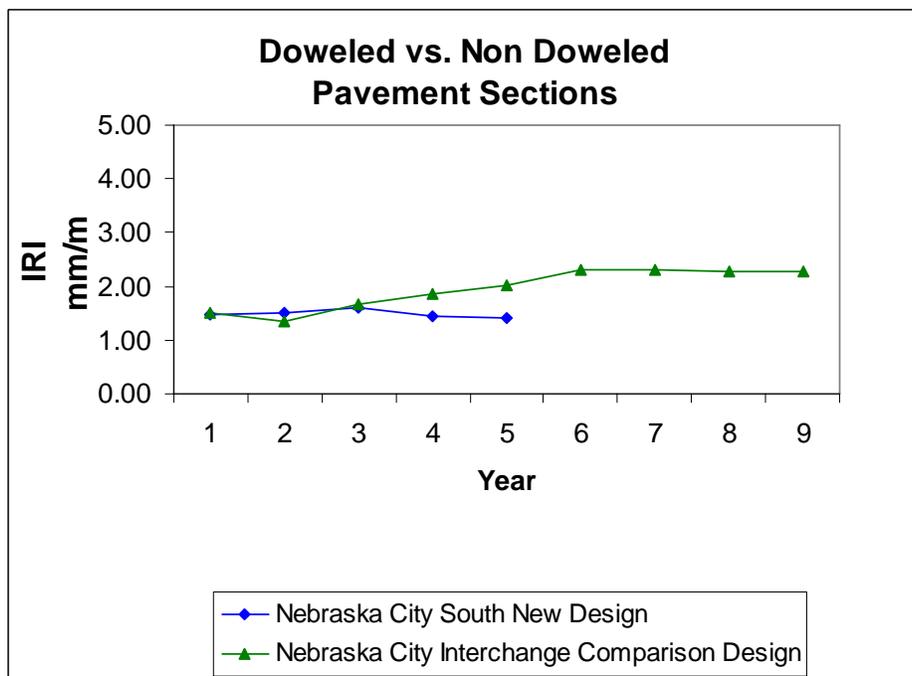
Figure 2.2: IRI, Neb. City South and Neb. City Int.

Over the past four years the doweled pavement has shown little increase in IRI while the conventional section showed a steady increase.

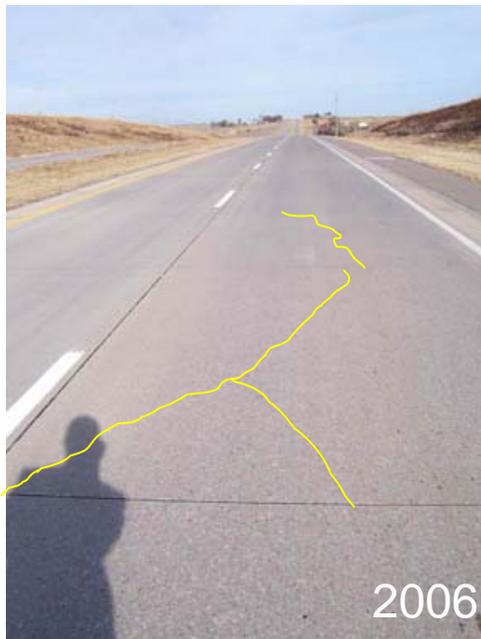
**Locations:** MM 44.9

- Perpendicular edge cracking along centerline.
- 2"– 8" transverse cracks approximately every four feet along centerline.
- High placement of tie bars across longitudinal joint caused surface cracking shown at left.

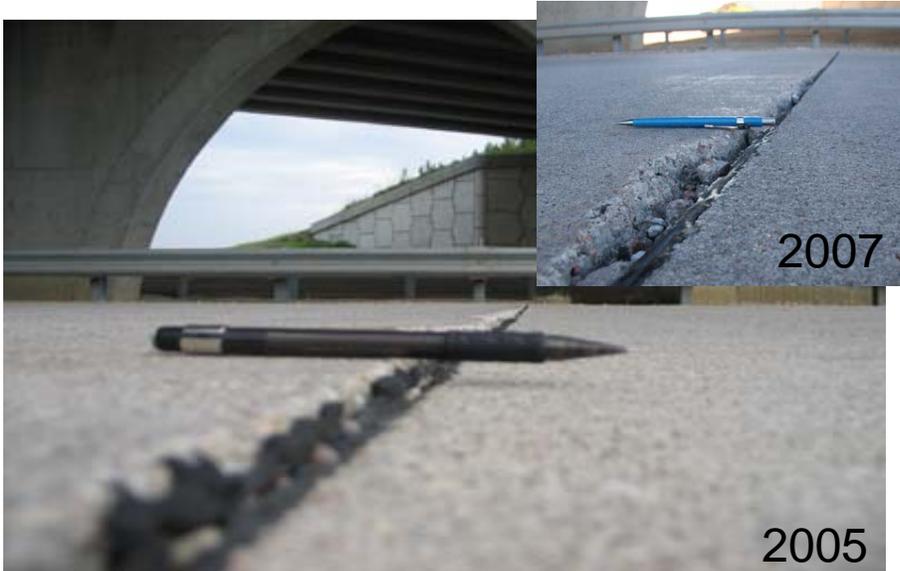
**Location:** MM 58.01

Faulting 6mm or greater.  
Severity of faulting varies with changes in temperature and soil moisture content.  
Image from 2005 shows more severe level of faulting.

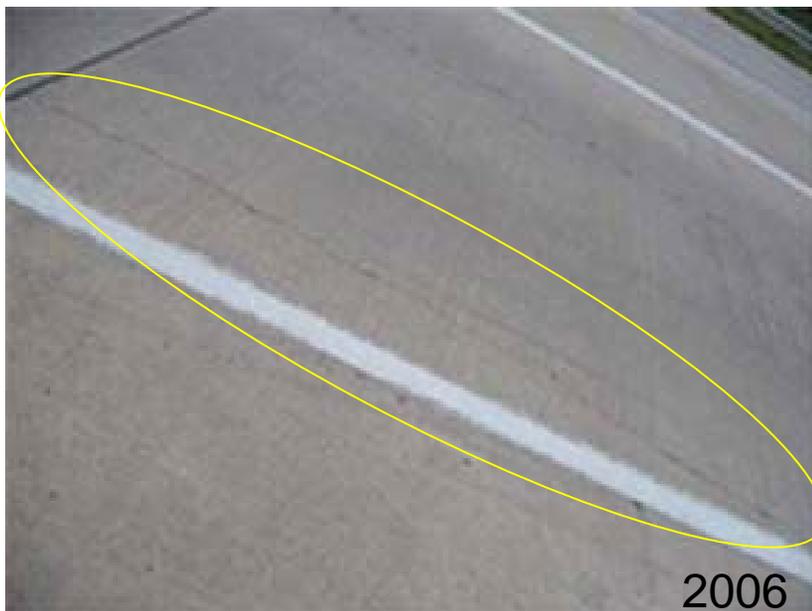
**Location:** MM 59

**Distresses Shown:** Longitudinal crack shown is about 10 feet long .

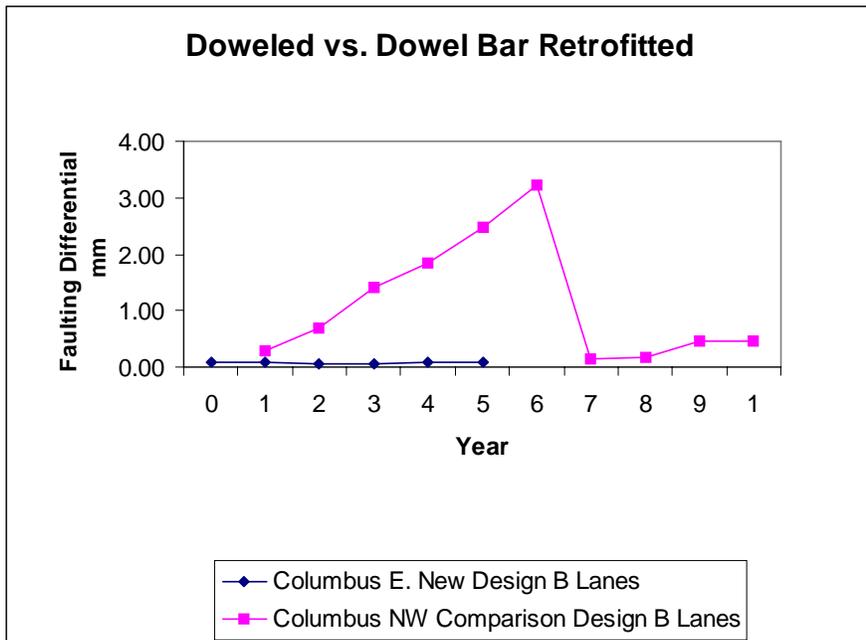
Figure 3.1: Faulting Differential, Columbus E. and Columbus NW.

Columbus NW, originally a non-doweled section, experienced a steady increase in the level of faulting to almost 3 mm after six years.

The level of faulting significantly decreased after a dowel bar retrofit was performed on the Columbus NW section in the seventh year. While Columbus NW has seen a slow increase in the level of faulting, faulting is now much less severe than prior to the dowel bar retrofit.

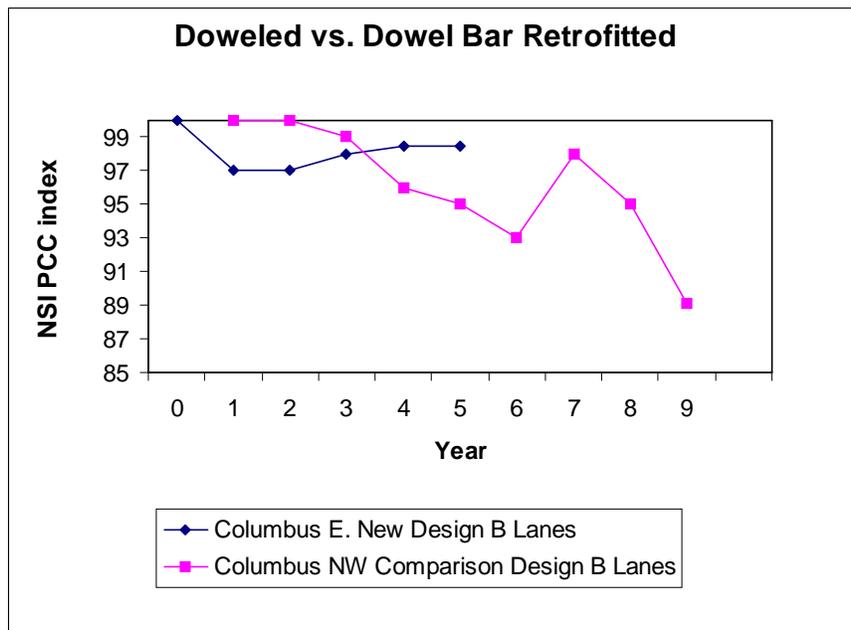
Figure 3.2: NSI PCC, Columbus E. and Columbus NW.

This graph shows how Columbus NW section reacted to a dowel bar retrofit in year seven. Since the retrofit, there has been a significant decrease in the Nebraska Serviceability Index (NSI). This decrease is caused by placing the retrofitted dowel bars too close to the shoulders, thereby causing cracking of pavement along the shoulders. This problem is visible in the pictures of the Columbus NW section.

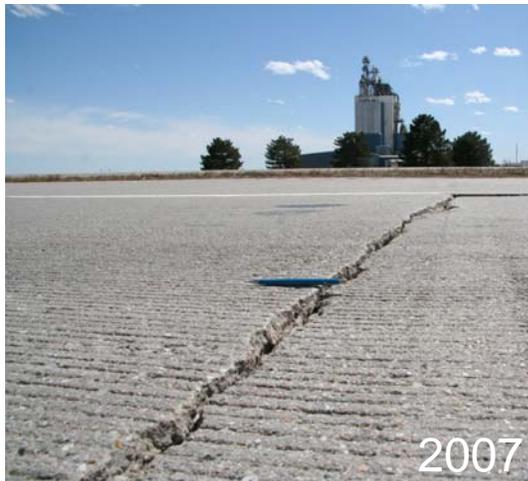
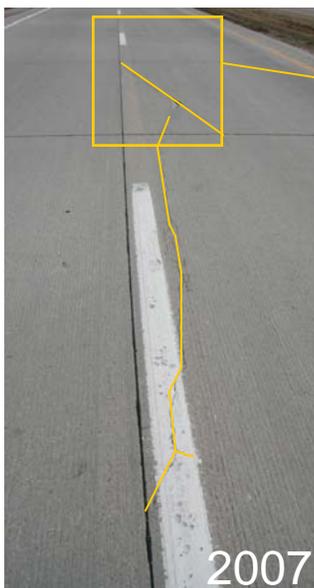
- Longitudinal cracking.
- Extends three panels i(~50 feet) in length.
- Longitudinal cracking is not typical of this section.

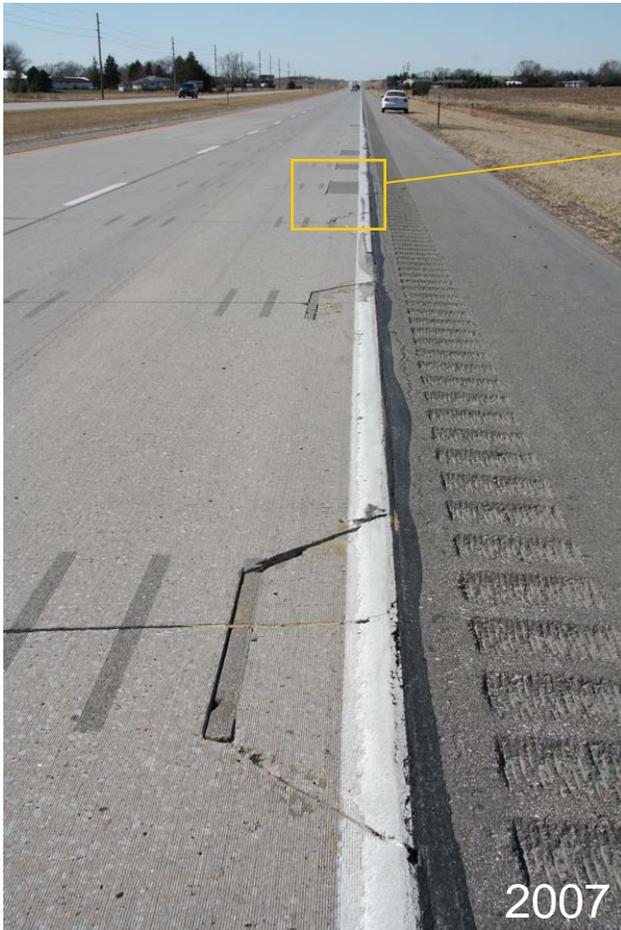
**Location:** MM 115.9

- Cracking along shoulder where dowel bars were retrofitted is common throughout the study section.
- Euroteck foam was used to prevent additional settling and to raise cracked panels.
- Retrofitted dowel bars placed too close to edge of pavement caused the cracking.
- Retrofitted dowel bars are now placed 6” closer to the centerline to prevent cracking of this type.

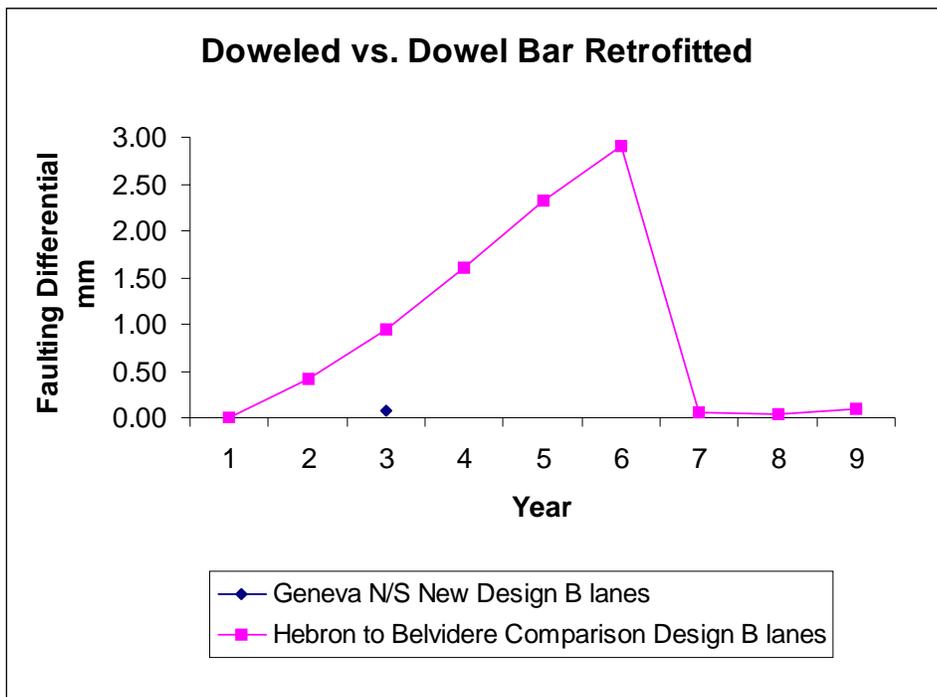
Figure 4.1: Faulting Differential, Geneva N/S and Hebron to Belvedere.

The doweled Geneva North and South section has outperformed the non-doweled conventional section with regard to most indicators.

A dowel bar retrofit in year seven of the Hebron to Belvidere section has resulted in faulting almost identical to that found when dowel bars were inserted during pavement construction.

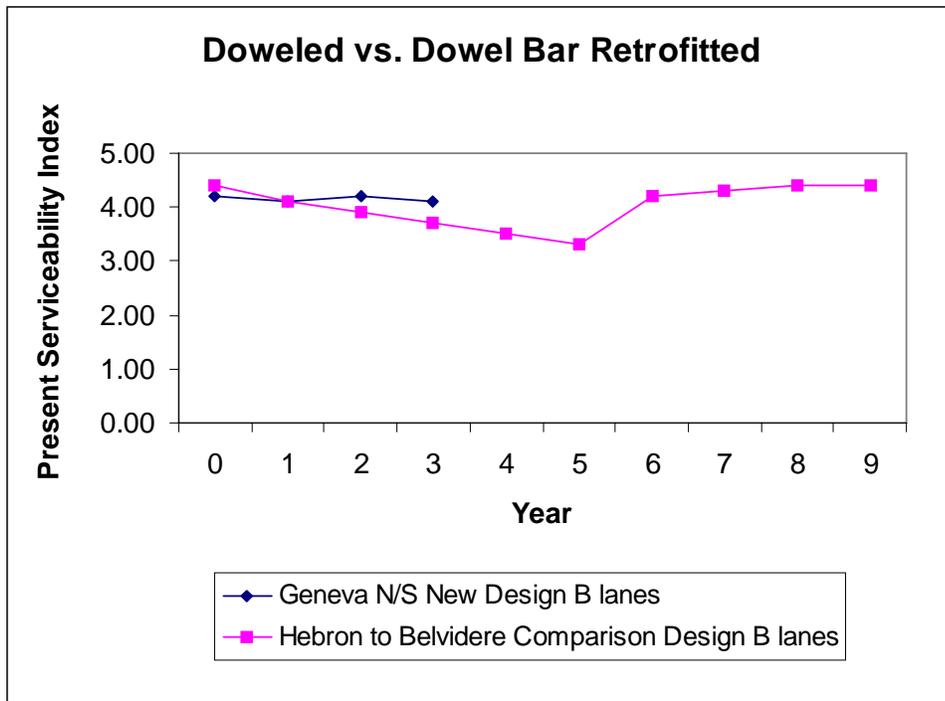
After five years, the Present Serviceability Index (PSI) dropped from a very good rating to a good rating. If that trend had continued, the PSI for Hebron to Belvidere would have decreased to a fair or poor rating within a few years.

The dowel bar retrofit in year seven increased the PSI to a level similar to that found in the innovative pavement section.

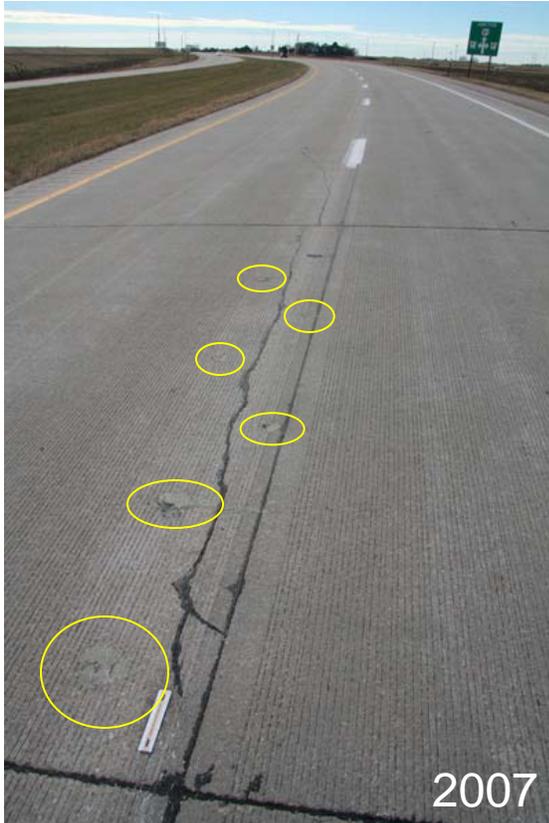
**Location:** MM 40

- Longitudinal cracking.
- Stitching with deformed bar to prevent further expansion of the cracks.

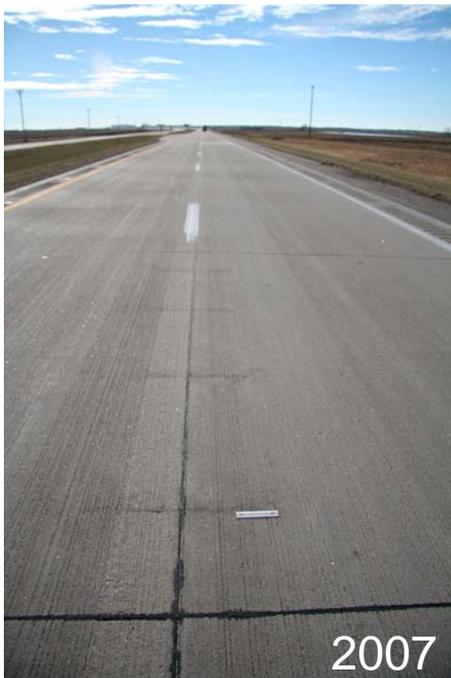
**Location:** MM 40.8

- Surface cracking extending through 11 to 12 panels along longitudinal joint.
- 2'8" cracks above tie bars across longitudinal joints.

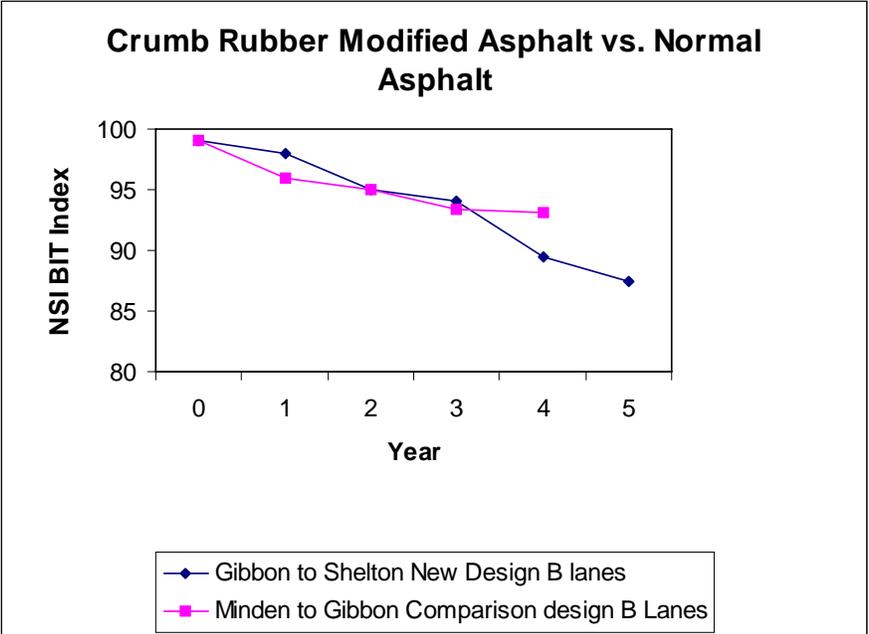
Figure 5.1: NSI Bit, Gibbon to Shelton and Minden to Gibbon.

The crumb rubber modified asphalt from Minden to Gibbon has outperformed the conventional asphalt comparison section with regard to surface condition of the pavement as measured by the NSI bituminous index (see graph at left).

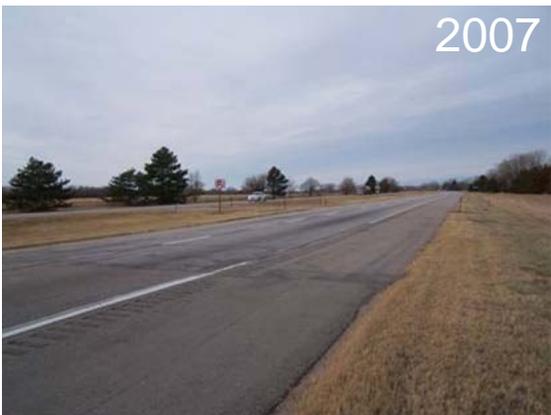
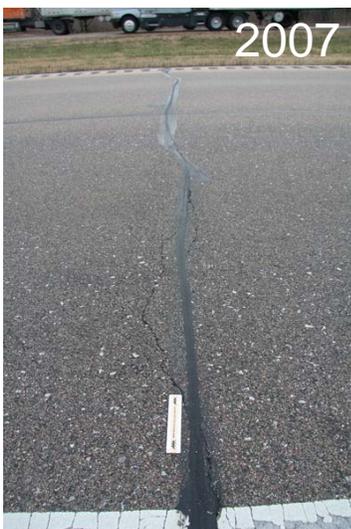
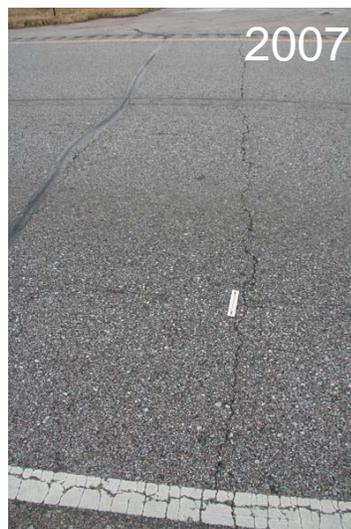
**Location:** MM 290.94

- Transverse cracking is common throughout the study section.

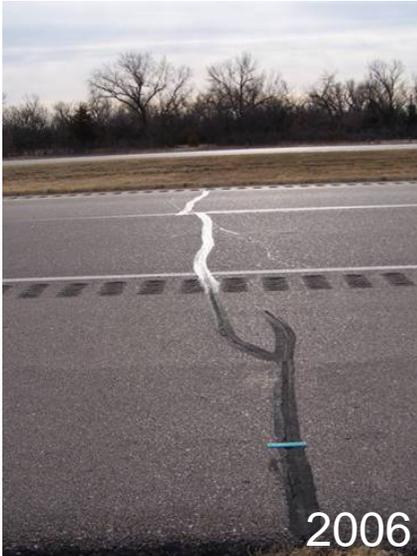
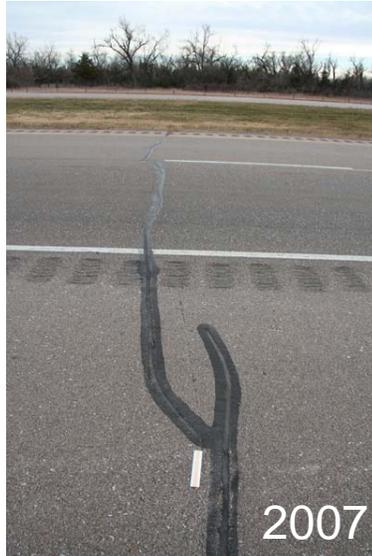
**Location:** MM 279.5

- High severity transverse cracking.
- Cracking beginning outside of areas where cracks have been sealed.

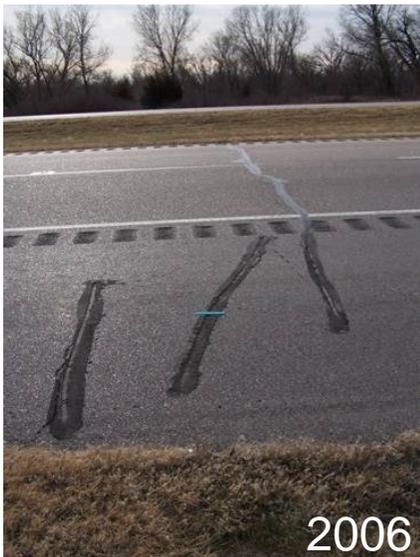
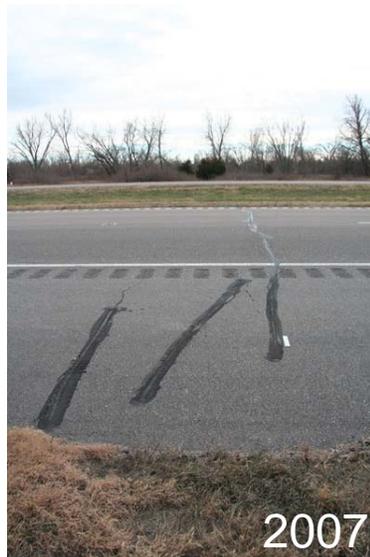
**Location:** MM 282

- High severity transverse cracking.
- High severity centerline cracking.

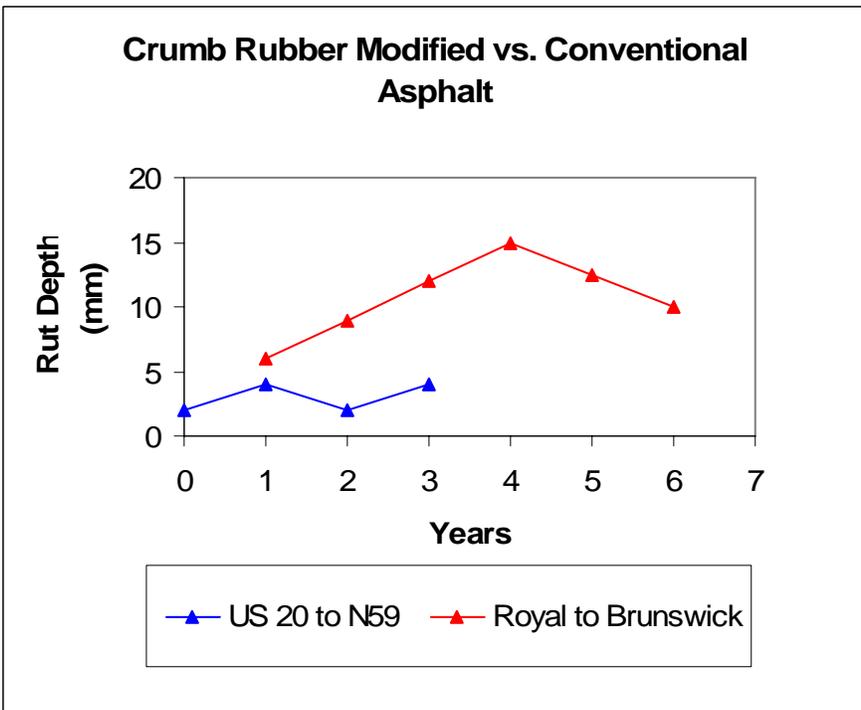
Figure 6.1: Rutting Depth, US20 to N59 and Royal to Brunswick.

The crumb rubber modified asphalt (US20 to N59) shows far less rutting than the conventional asphalt pavement section.

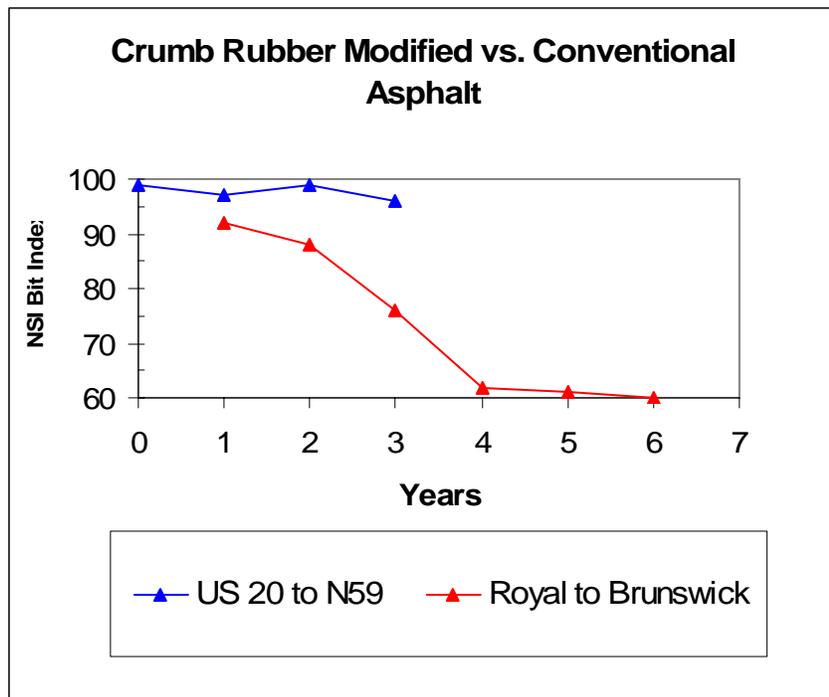
The crumb rubber modified asphalt (US20 to N59) has consistently outperformed conventional asphalt with regard to surface condition of the pavement as reflected by the NSI bituminous index.

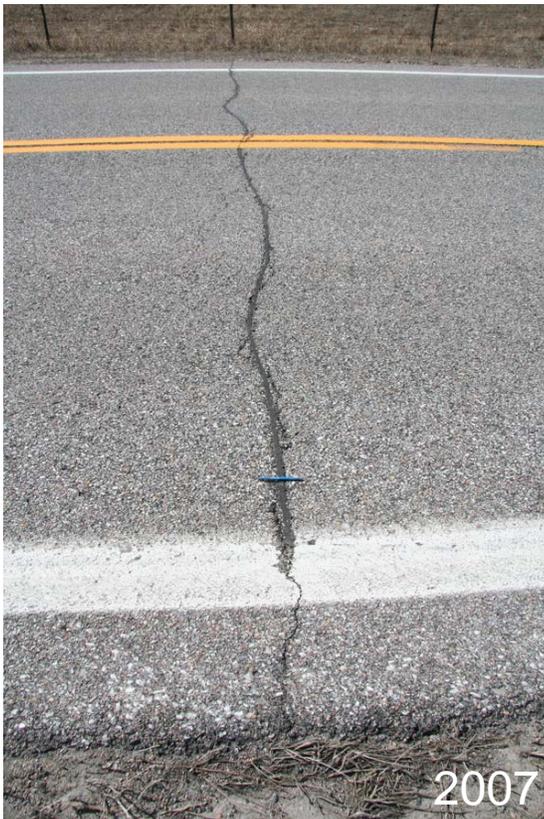
**Location:** MM 172.6

- Transverse cracking across both lanes and shoulder.

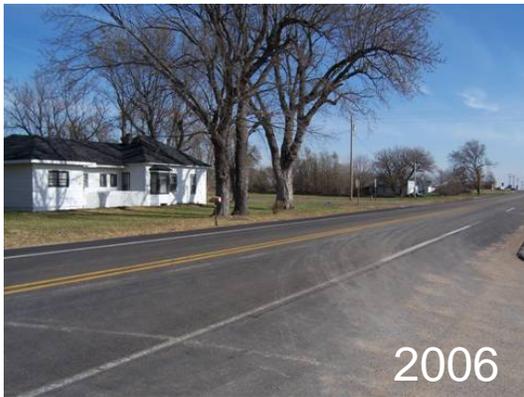
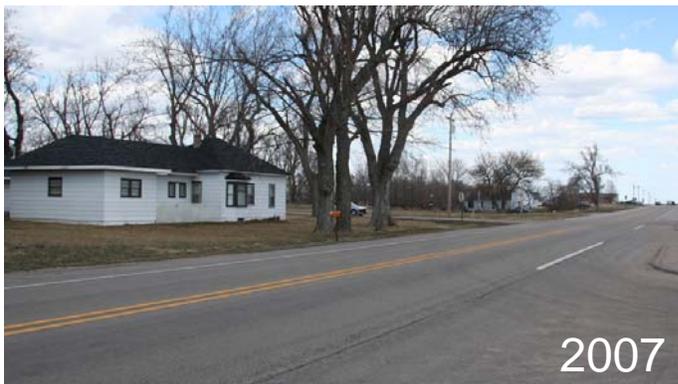
**Location:** MM 337.58

- New wearing course in 2006.
- Minor surface distortion; some appearance of wear in 2007.

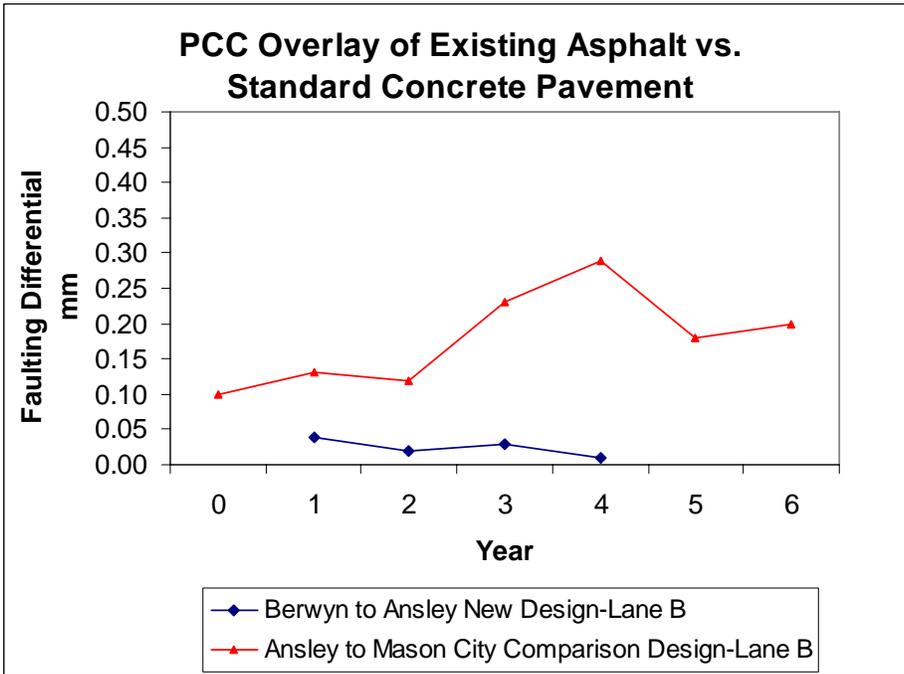
Figure 7.1: Faulting Differential, Berwyn to Ansley and Ansley to Mason City.

While the non-dowelled pavement has seen an increasing trend of faulting over the past six years, the dowelled pavement has shown little to no faulting over the four years of the study.

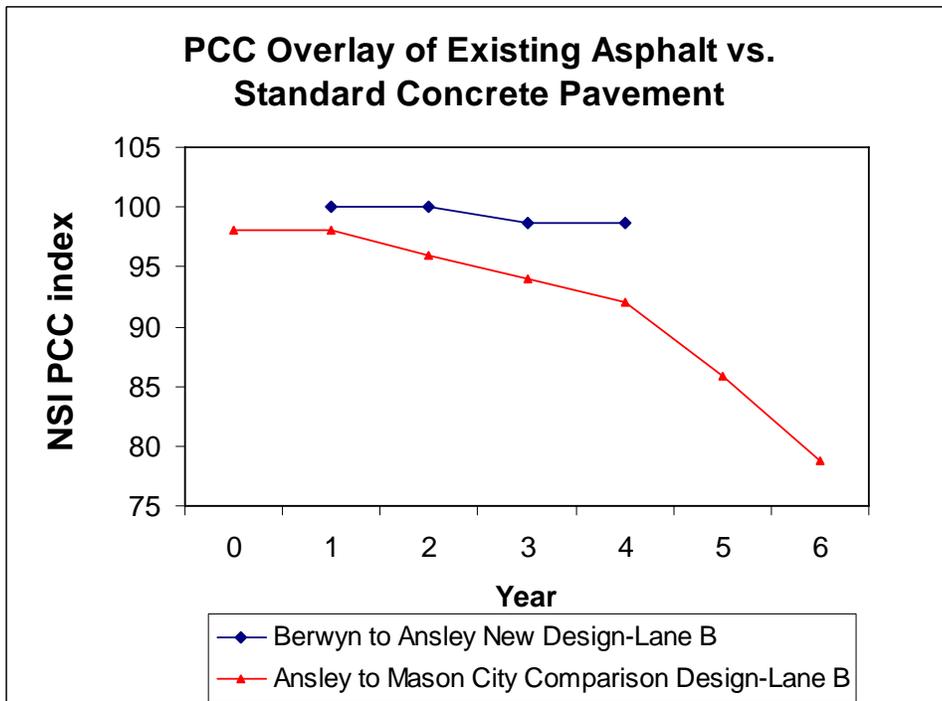
Figure 7.2: NSI PCC, Berwyn to Ansley and Ansley to Mason City.

The PCC overlay has outperformed the comparison section in relation to surface condition of the pavement.

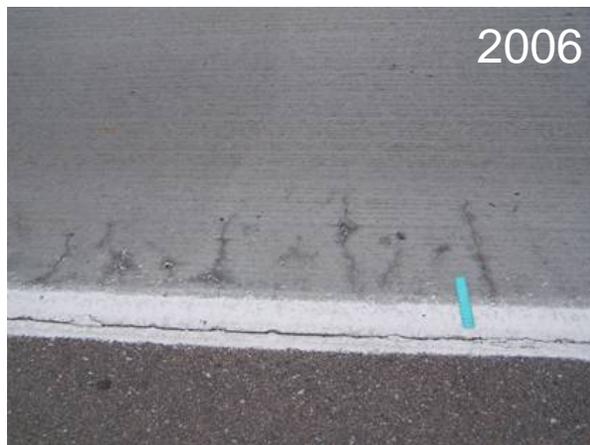
**Location:** MM 299.2

- Edge cracking adjacent to shoulder.

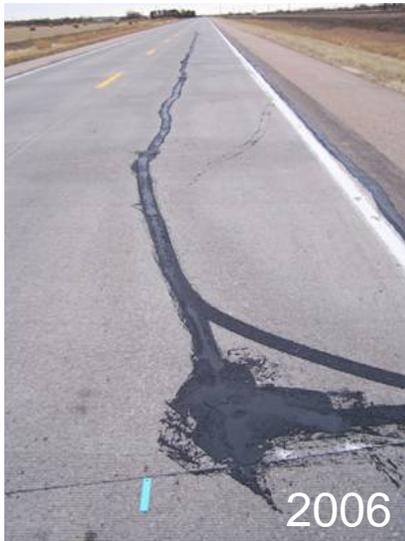
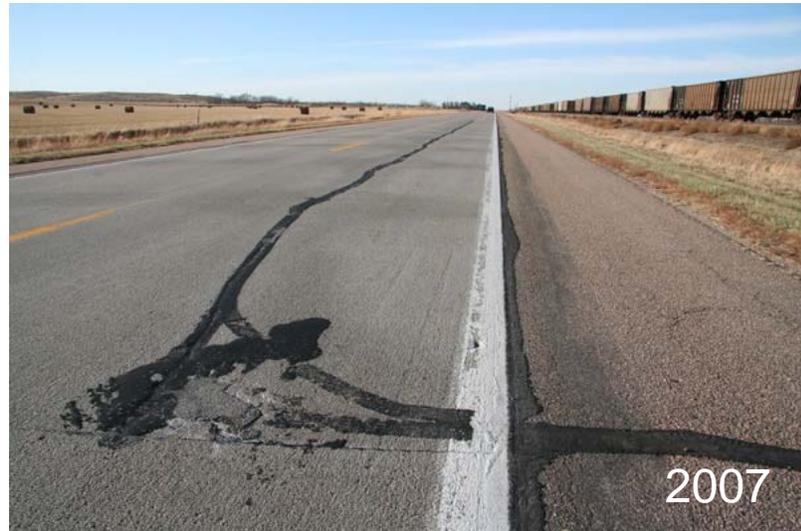
Location: MM 298.6

- High severity longitudinal cracking.
- Low pavement wear in wheel paths.
- ASR cracking at joints and cracks was less visible in 2007 than in 2006.

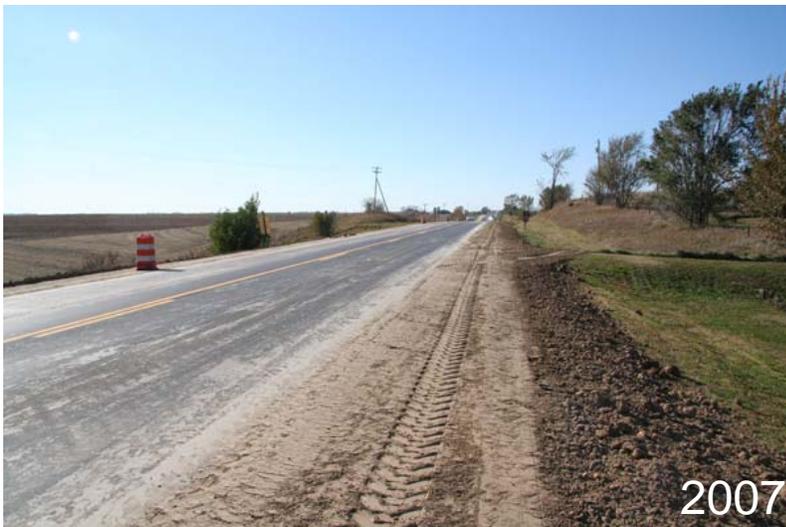
- Finish grading was being performed on the shoulders of study sections during site visit in fall of 2007.

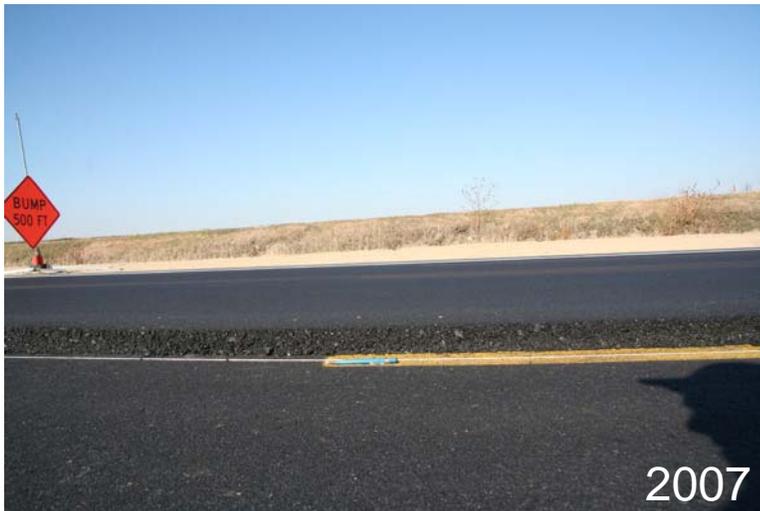
- Contractor was finishing construction during site visit in fall of 2007.
- Picture shows construction of wearing course.

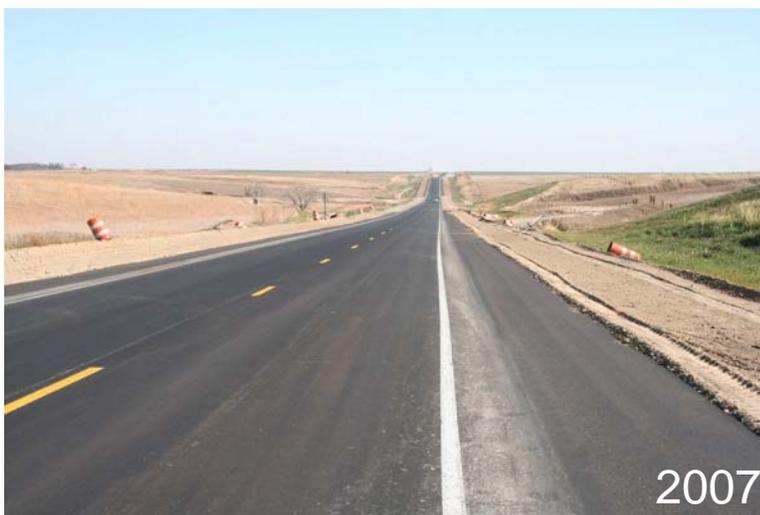
- Completed portion of section with final grading on the shoulder.

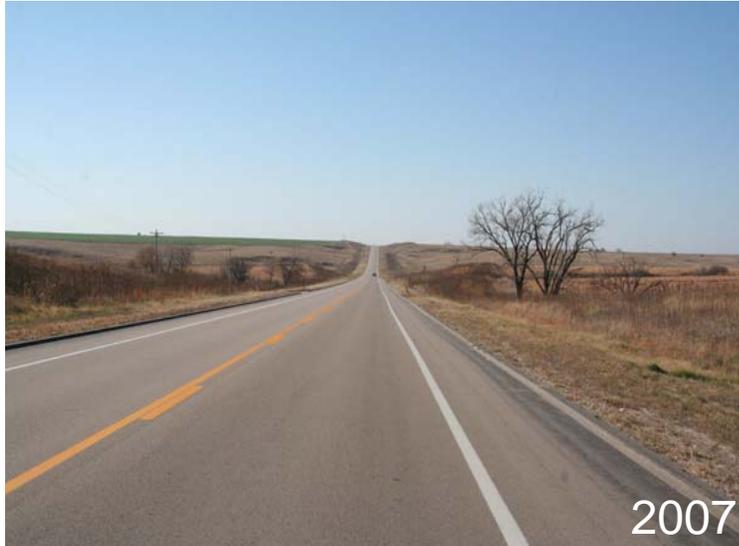
- The study section was in excellent condition during the fall of 2007.

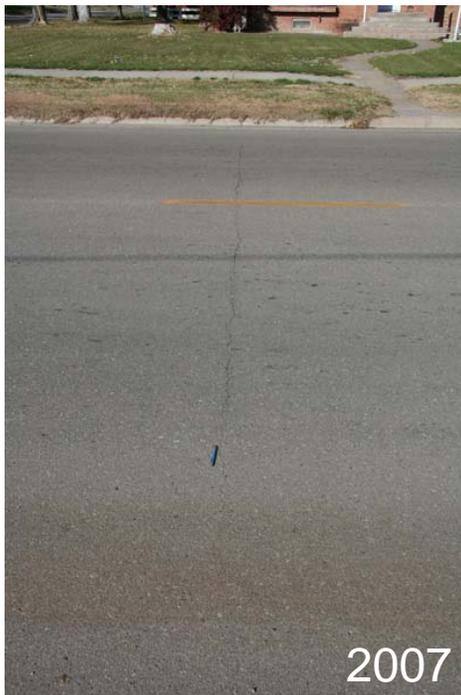
- Only visible crack was in Republican City near end of the study section.

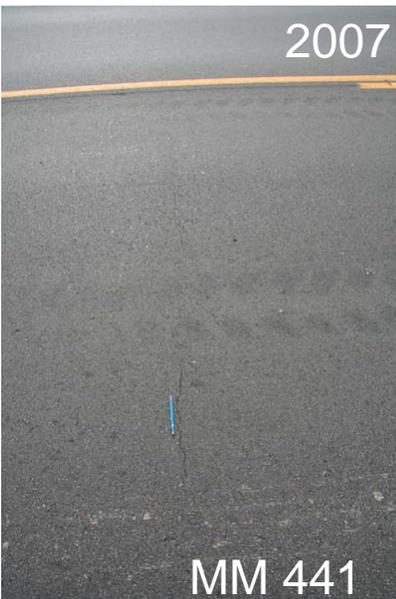
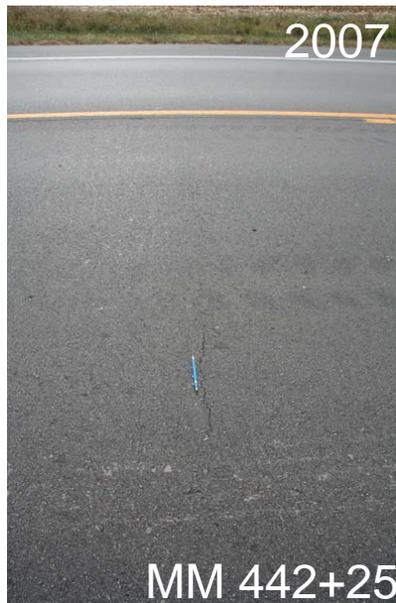
**Location:** MM 441 and 442+25

- Thin and short transverse cracking.
