The Archeology of an 1891 Officers' Quarters (25DW55-B-14) at Fort Robinson, Nebraska:

Report on the 2012 Excavation

By Amy Koch and Terry L. Steinacher

Prepared for the Nebraska Game and Parks Commission

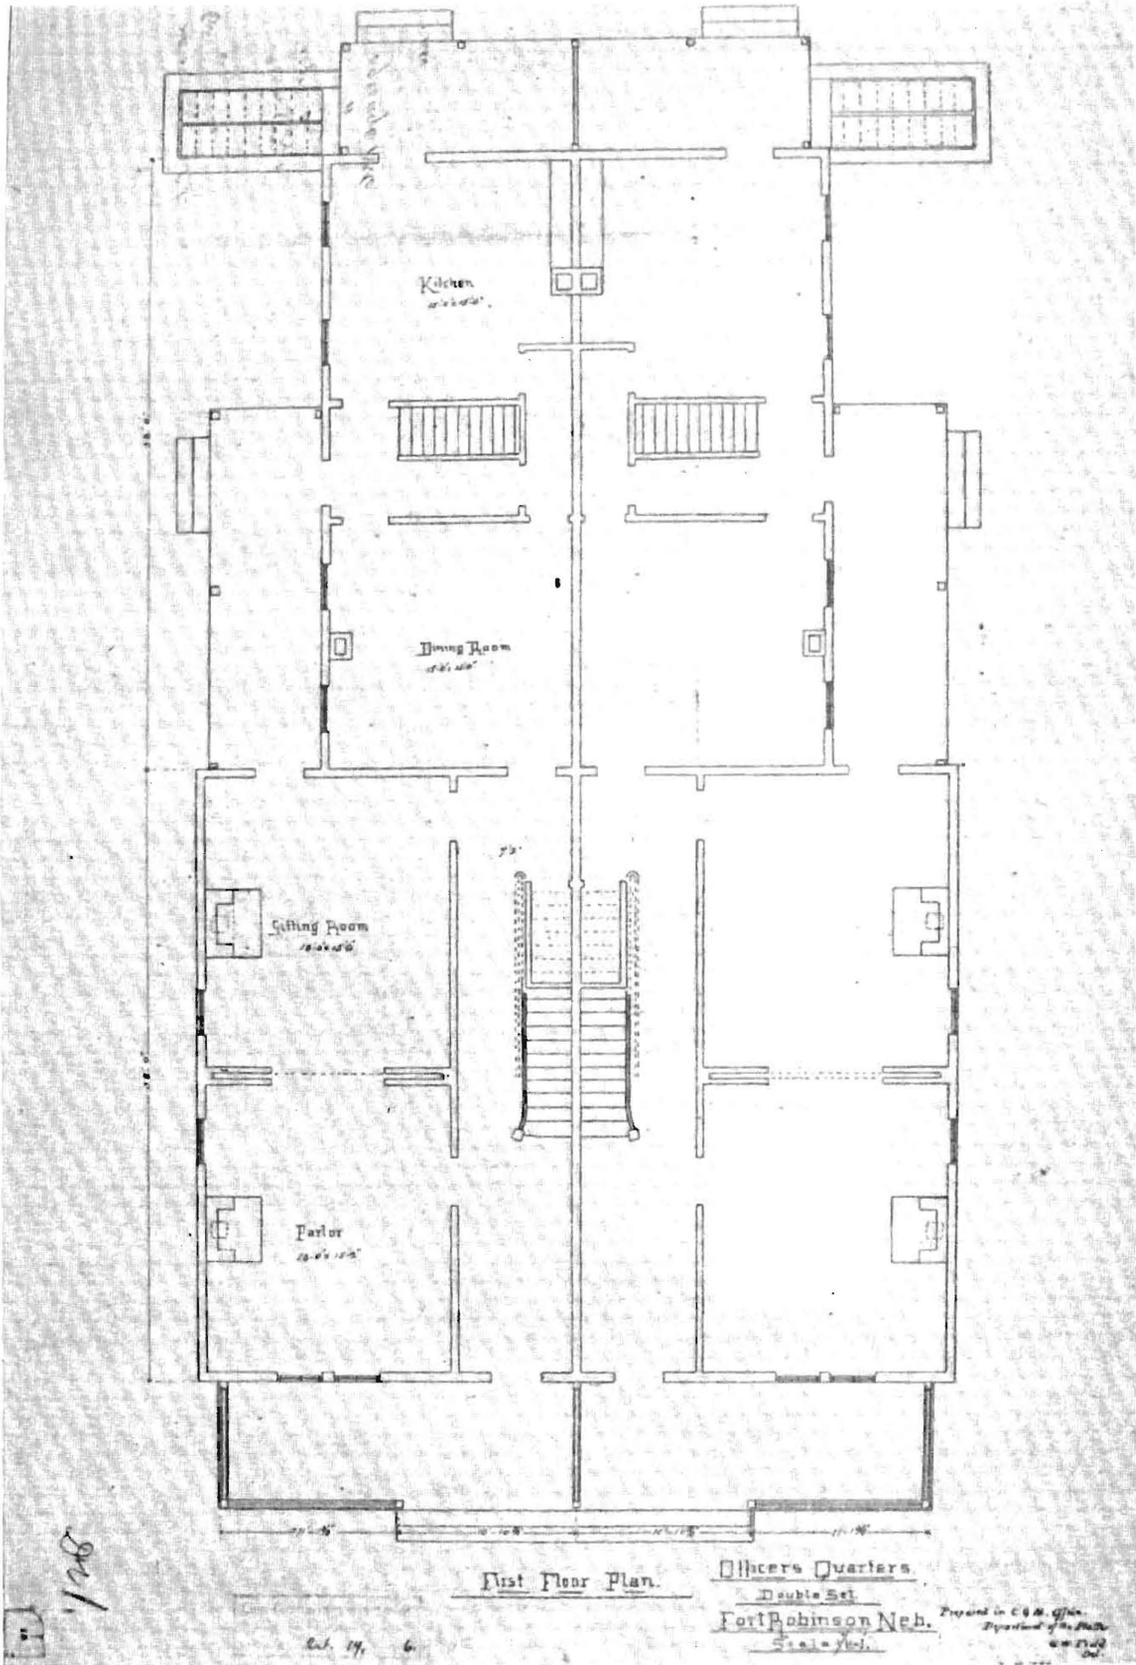
Figure 3. Plan No. OQ-36, Officers' Quarters, double set, 2 stories+attic, Date 1886, Basic Unit D from Grashof (1986).

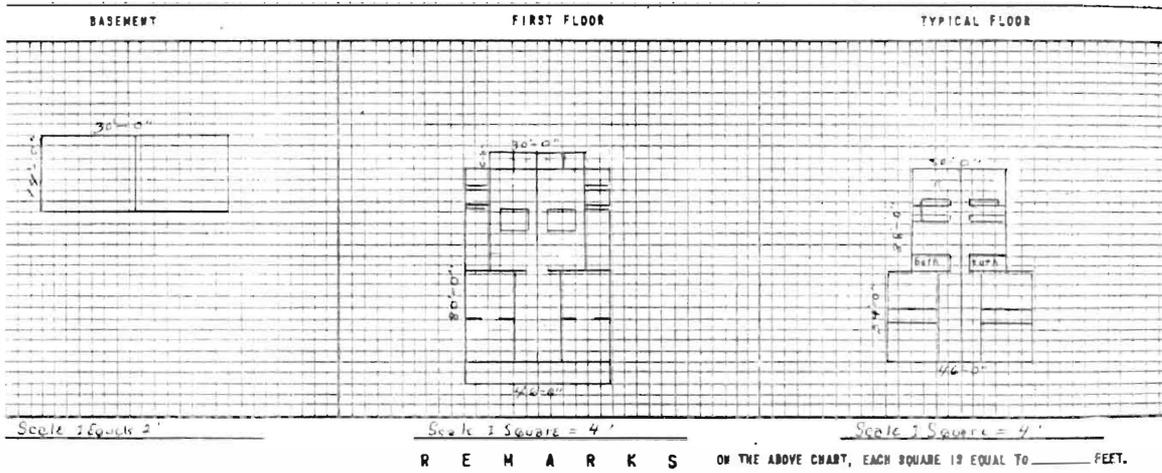
Figure 6. B-14 floor plan with room dimensions.

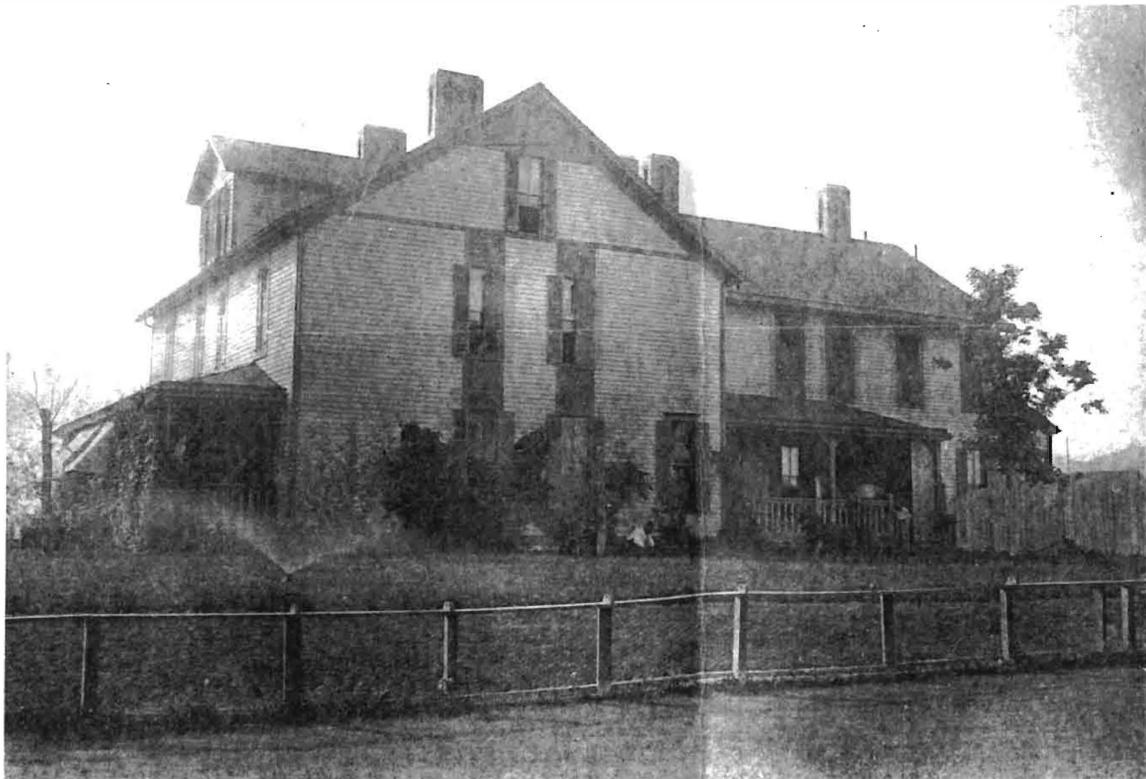
Plate 1. B-14 Officers' Quarters (1890s).

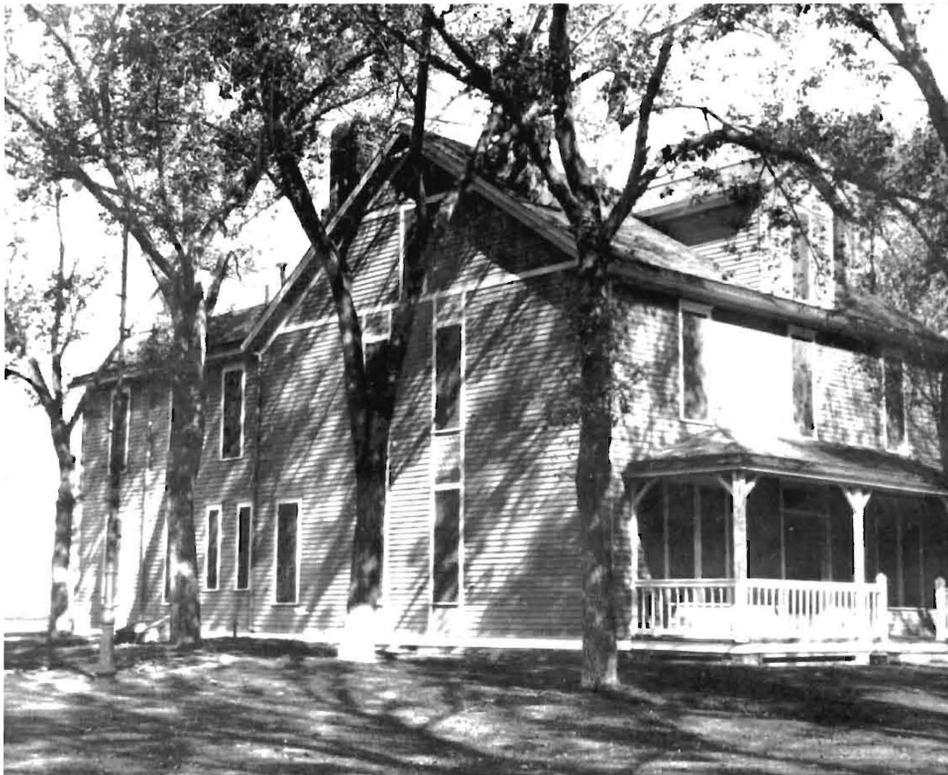
Plate 2. B-14 Officers' Quarters with enclosed side porches (1940s).

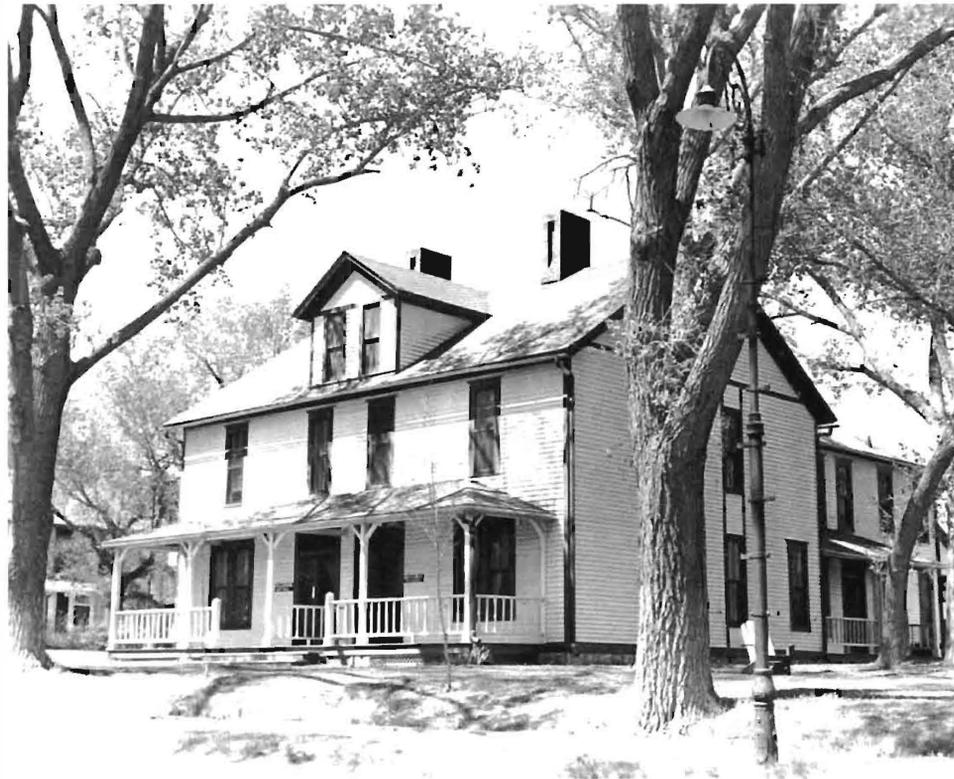
Plate 3. B-13 Officers' Quarters showing B-14 to the west (left).

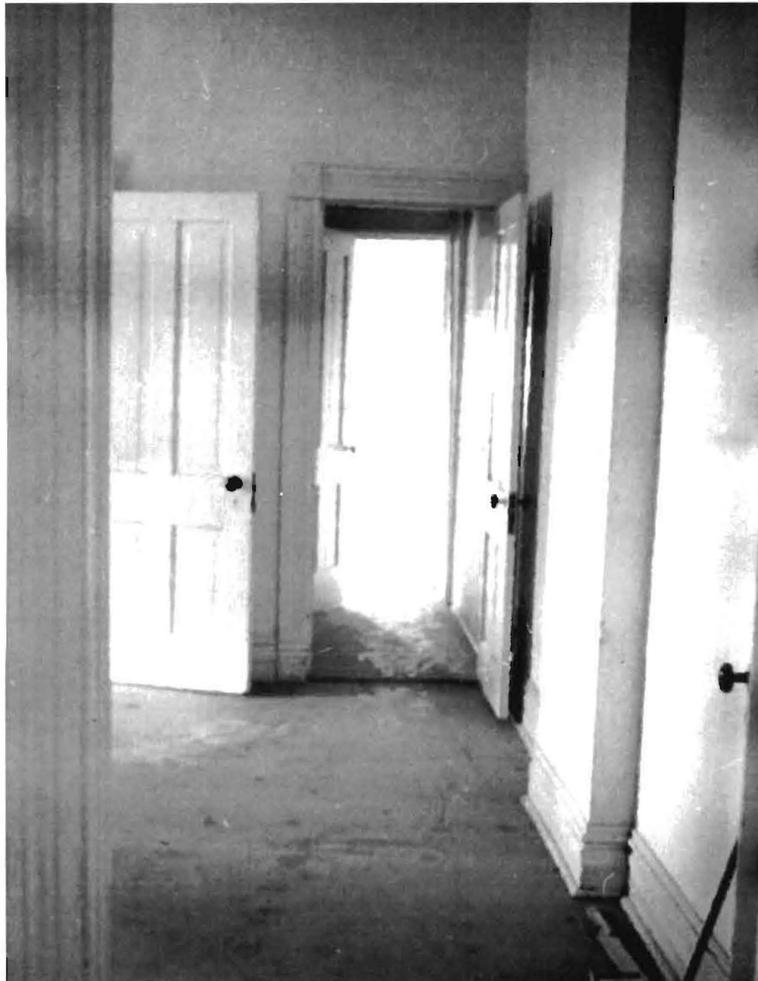
Plate 4. B-13 Officers' Quarters interior second floor.

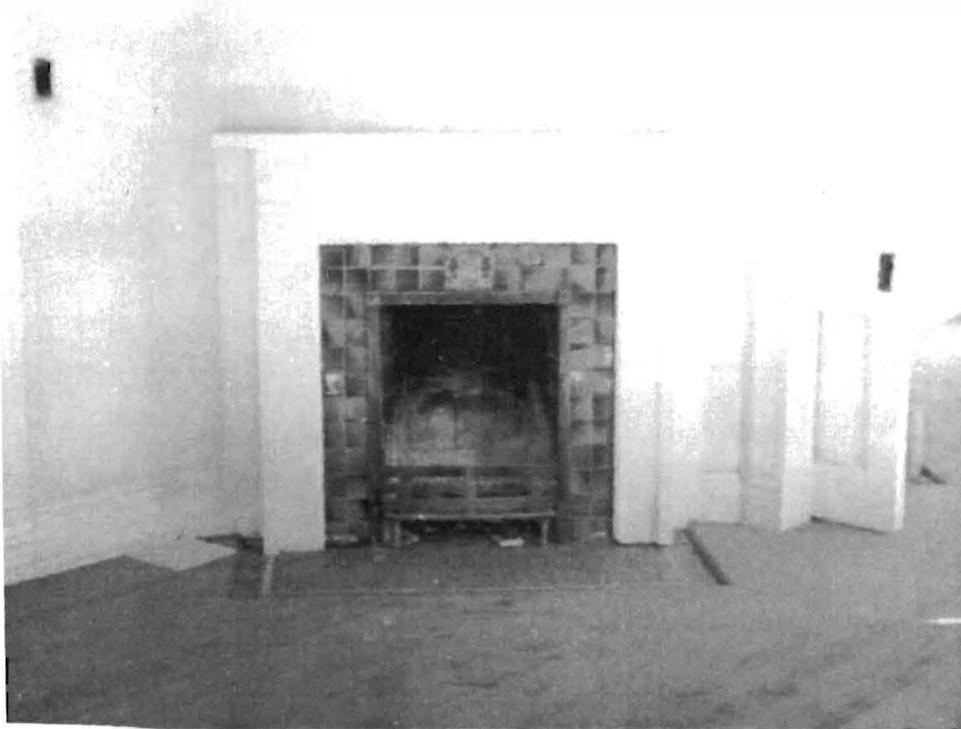
Plate 7. B-13 Officers' Quarters interior first floor.

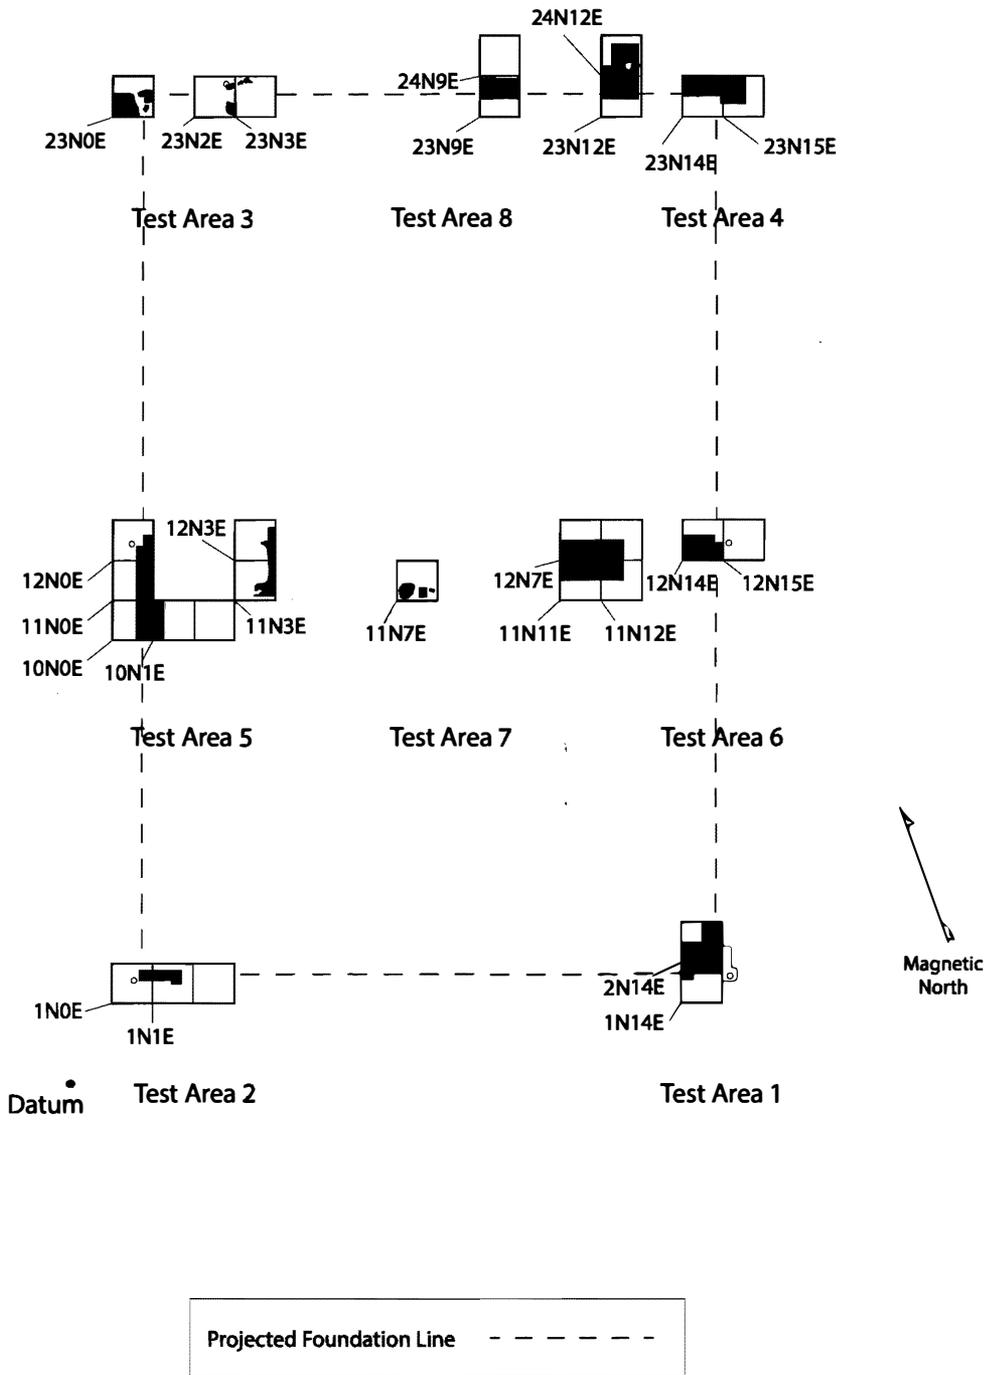
Figure 10. Plan view of 2012 test units excavated at 25DW55-B-14 Officers' Quarters.

In all, 20 1 x 1 m, three 1 x 0.5 m, one 0.75 x 0.75 m, two 0.5 x 0.5 m, and two 0.25 x 0.25 m units were excavated (Figure 10). Depths ranged from 10-70 cm. Excavations resulted in various patterns and unit dimensions. Since each unit was placed with specific objectives in mind, e.g. locating the southwest corner of the foundation, several continuous units can be grouped based upon the reasons they were excavated. They are: Areas 1-4 (search for building corners); Areas 5-7 (search for exterior and interior wall foundations; Area 8 (investigate the basement feature).

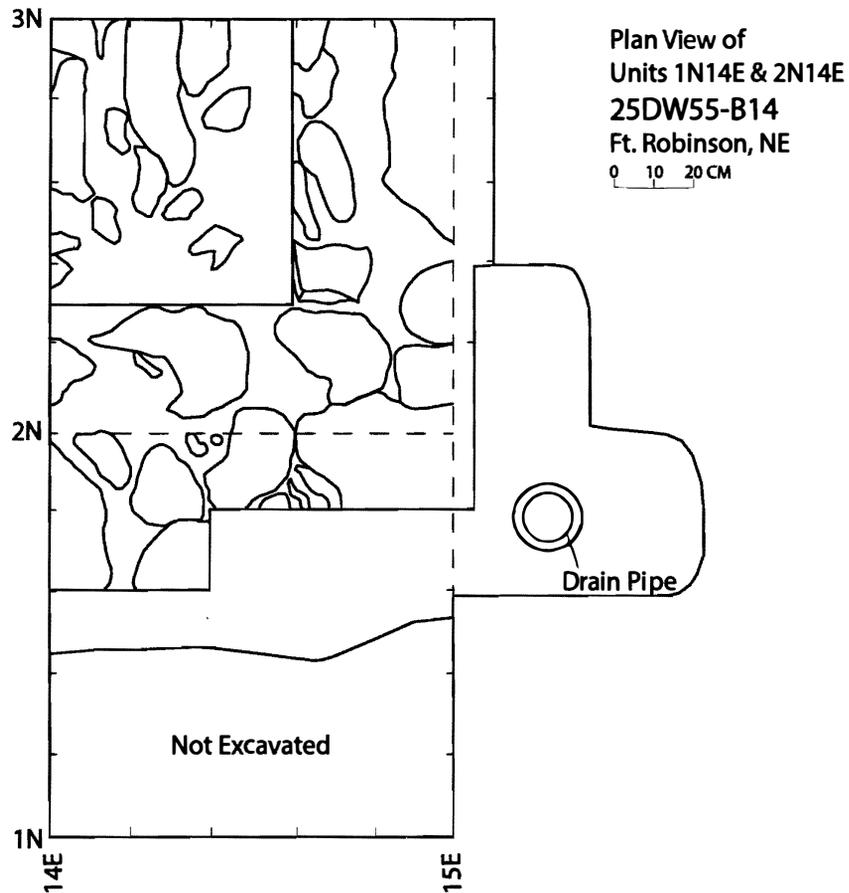
Figure 11. Plan view of test units 1N 14E & 2N 14E (Test Area 1), showing the southeast corner of the building foundation and exterior drain pipe.

Located in the southeast portion of the site grid, Area 1 consisted of two 1 x 1 meter squares (1N14E and 2N14E) excavated to locate the southeast corner of the foundation (Plate 15) (Figures 11, 12, and 13). The contiguous units were excavated to depths ranging from 20-40 cm. These units were originally placed as a result of exploratory shovel skimming a portion of what was assumed to be a north-south wall segment exposed on the surface. When exposed, the foundation corner consisted of limestone rocks held together by concrete mortar. The exterior face of the foundation was plastered with a smooth stucco finish approximately 2 ½ in thick. Width of the foundation wall from north to south was

40 cm; width of the foundation wall from east to west was approximately 50 cm. A clay drain pipe, oriented vertically, was exposed while cleaning around the edges of the foundation. Given the pipe's position relative to the foundation wall, it was likely outside the building. A concentration of rubble and mortar was exposed interior to the foundation corner. This may have been the result of walls crumbling during demolition (Plate 16).

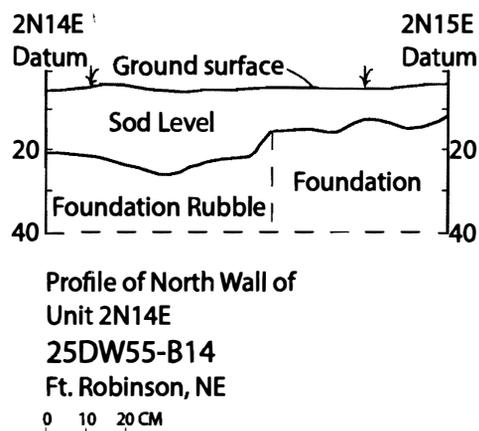
Figure 12. Profile of test unit 2N 14E (Test Area 1) north wall, showing foundation and interior rubble.

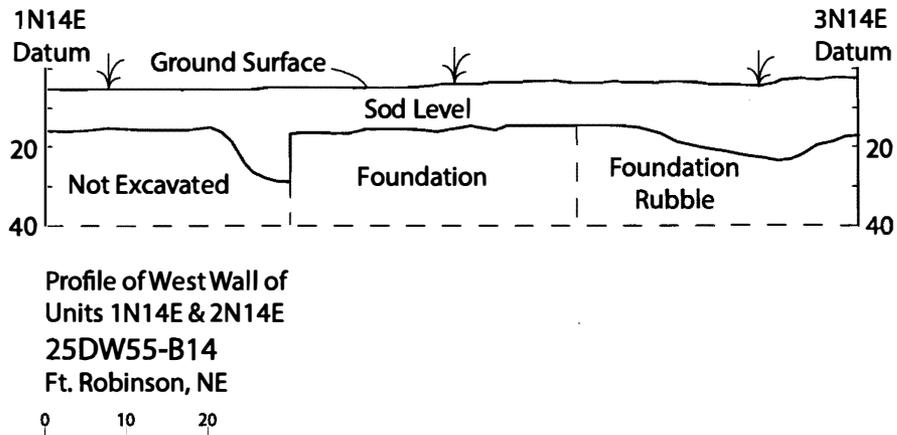
Figure 13. Profile of test units 1N 14E & 2N 14E (Test Area 1) west wall, showing foundation and interior rubble.

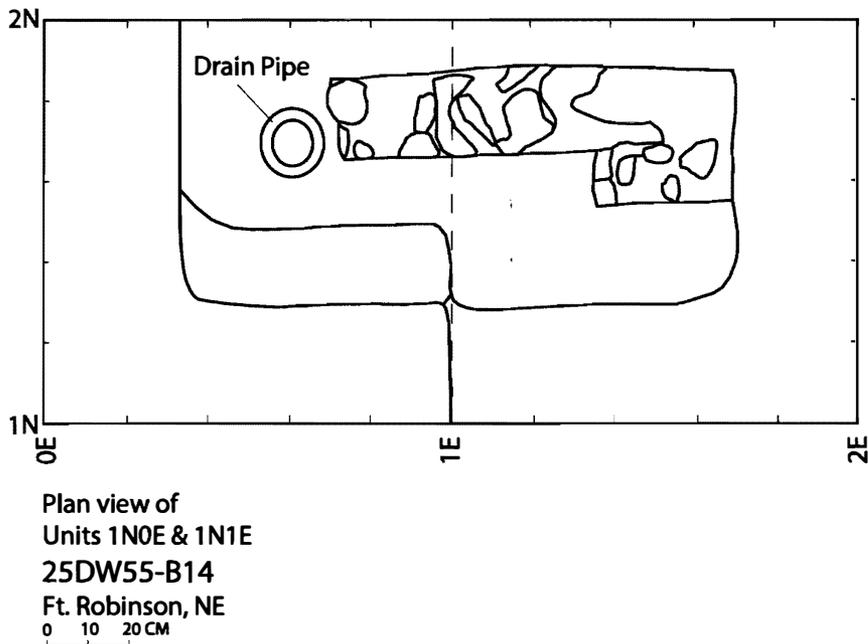
Figure 14. Plan view of test units 1N 0E & 1N 1E (Test Area 2), showing southwest corner of the building foundation and exterior drain pipe.

Located in the southwest portion of the site grid, Area 2 consisted of three 1 x 1 meter squares (1N0E, 1N1E and 1N2E) excavated to locate the southwest corner of the foundation (Plate 17). The contiguous units were excavated to depths ranging from 20-30 cm. The first of these units excavated (1N2E) yielded no foundation remains and was abandoned. The foundation corner, exposed in units 1N0E and 1N1E mirrored the southeast corner uncovered in Area 1. The exterior face of the foundation was also plastered with smooth stucco. Wall widths appeared to be similar to the southeast corner. Due to the position of the units within the grid, the entire interior/exterior walls of the corner were not fully exposed to enable full width measurements or observe whether fallen rubble was present interior to the foundation. A clay drainpipe, oriented vertically, was also exposed exterior to the building (Figure 14).

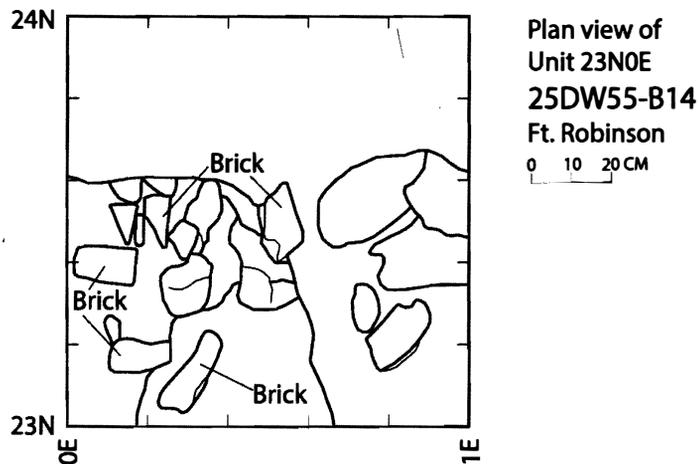
Figure 15. Plan view of test unit 23N 0E (Test Area 3), showing outside porch foundation corner and brick support remnants.

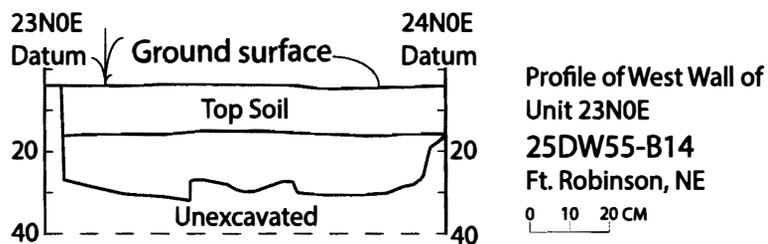
Figure 16. Profile of test unit 23N 0E (Test Area 3), west wall.

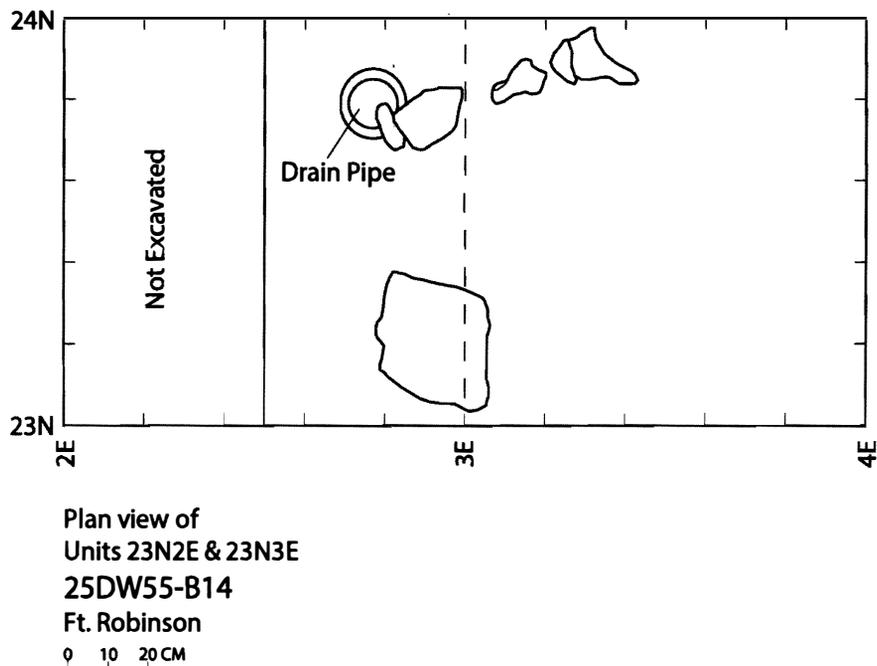
Figure 17. Plan view of test units 23N 2E & 23N 3E (Test Area 3), showing heavily disturbed northwest corner of building with exterior drain pipe in situ.

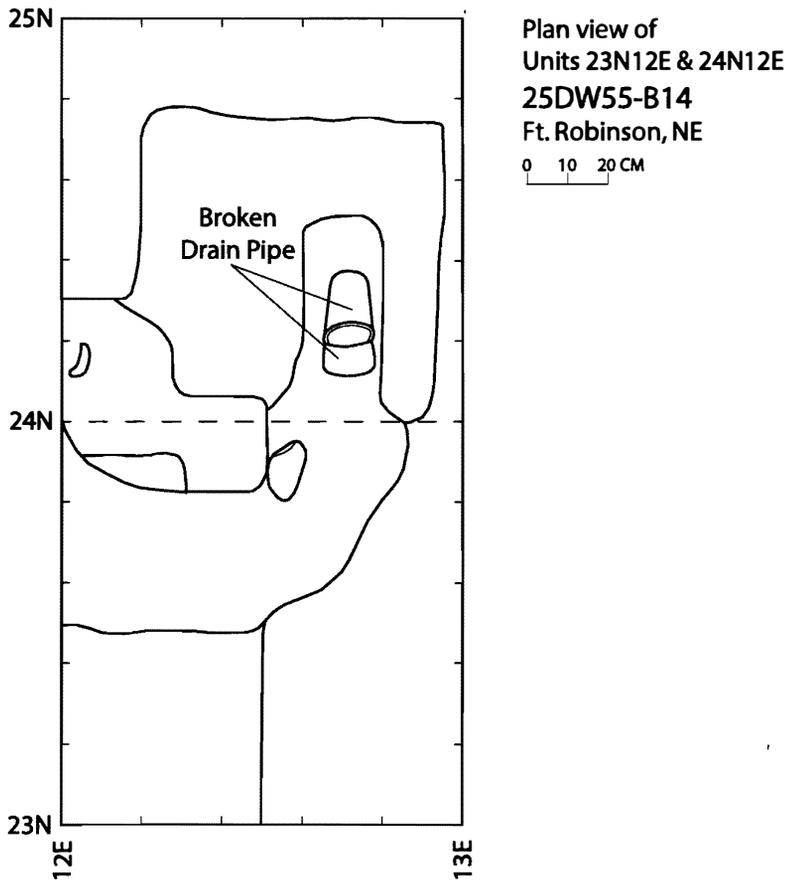
Plan view of
 Units 23N12E & 24N12E
 25DW55-B14
 Ft. Robinson, NE
 0 10 20 CM

Figure 19. Plan view of test units 23N 12E & 24N 12E (Test Area 4), showing original northeast corner of building and exterior drain pipe.

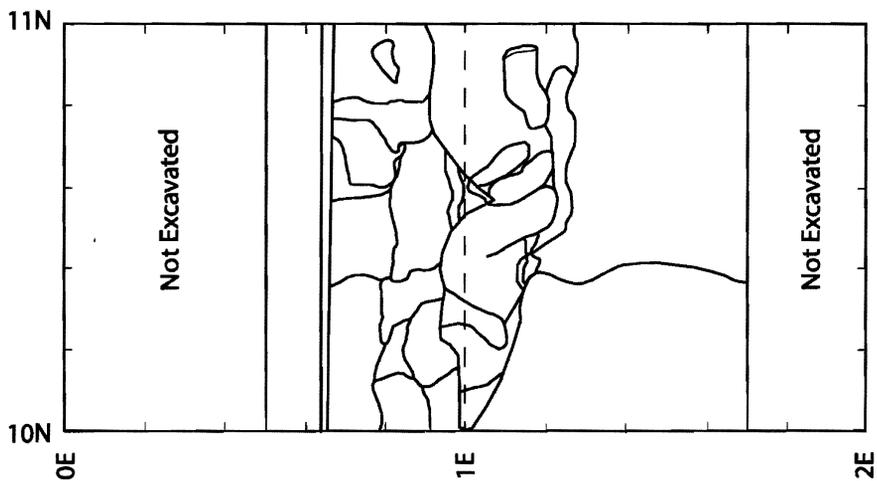
Plan view of
Units 10N0E & 10N1E
25DW55-B14
Ft. Robinson, NE
0 10 20 CM

Figure 20. Plan view of test units 10N 0E & 10N 1E (Test Area 5), showing west wall remnant of building foundation.

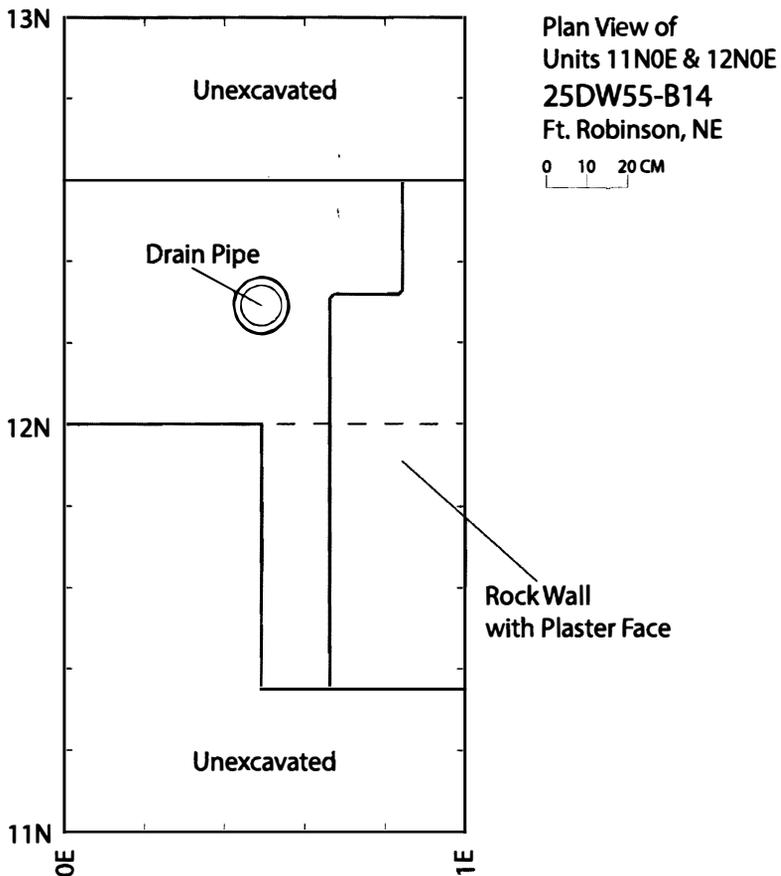
Plan View of
Units 11N0E & 12N0E
25DW55-B14
Ft. Robinson, NE
0 10 20 CM

Figure 21. Plan view of test units 11N 0E & 12N 0E (Test Area 5), showing portions of west foundation wall, corner of original porch, and exterior drain pipe.

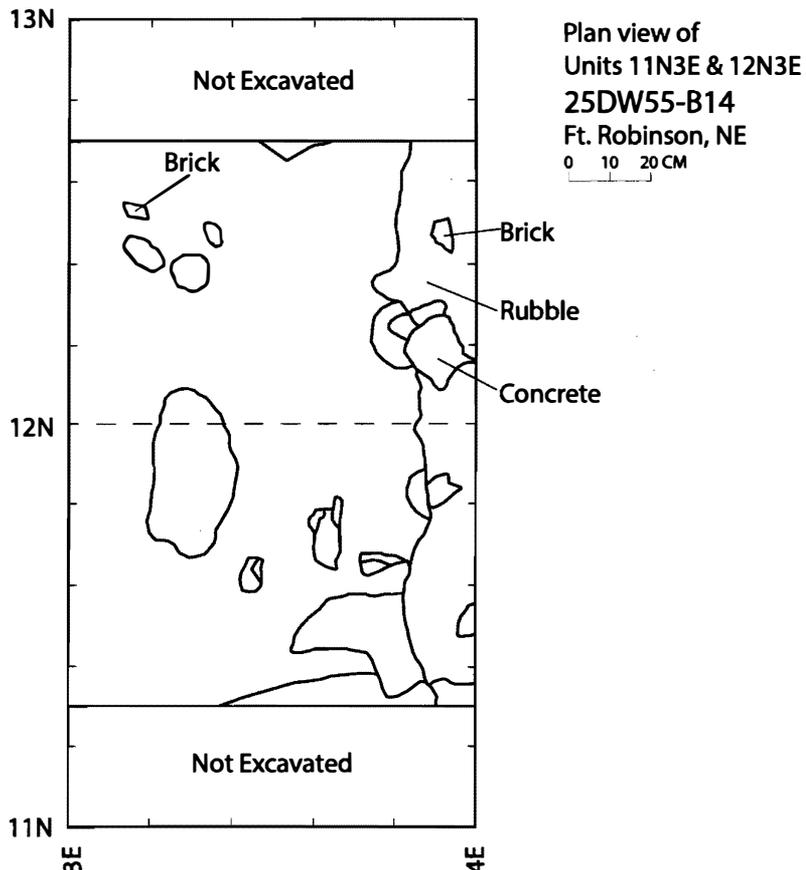
Figure 22. Plan view of test units 11N 3E & 12N 3E (Test Area 5), showing interior rubble pile of foundation stones and brick fragments.

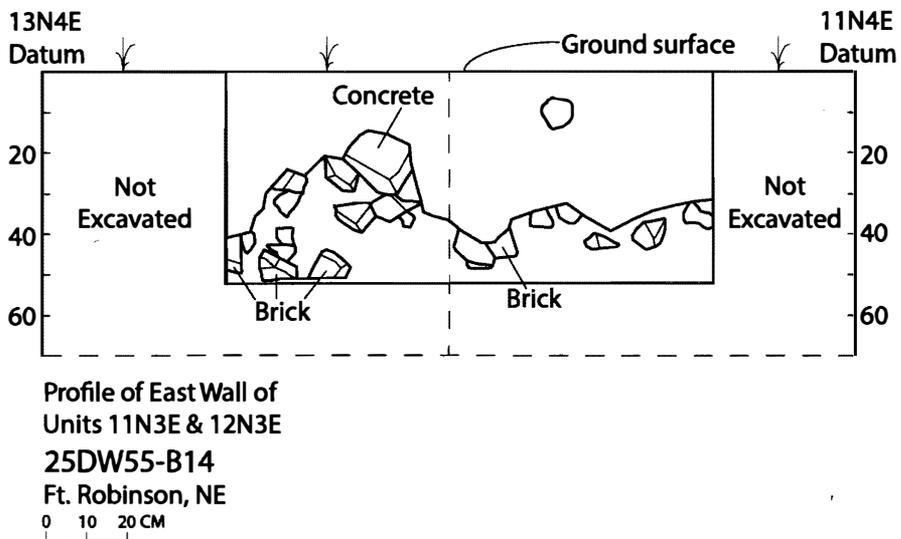
Figure 23. Profile of test units 11N 3E & 12N 3E (Test Area 5) east wall, showing interior rubble pile of foundation stones and brick fragments.

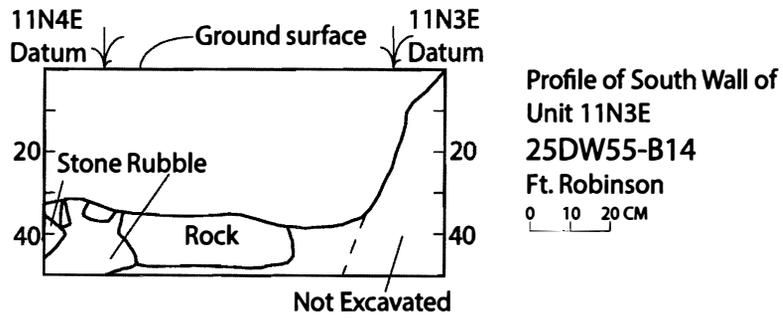
Figure 24. Profile of test unit 11N 3E (Test Area 5) south wall, showing interior rubble pile of foundation stones.

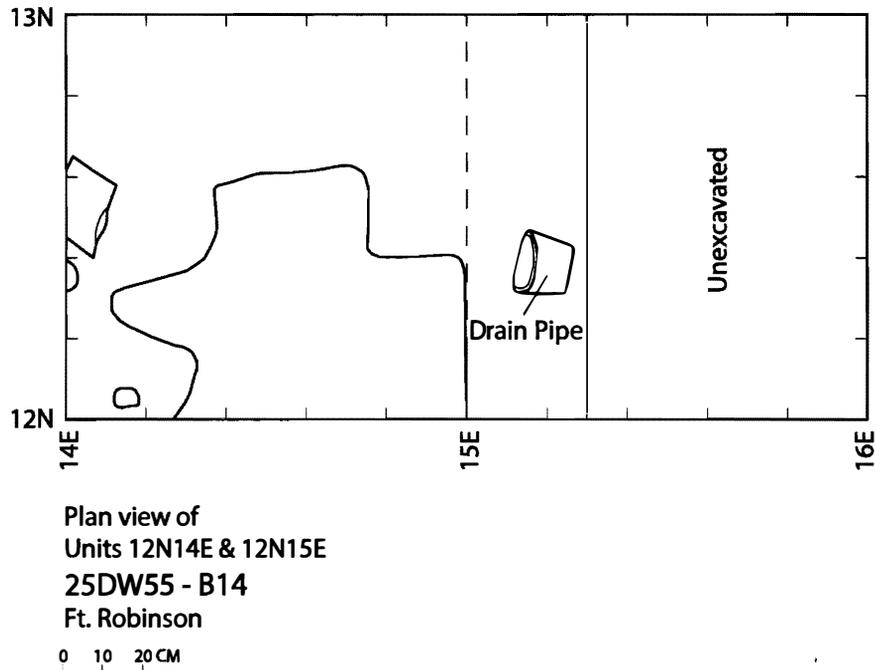
Figure 29. Plan view of test units 12N 14E & 12N 15E (Test Area 6), showing corner of original porch along east foundation wall and exterior drain pipe.

Located along the eastern portion of the site grid, Area 6 consists of one set of four units (12N11E, 12N12E, 11N11E, and 11N12E) (Figure 25, 26, 27, and 28) and one set of two units (12N14E and 12N15E) (Figure 29). Of the four unit set, the first two listed measured 0.5 x 0.5 m and the second two units measured 0.25 x 0.25 m. Excavated to a depth of 45 cm these units revealed a portion of a disturbed interior wall (Plate 24). The set of two contiguous units were excavated to depths ranging from 20-40 cm. Excavation of these units revealed an outside foundation corner identical in structure to the corner excavated Area 5 on the west side of the building (Plate 25). A clay drainage pipe exterior to the building was also uncovered (Plate 26).

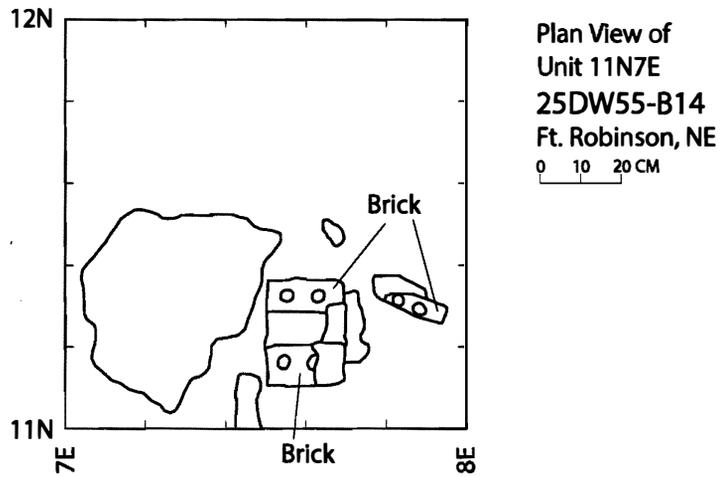
Figure 30. Plan view of test unit 11N 7E (Test Area 7), showing possible interior foundation wall and concrete/brick support.

Located near the center of the site grid, Area 7 consists of one 1 x 1 m square (11N7E). This unit was excavated to a depth of 10 cm to expose remains of a possible interior foundation wall and a large concrete and brick support (Plate 27) (Figure 30).

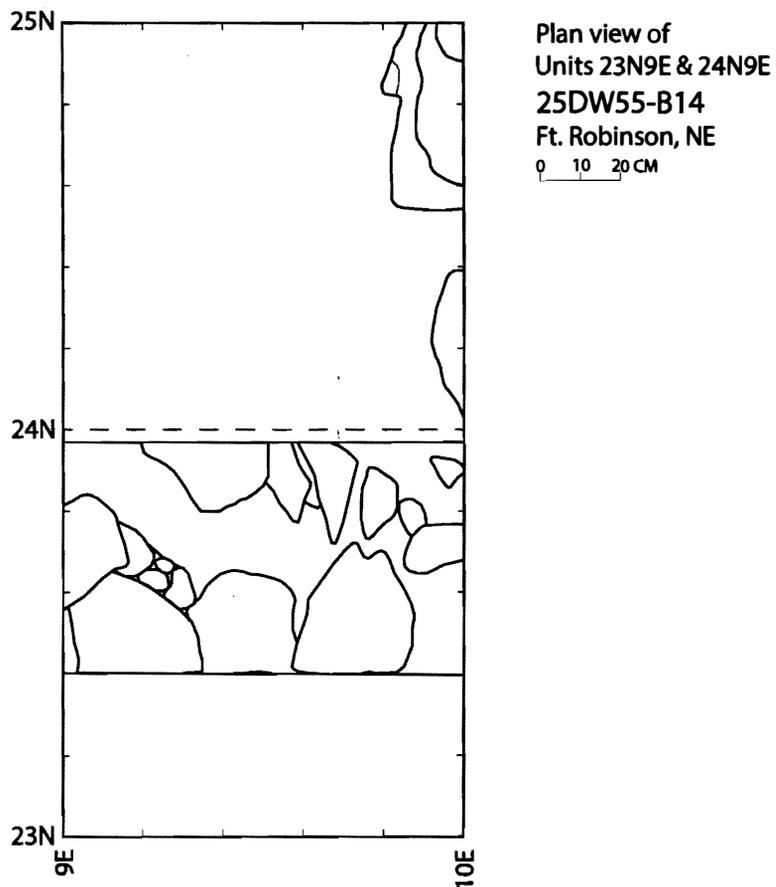
Figure 31. Plan view of test units 23N 9E & 24N 9E (Test Area 8), showing rear wall of building foundation.

Located near the rear of the structure and the north end of the site grid, Area 8 consists of two contiguous 1 x 1 m units (23N9E and 24N9E) (Figure 31, 32, 33, 34, and 35). These units were excavated to depths ranging from 40-70 cm to investigate the rear of the quarters and the basement feature. The first of these units excavated (23N9E) exposed a foundation wall section running from east to west associated with the rear of the building. The second unit excavated to the north is most likely associated with a basement type feature. Plans from the archive file indicate the feature measured 14 x 30 ft. A considerable amount of coal and clinker (burned coal) was recovered from these units (Plates 28, 29).

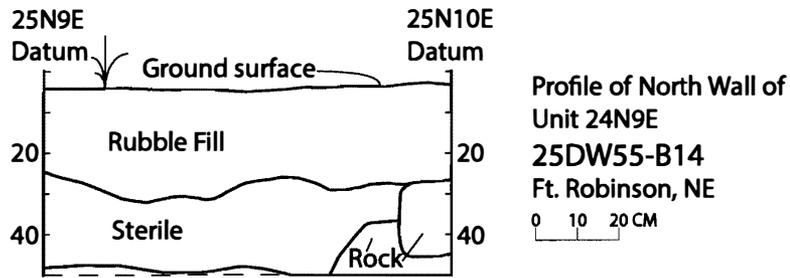
Figure 32. Profile of test unit 24N 9E (Test Area 8) north wall, showing rubble filled basement feature.

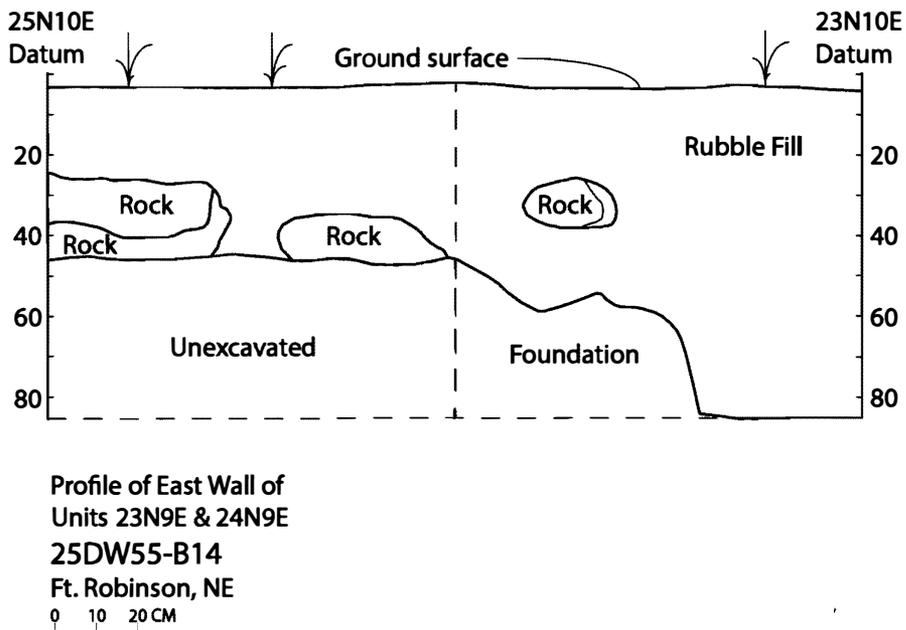
Figure 34. Profile of test units 23N 9E & 24N 9E (Test Area 8) east wall, showing rear wall of foundation.

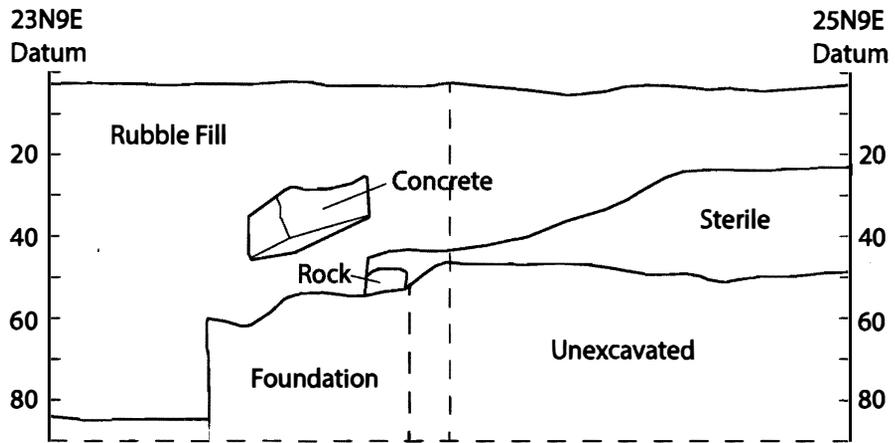
Profile of West Wall of
 Units 23N9E & 24N9E
 25DW55-B14
 Ft. Robinson, NE

Figure 35. Profile of test units 23N 9E & 24N 9E (Test Area 8) west wall, showing rear wall of foundation.

The basement area noted in plans was investigated by several test squares to confirm the feature's existence and determine if significant artifactual material was present that would add to the interpretation of the building. The basement was located, but unfortunately it was filled with rubble and large amounts of furnace coal, slag, and clinker (Figure 35). No further excavation was therefore conducted into the basement.

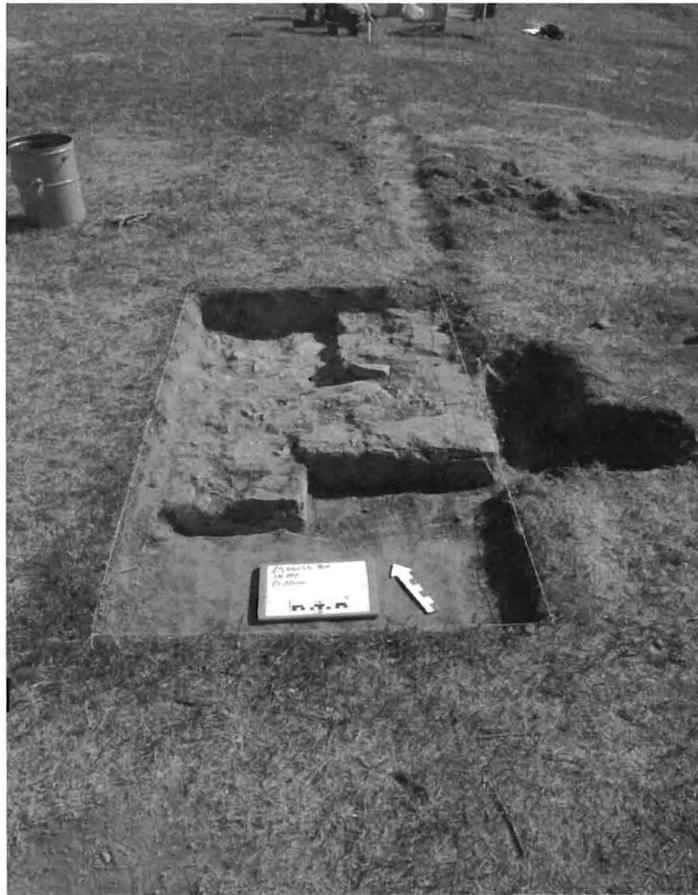
Plate 15. Plan view of Test Area 1 (southeast corner of building) includes test units 1N 14E & 2N 14E.

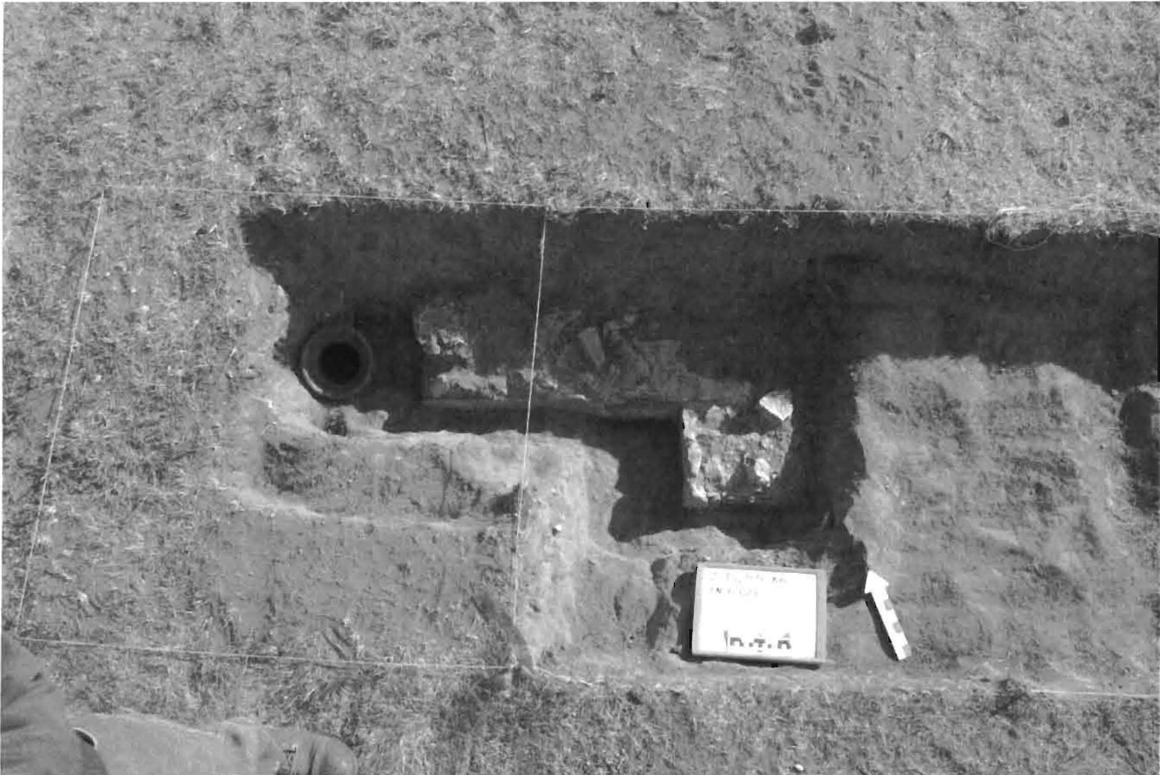
Plate 17. Plan view of Test Area 2 (southwest corner of building) includes test units 1N 0E, 1N 1E, & 1N 2E.

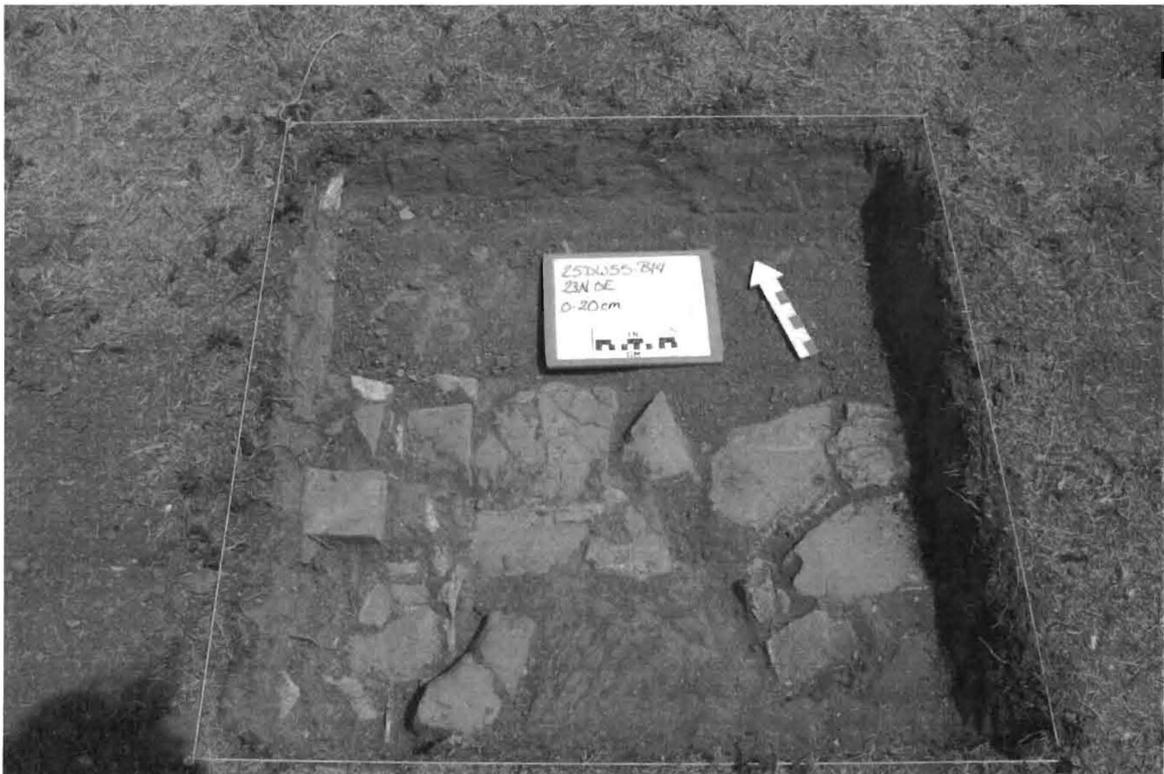
Plate 18. Plan view of Test Area 3 (outside porch foundation corner and brick support remnants) includes test unit 23N 0E.

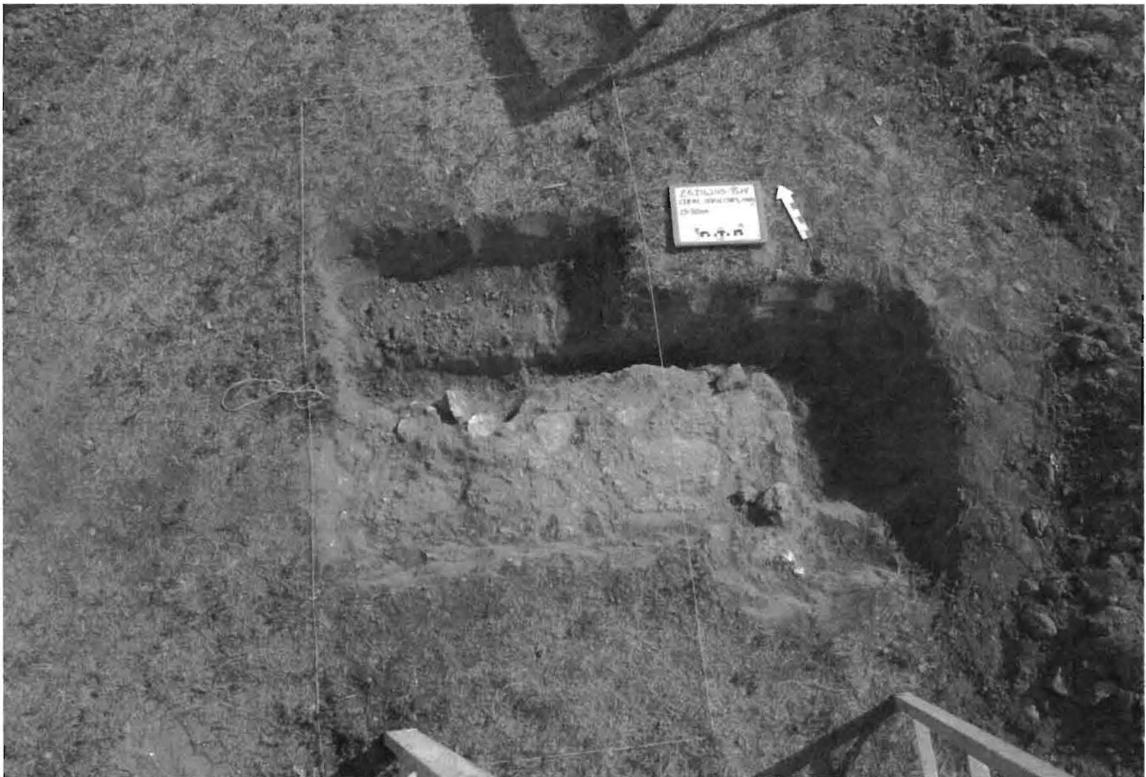
Plate 19. Plan view of Test Area 4 (northeast corner of remodeled building) includes test units 23N 14E, 23N 15E, 23N 12E, & 24N 12E.
