The Archeology of an 1891 Officers' Quarters (25DW55-B-14) at Fort Robinson, Nebraska:

Report on the 2012 Excavation

By Amy Koch and Terry L. Steinacher

Prepared for the Nebraska Game and Parks Commission

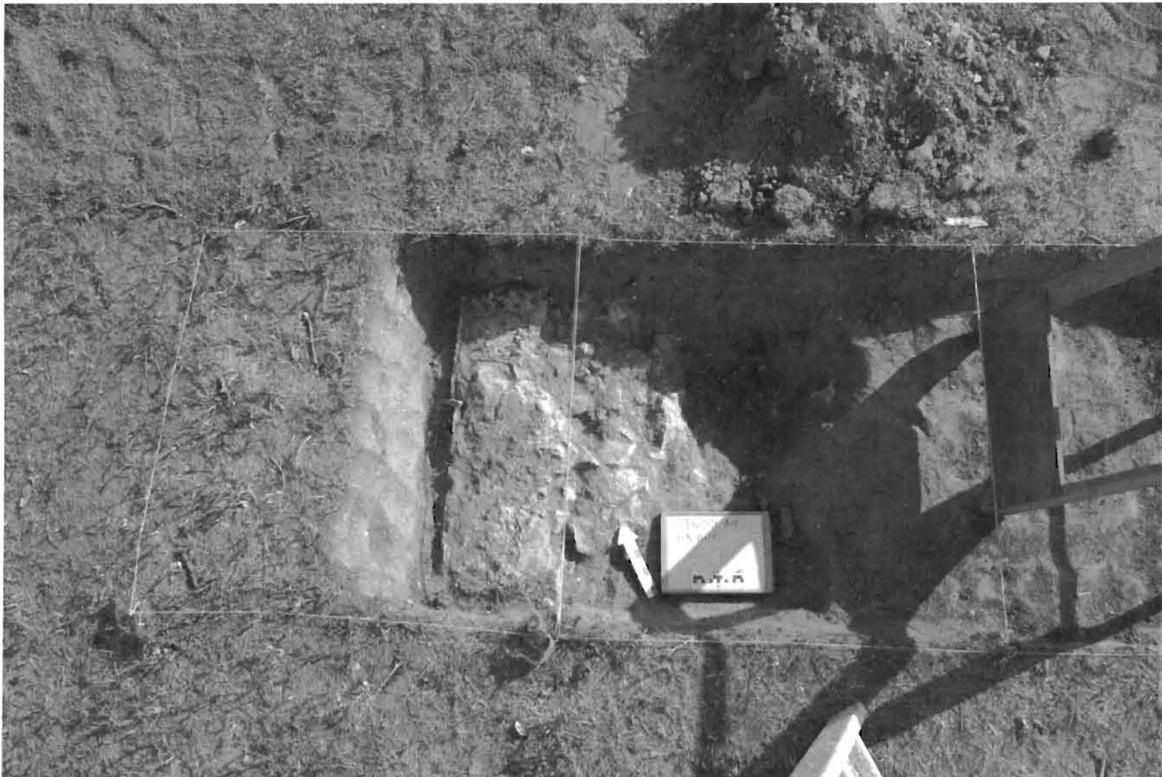
Plate 21. Plan view of Area 5 west wall, includes test units 10N 2E, 10N 0E, 10N 1E, 11N 0E, 12N 0E, 11N 3E, & 12N 3E.

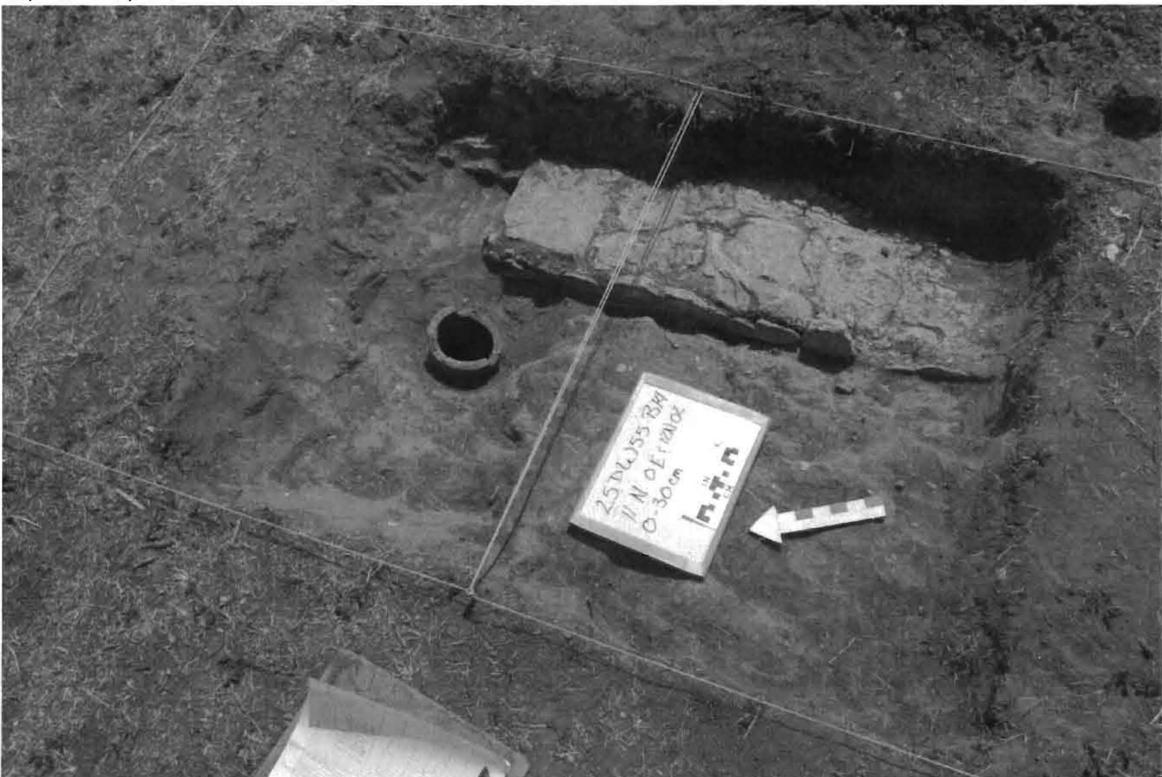
Plate 22. Plan view of Test Area 5 with corner of original porch and exterior drainage pipe .

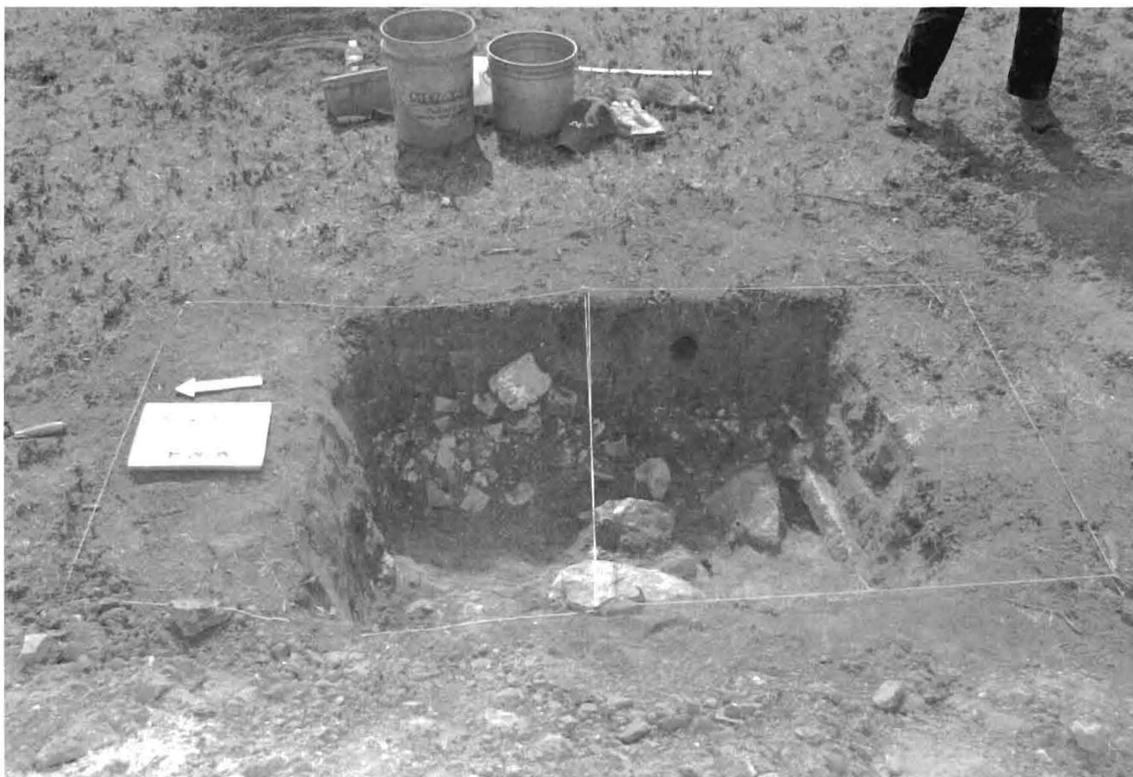
Plate 23. Plan view of Test Area 5 interior wall rubble.

Located along the western edge of the site grid, Area 5 consists of a roughly "U-shaped" configuration of excavation units (Plate 20). The first 1 x 1 m unit (10N2E) failed to reveal any portion of the west foundation wall. Excavation ceased at 20 cm. The west wall of the foundation was finally exposed in two contiguous units (10N0E and 10N1E) excavated to depths between 16 cm and 20 cm (Plate 21) (Figure 20). The interior face of the wall had crumbled, but the estimated width was approximately 50 cm. The exterior face of the foundation was plastered with smooth stucco. Units 11N0E and 12N0E (Plate 22) (Figure 21) were excavated to 20 cm and revealed portions of the west foundation wall, an exterior corner, and a clay drain pipe, oriented vertically, outside the building. The final two contiguous units (11N3E and 12N3E) (Figure 22, 23, and 24) were 1 x 1 m units excavated to search for an internal building foundation corner. Excavated to approximately 50 cm, the unit produced foundation stones and bricks in a rubble pile, evidently the result of demolition (Plate 23).

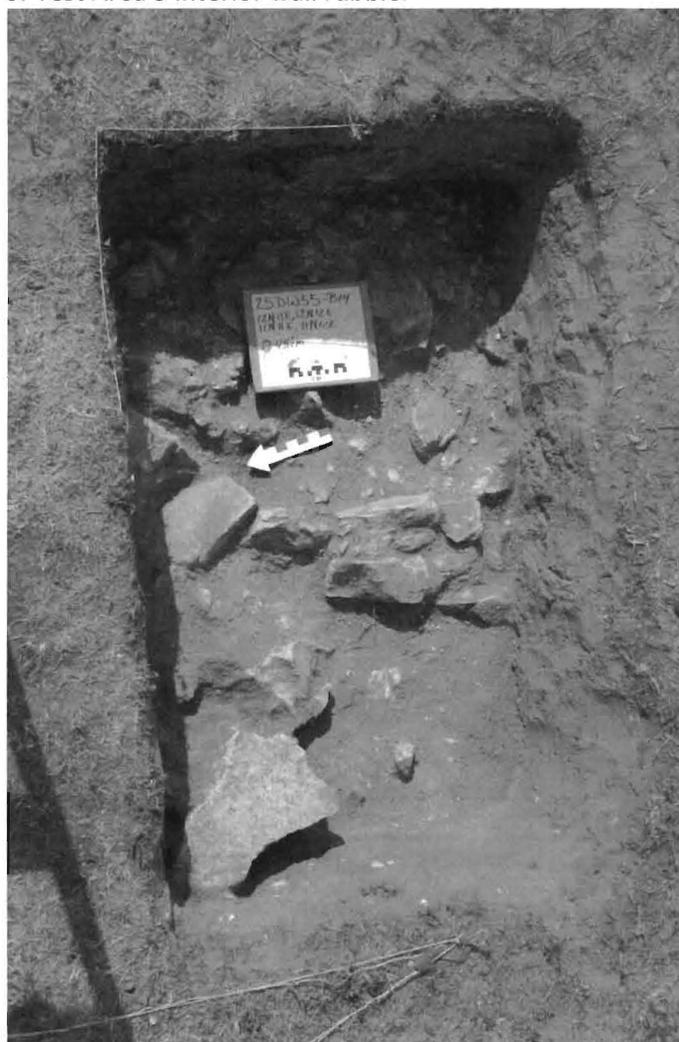
Plate 24. Plan view of Test Area 6 disturbed interior wall includes test units 12N 11E, 12N 12E, 11N, 11E, 11N 12E, 12N 14E, & 12N 15E.

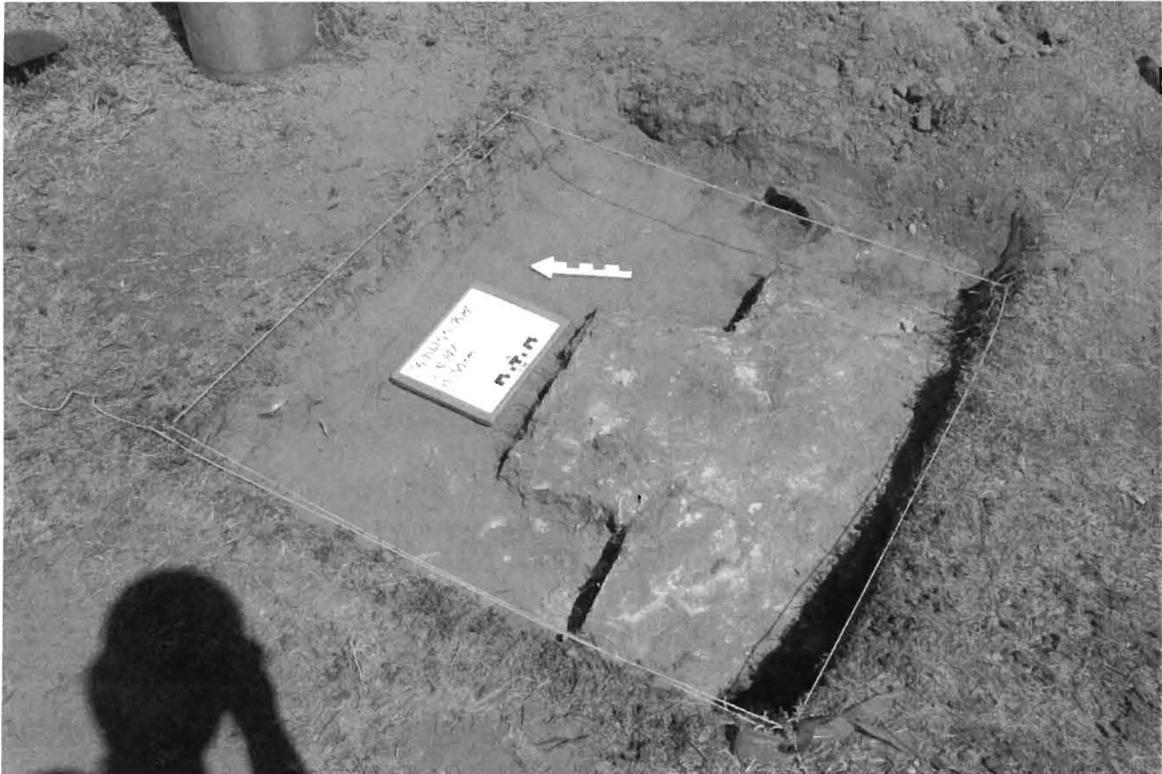
Plate 25. Plan view of Test Area 6 corner of original porch along east foundation with exterior drain pipe includes test unit 12N 14E.

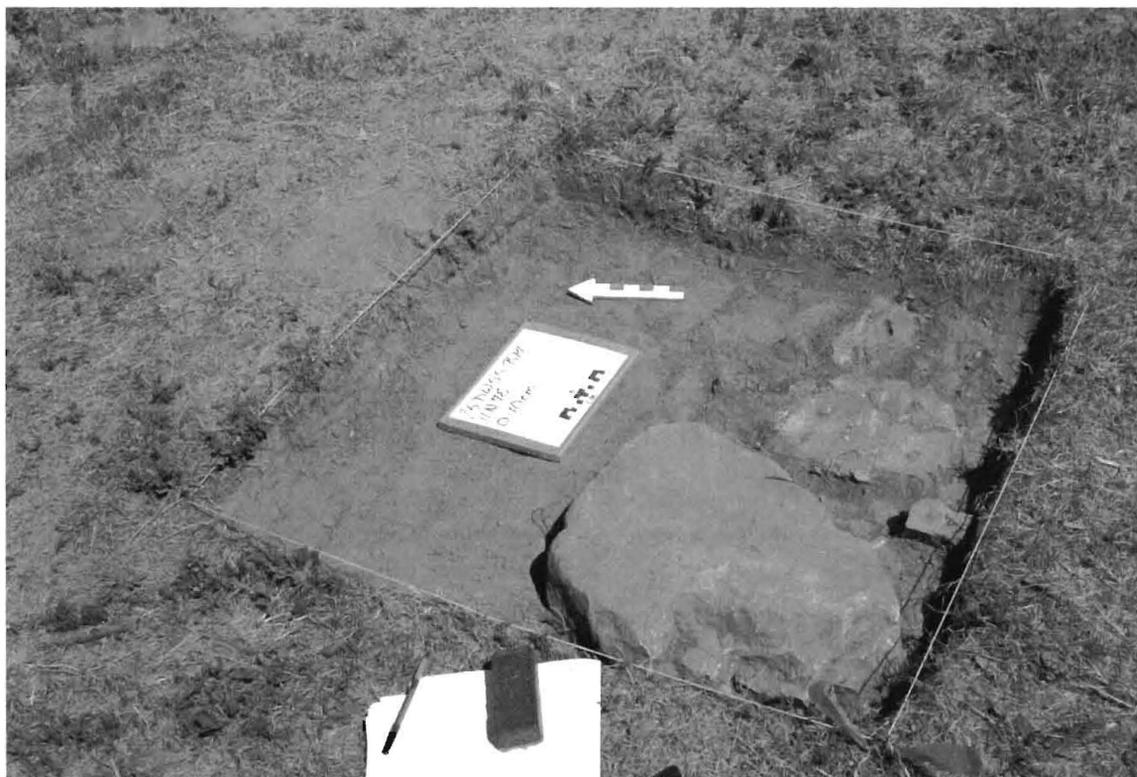
Plate 27. Plan view of Test Area 7 possible interior wall with brick support includes test unit 11N 7E.

Located near the center of the site grid, Area 7 consists of one 1 x 1 m square (11N7E). This unit was excavated to a depth of 10 cm to expose remains of a possible interior foundation wall and a large concrete and brick support (Plate 27) (Figure 30).

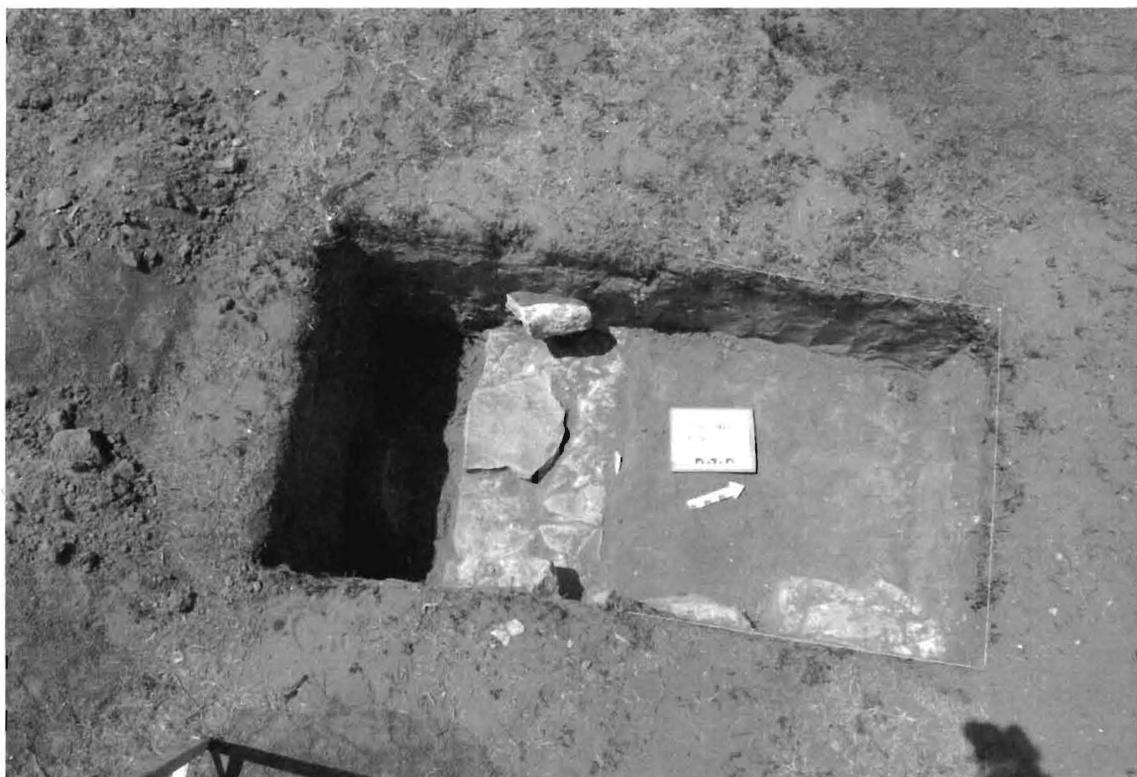
Plate 28. Plan view of Test Area 8 (back of building) includes test units 23N 9E & 24N 9E.

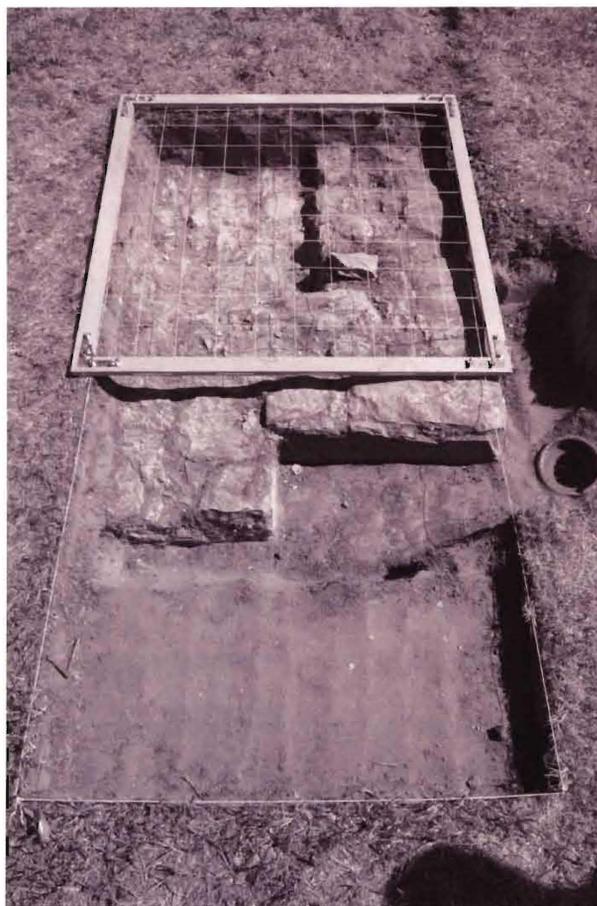
Plate 31. Area 1 drain pipe in situ.

Six clay drain pipes were uncovered during excavation. At each corner of the building foundation and along two corners of the former porches, clay drain pipes ran vertically into the ground to drain roof runoff away from the building (Plate 31). Forty-nine clay drain pipe fragments were recovered, weighing 4.5 kg. A section of one of the corner pipes was preserved (Plate 32).

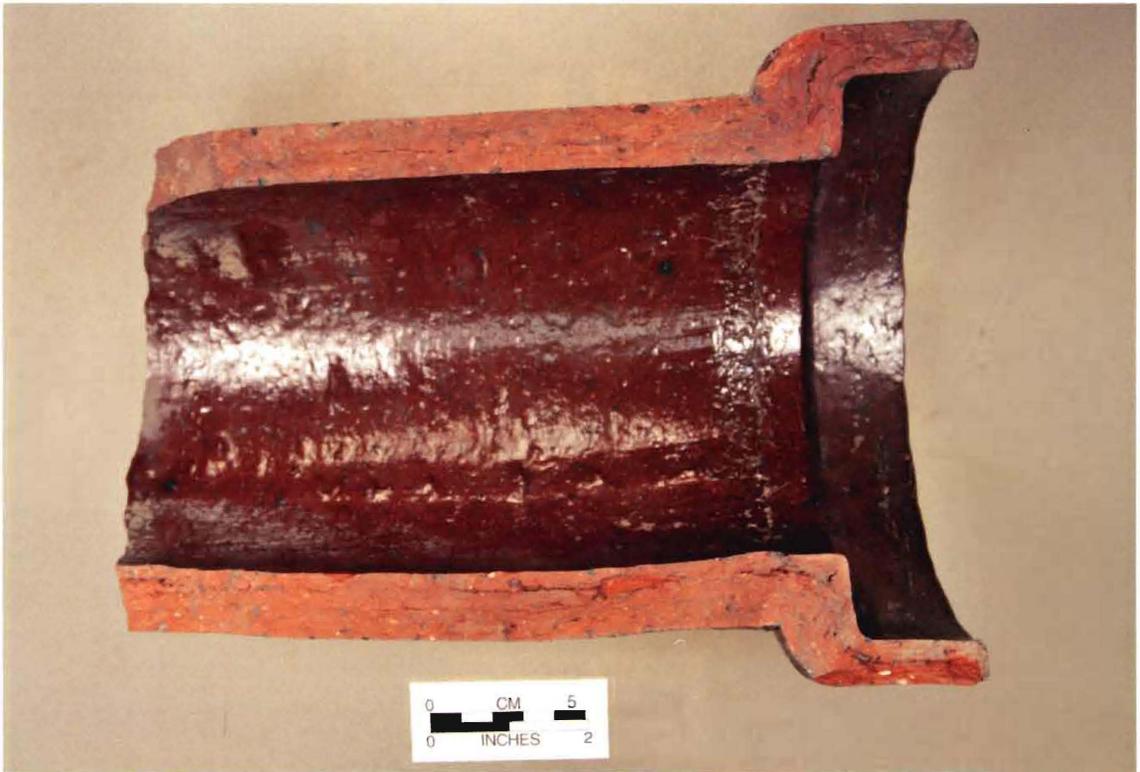
Plate 32. Ceramics. Clay drain pipe cross-section

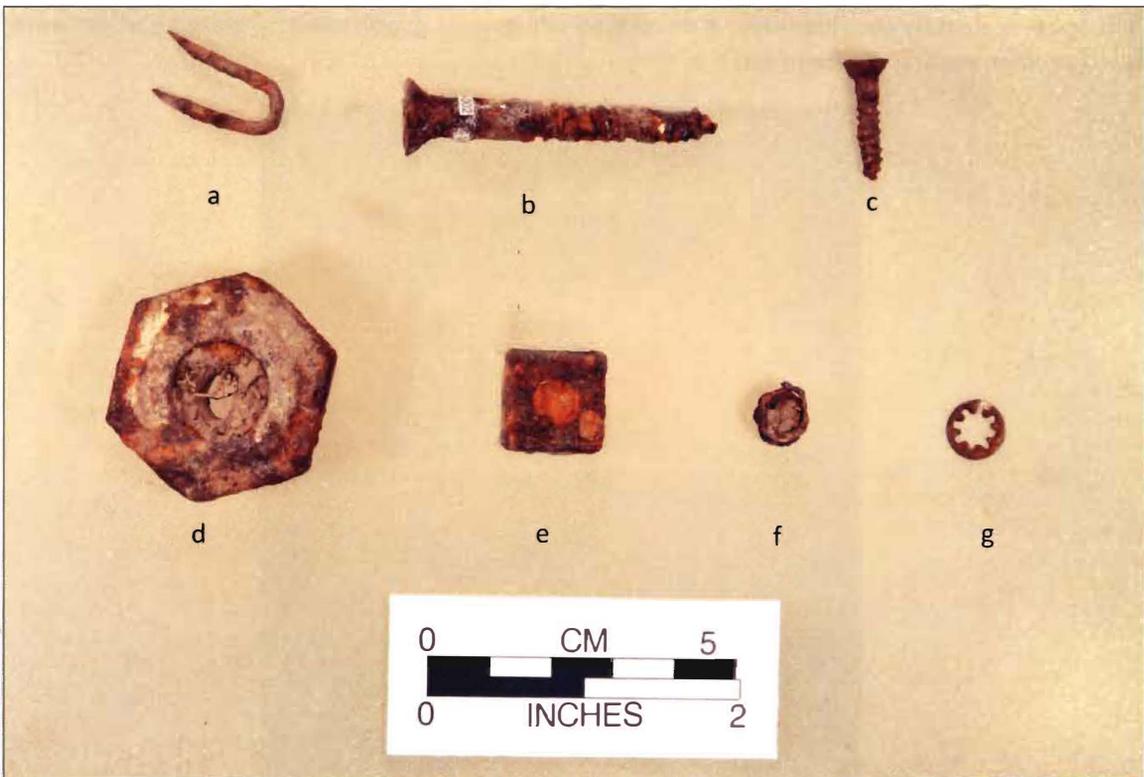
Plate 33. Household Related Hardware. a: staple; b: wood screw; c: wood screw; d: hexagonal nut; e: square nut; f: spring fragment; g: washer

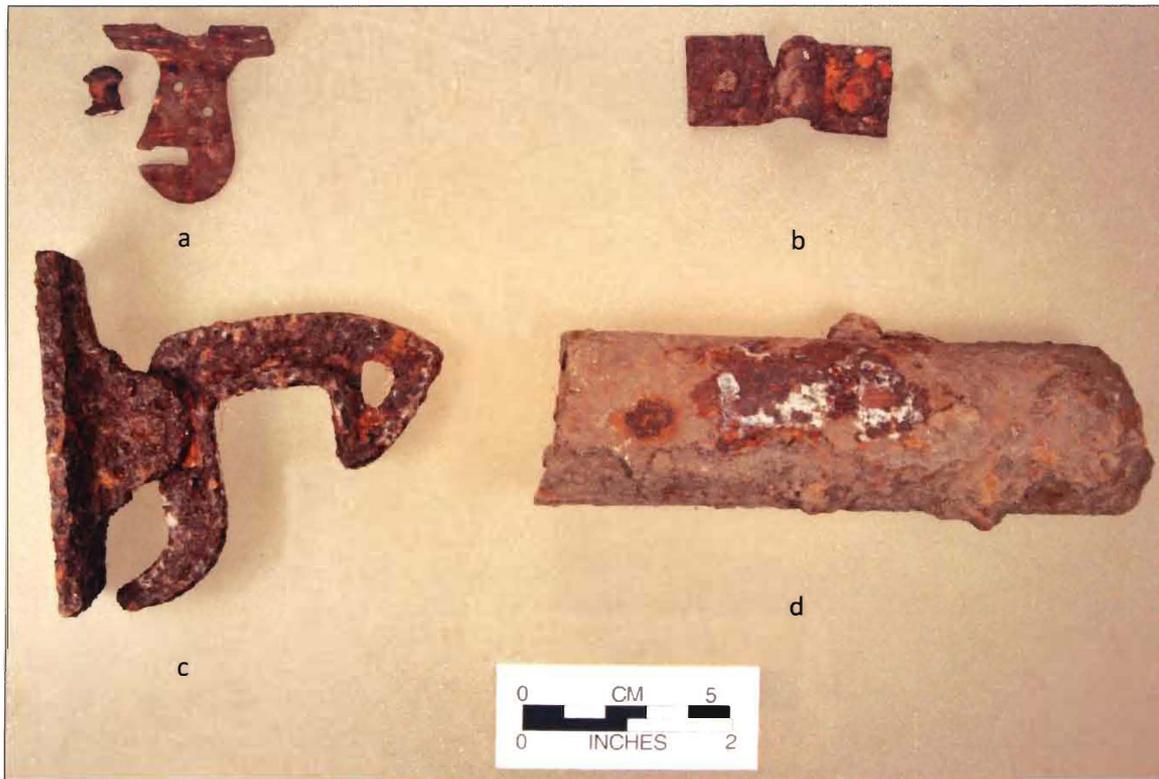
Plate 34. Door, Window, and Other Hardware. a: window shade bracket; b: bolt latch catch; c: gate latch; d: window weight fragment.

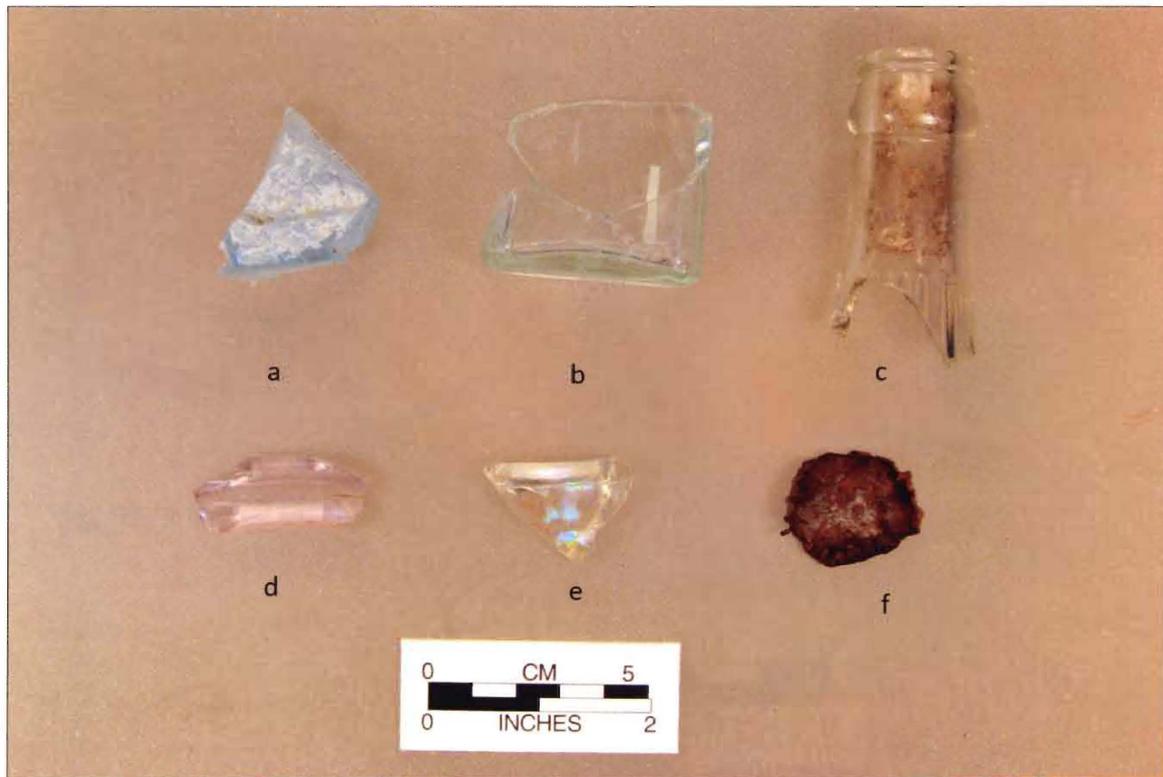
Plate 35. Glass. a: bottle base; b: bottle base; c: bottle neck and rim; d: bottle lip fragment; e: bottle lip fragment; f: crimped bottle cap.

Two base segments of rectangular bottles are represented (Plate 35: a, b). One base has a slight base rim of blue-green glass, and a second of a clear glass. The second is marked on the base with a "7", a "P" within a circle, and the number "258". In addition on one of the narrow sides the letters "CAS...".

Three neck and rim fragments of bottles were recovered. The first fragment is from a clear glass bottle manufactured by an automated bottle machine (Plate 35: c). Another fragment of a narrow-necked bottle is made from a light-pinkish glass (Plate 35: d). The final glass fragment is a rim section from a clear glass bottle with a round lip and molded flutes on the neck (Plate 35: e). Two metal bottle caps for soda or beer bottles were also recovered (Plate 35: f).

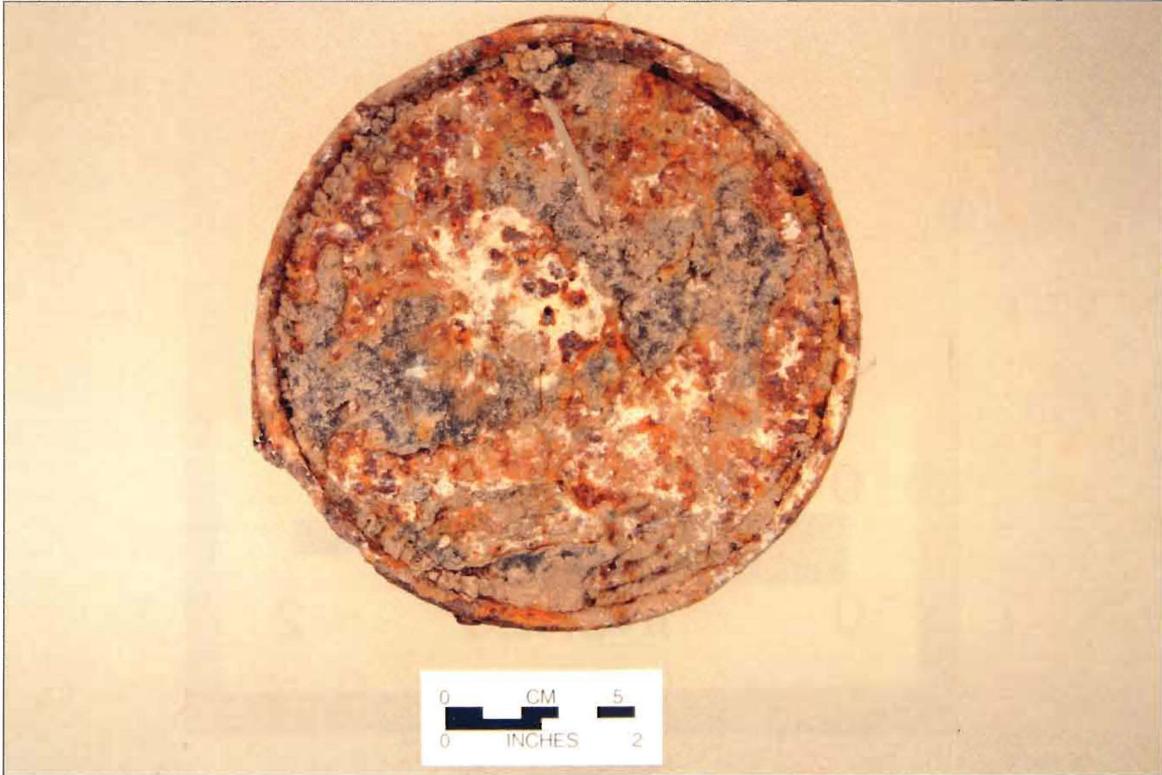
Plate 39. Miscellaneous Artifacts. Gallon paint can lid.

Additional items recovered included a gallon paint can lid (Plate 39), a cavalry picket pin (Plate 40), a pencil eraser, and two clothes pin springs.

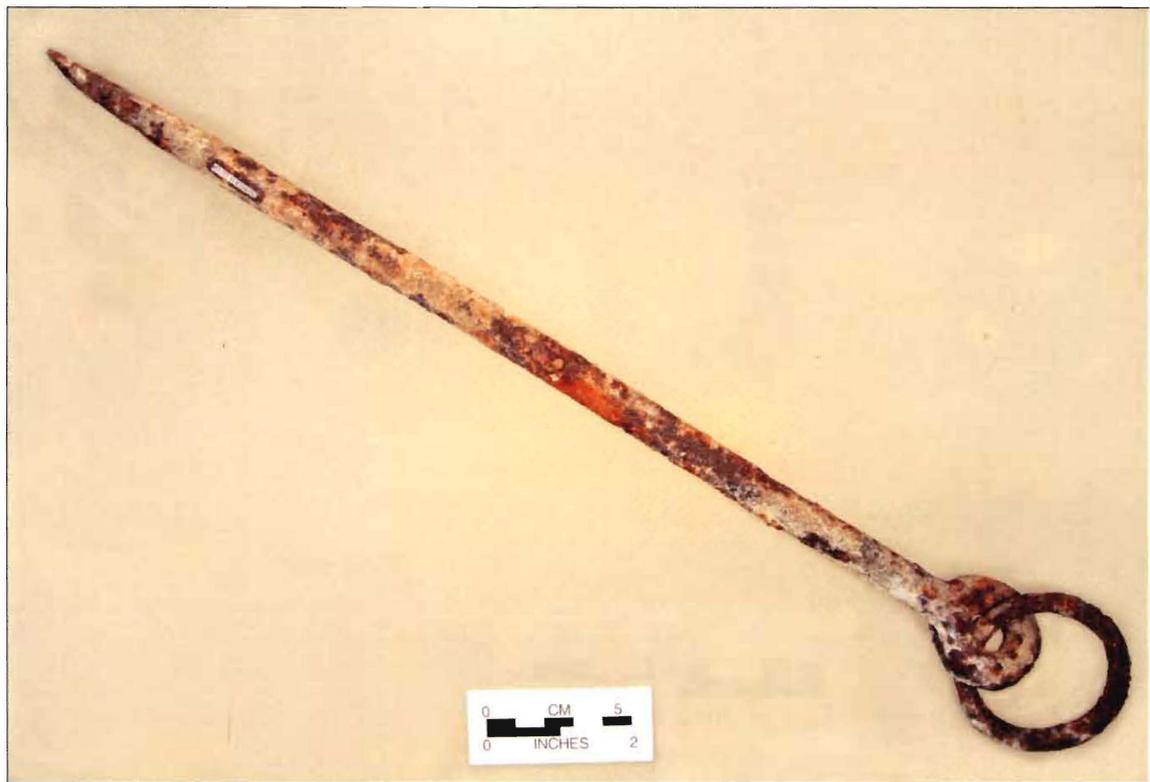
Plate 40. Miscellaneous Artifacts. Cavalry picket pin.

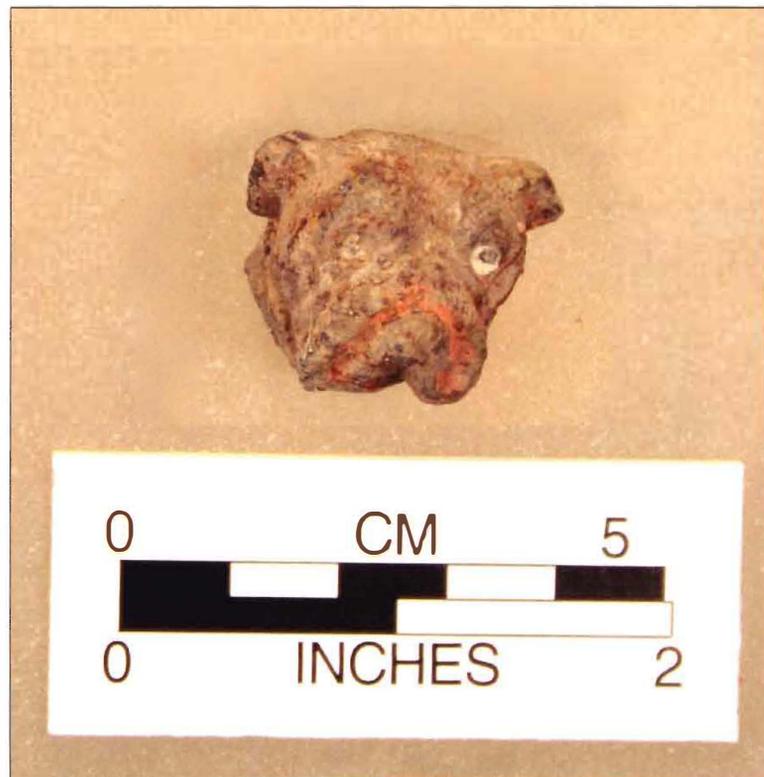
Plate 41. Miscellaneous Artifacts. Cast Pewter or lead bulldog head.

The final item is a small cast pewter or lead bulldog head finial made to fit onto a circular rod with fragments of reddish paint on the mouth and white on the eyes (Plate 41).
