**DEVELOPMENT, TESTING, AND EVALUATION
OF NDOR'S TL-5 AESTHETIC OPEN
CONCRETE BRIDGE RAIL**

MIDWEST ROADSIDE SAFETY FACILITY

MwRSF Research Report No. TRP-03-148-05

December 1, 2005

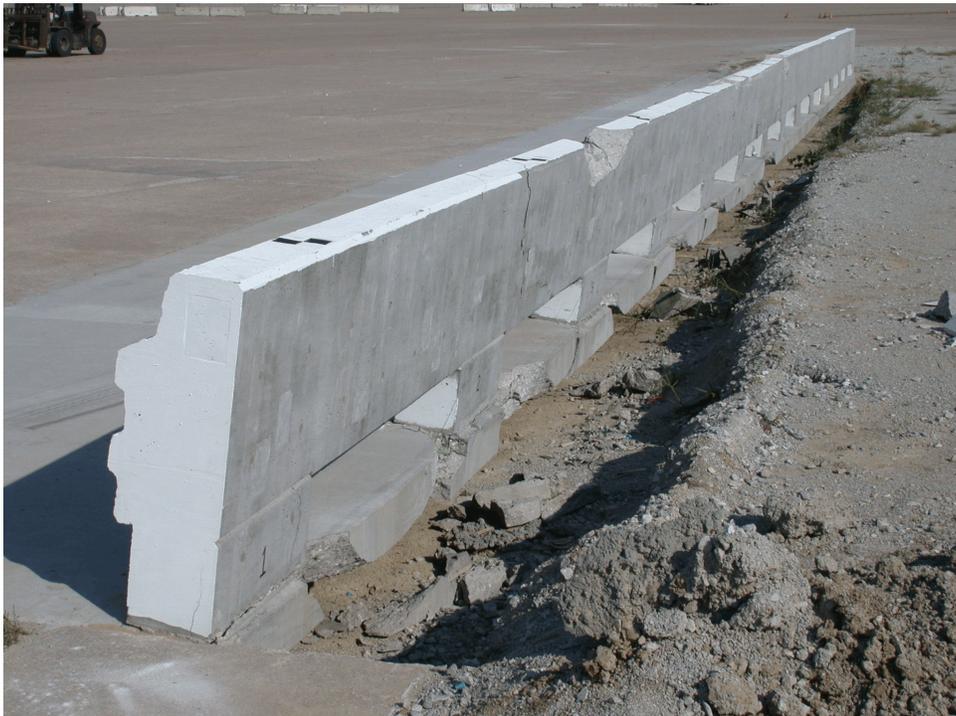
Figure 34. Bridge Rail Damage, Test ACBR-1

the rail at the center of post no. 8. Minor cracks were also found in the rail between post nos. 1 and 10.

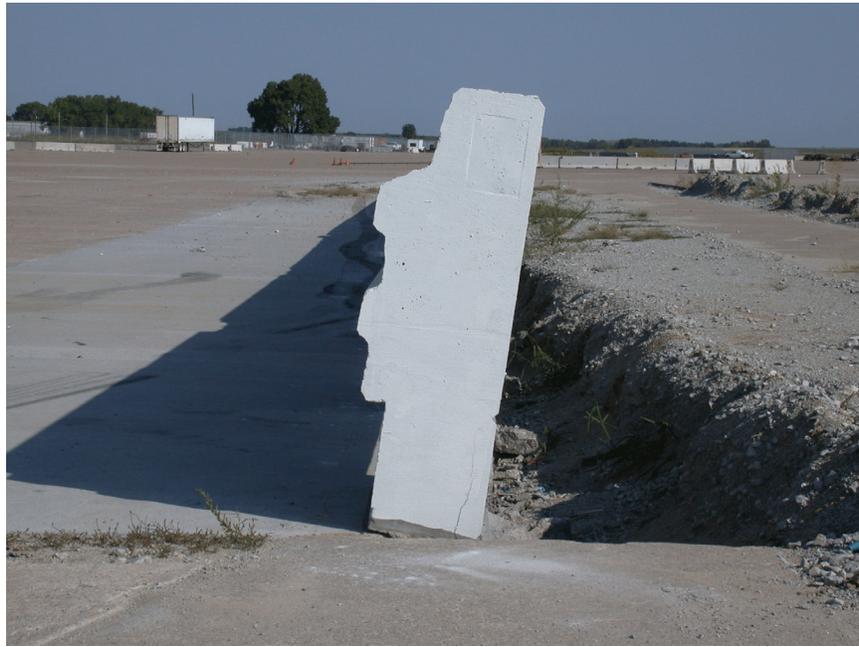
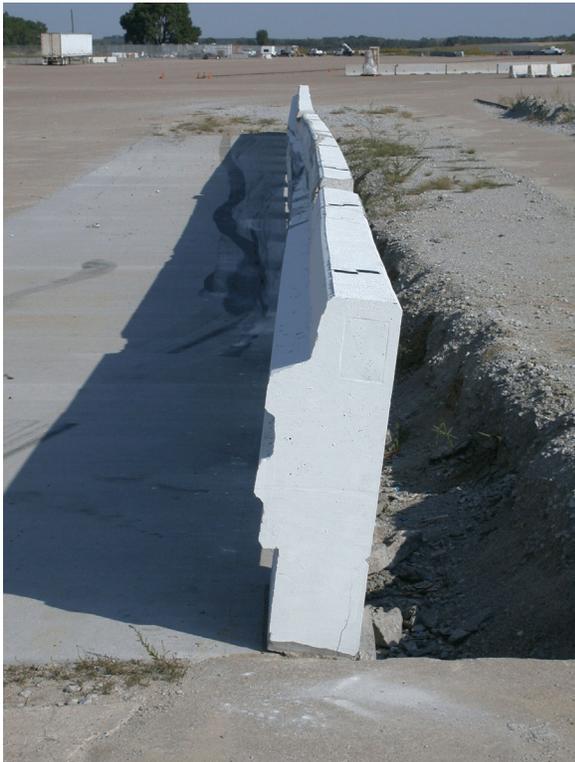
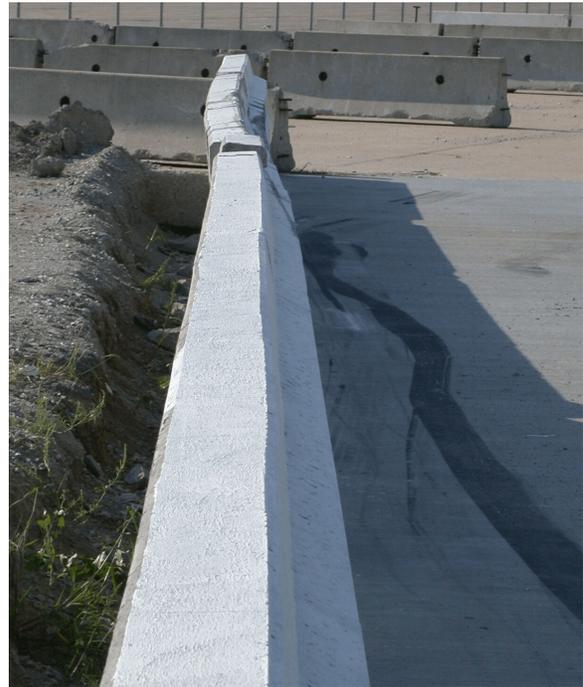
Figure 35. Bridge Rail Damage, Test ACBR-1

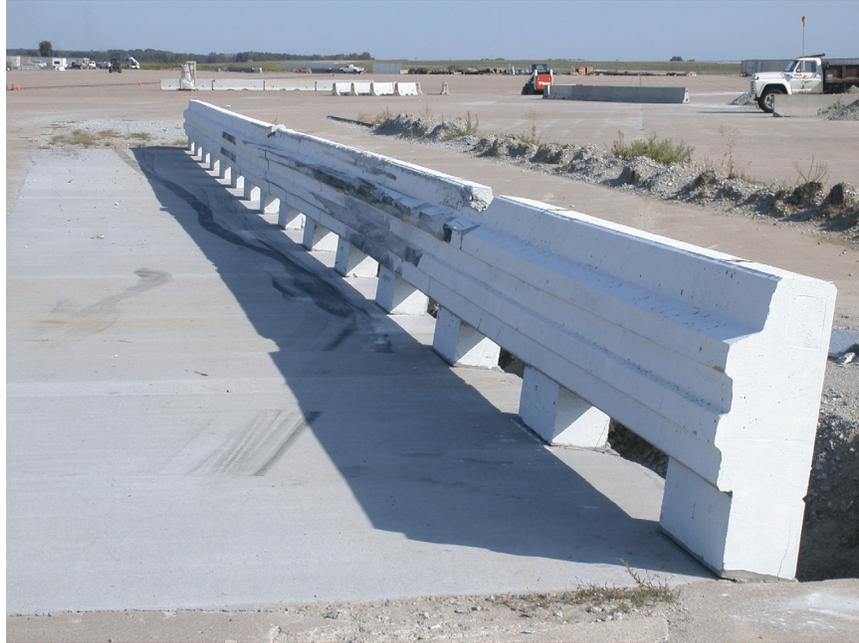
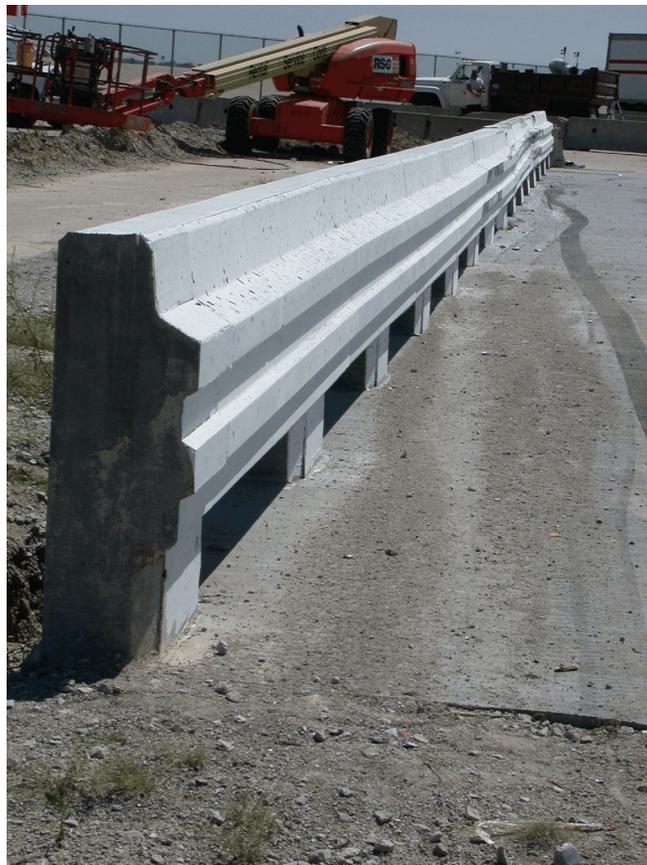
Figure 36. Bridge Rail Damage, Test ACBR-1

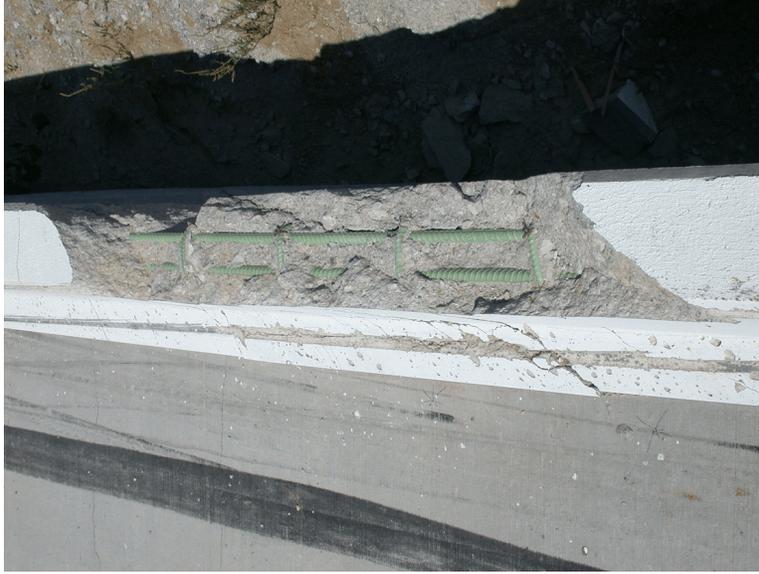
Figure 37. Bridge Rail Damage, Test ACBR-1

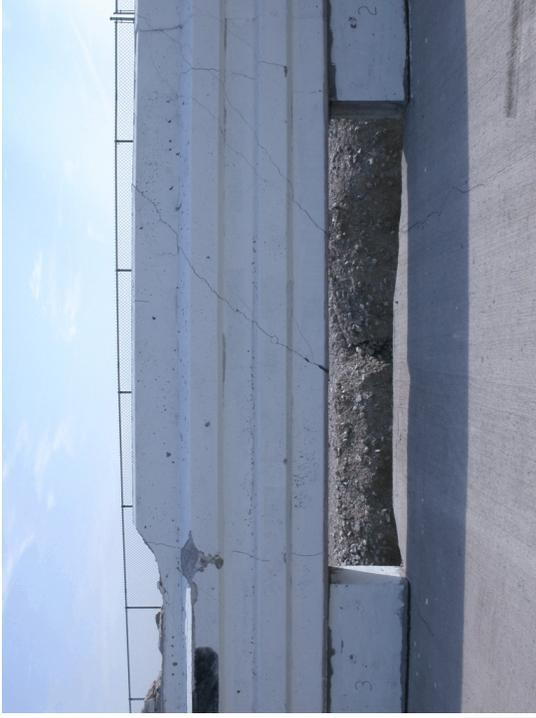
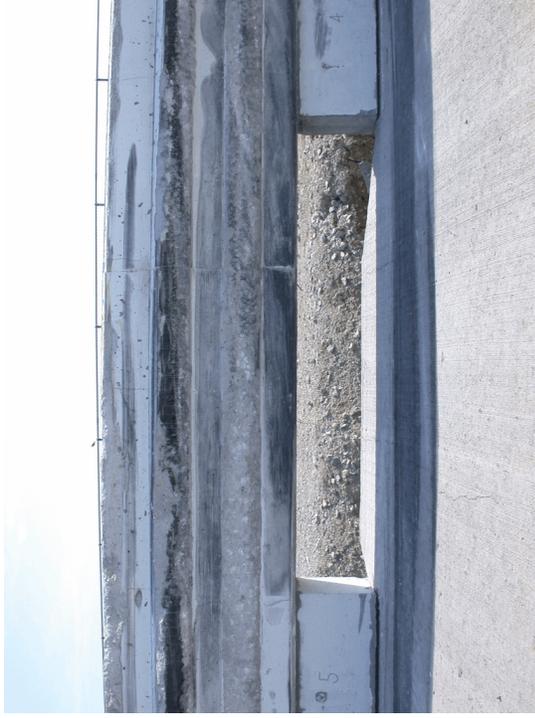
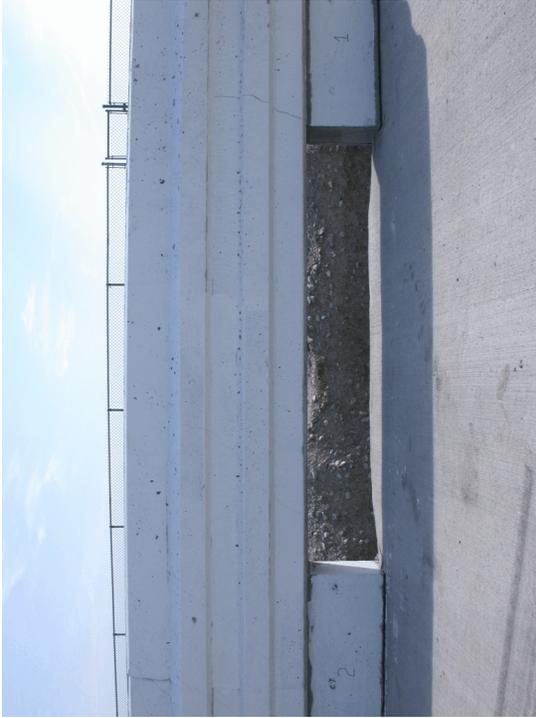
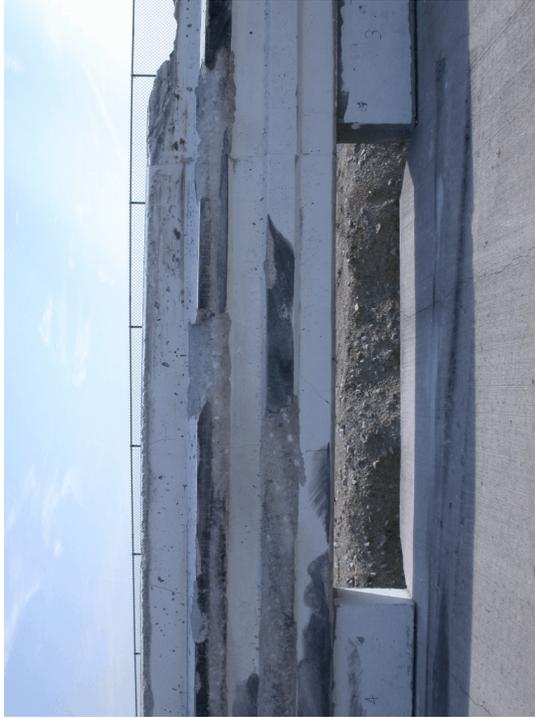
Figure 38. Traffic-Side Bridge Rail Damage at Spans Between Post Nos. 1 through 5, Test ACBR-1

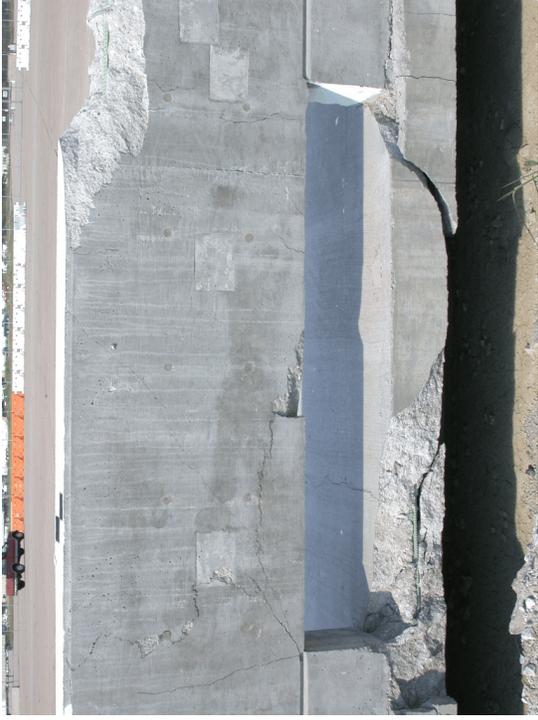
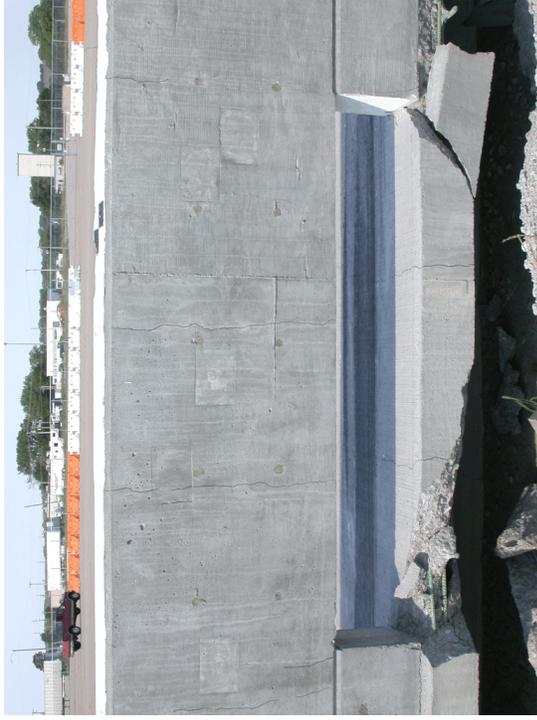
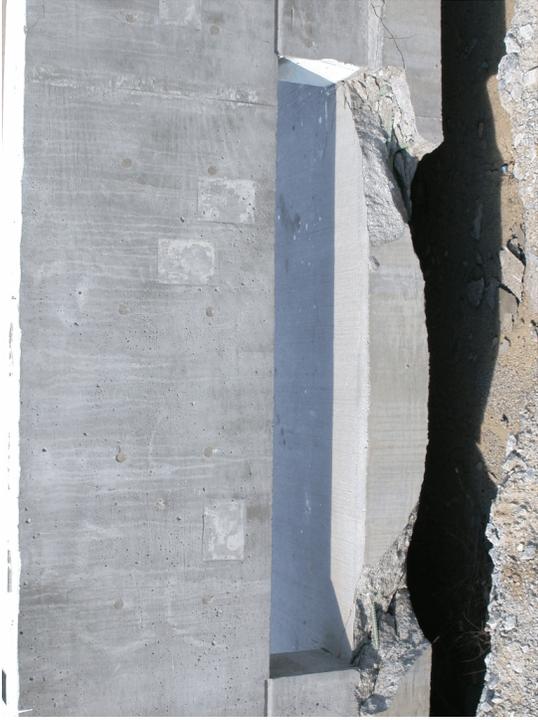
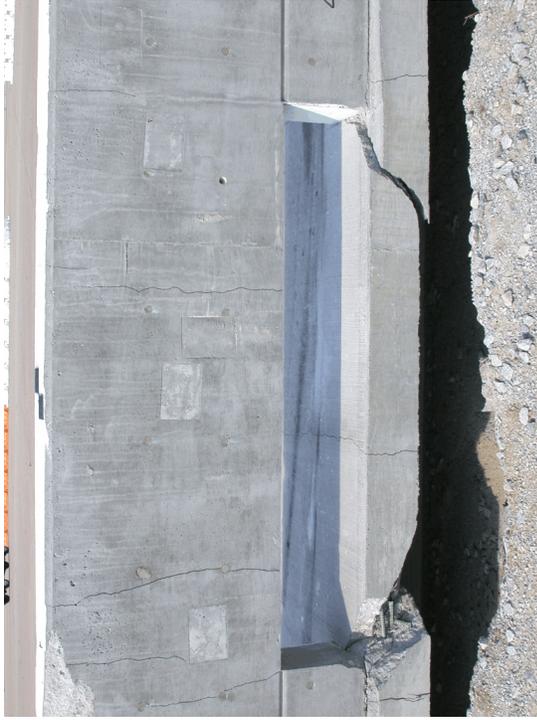
Figure 40. Back-Side Bridge Rail Damage at Spans Between Post Nos. 1 through 5, Test ACBR-1

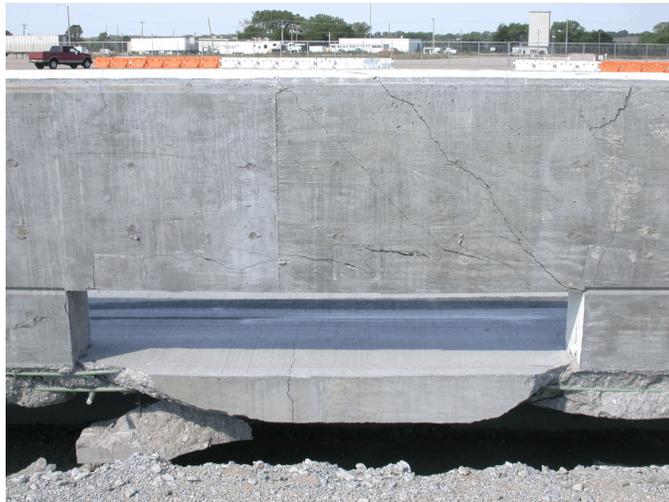
Figure 41. Back-Side Bridge Rail Damage at Spans Between Post Nos. 5 through 8, Test ACBR-1

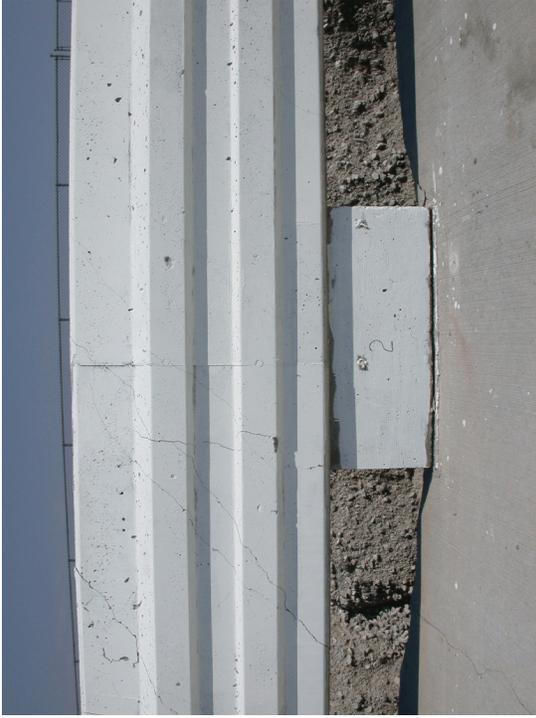
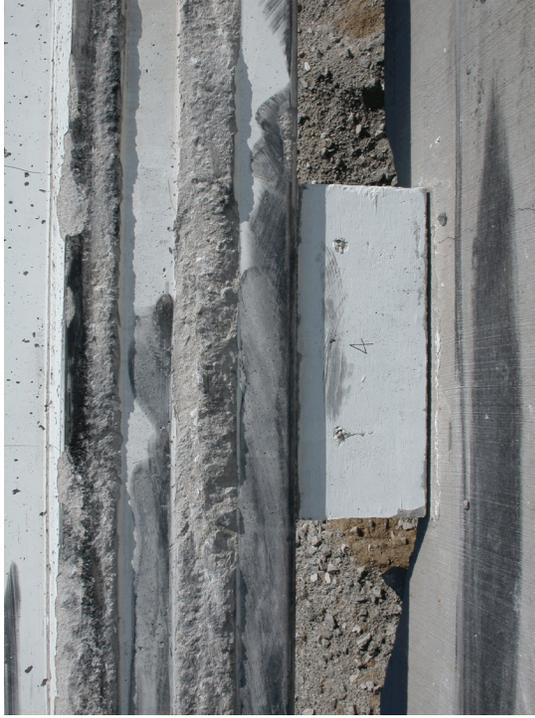
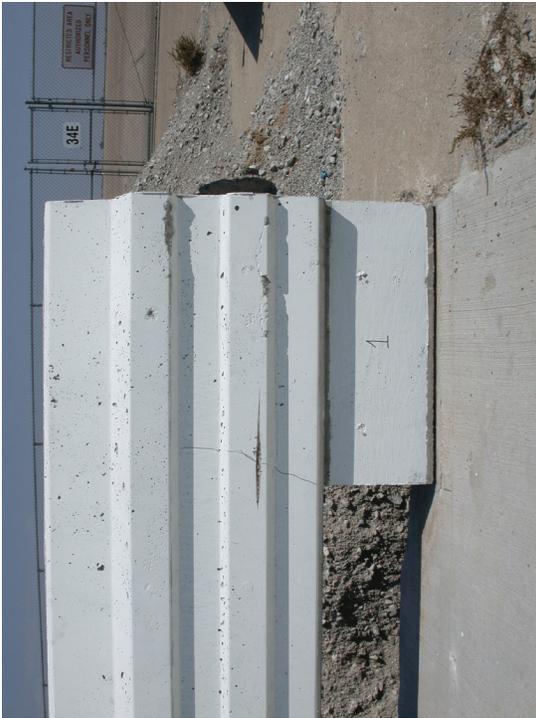
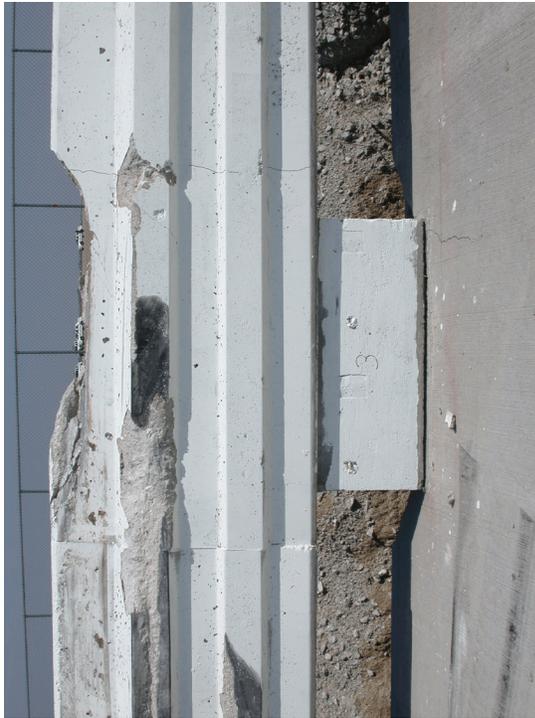
Figure 42. Traffic-Side Bridge Rail Damage at Post Nos. 1 through 4, Test ACBR-1

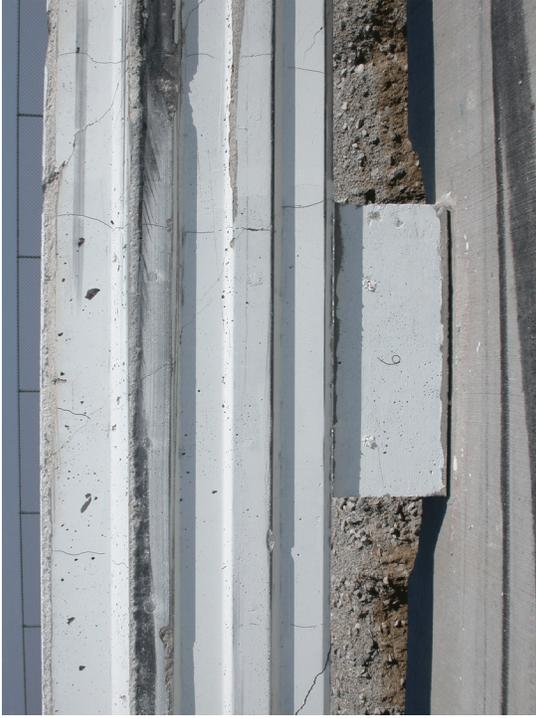
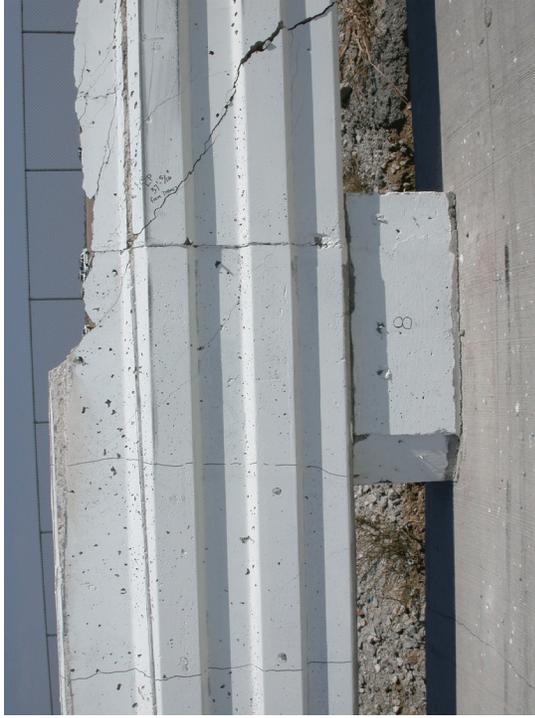
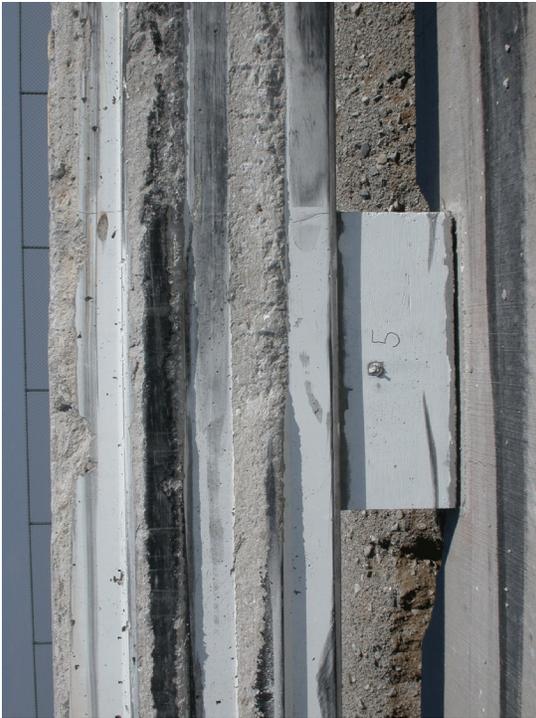
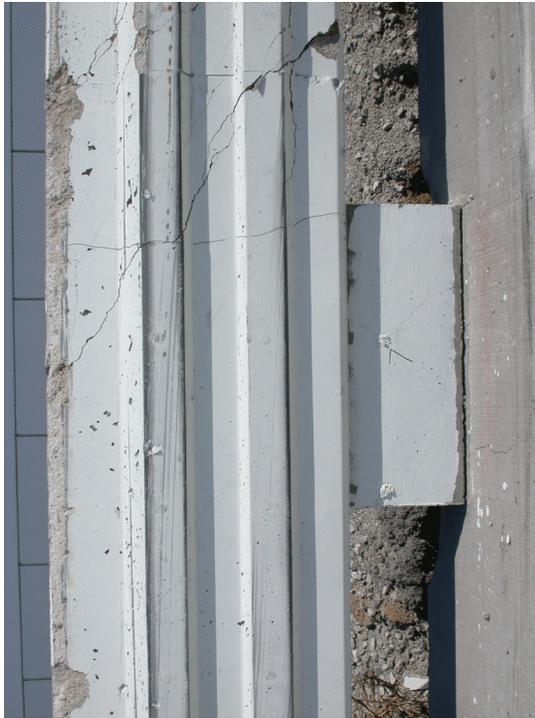
Figure 43. Traffic-Side Bridge Rail Damage at Post Nos. 5 through 8, Test ACBR-1

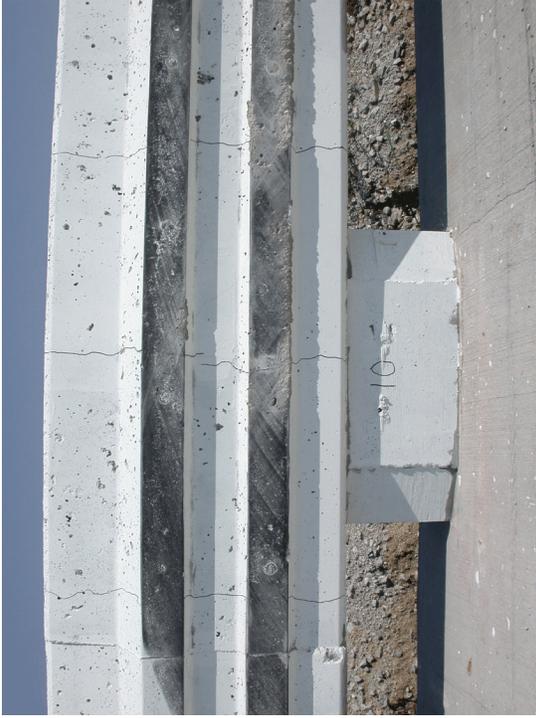
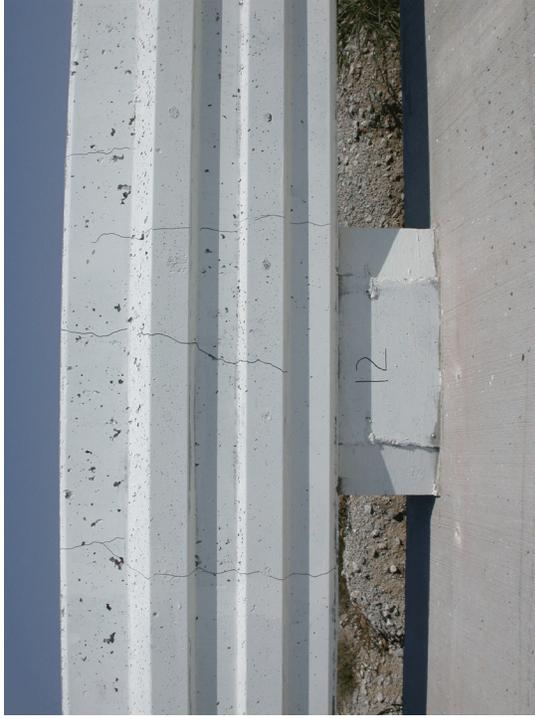
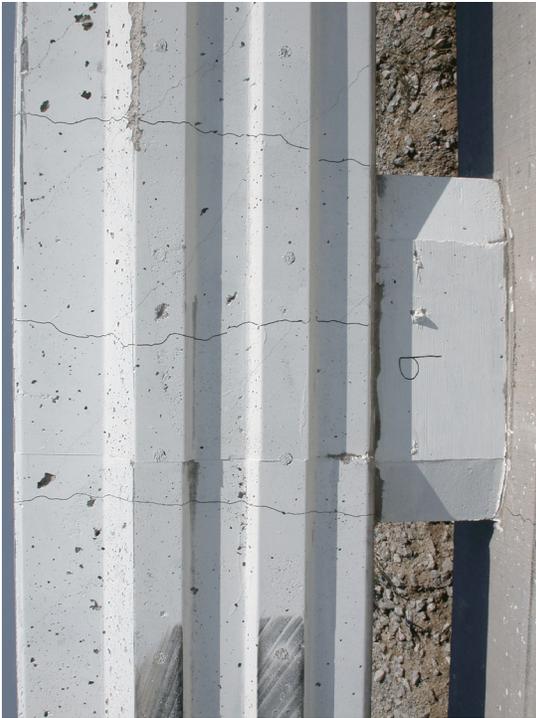
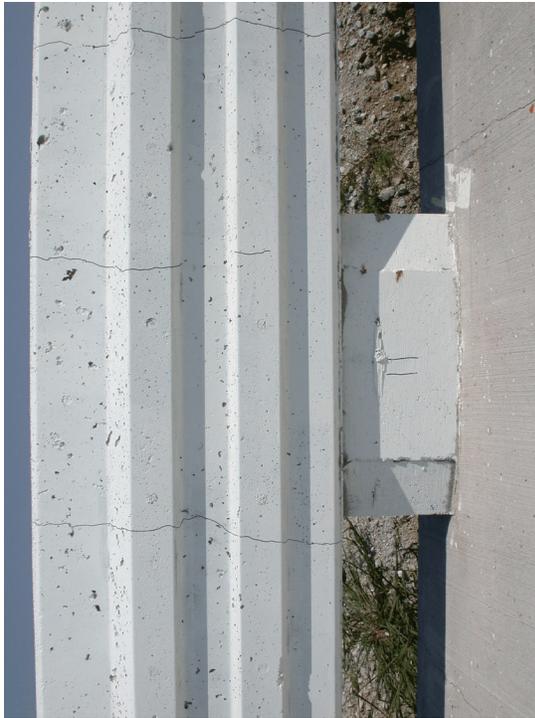
Figure 44. Traffic-Side Bridge Rail Damage at Post Nos. 9 through 12, Test ACBR-1

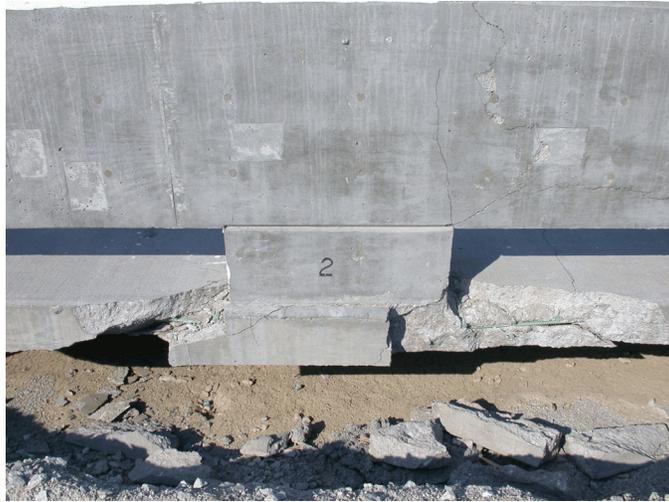
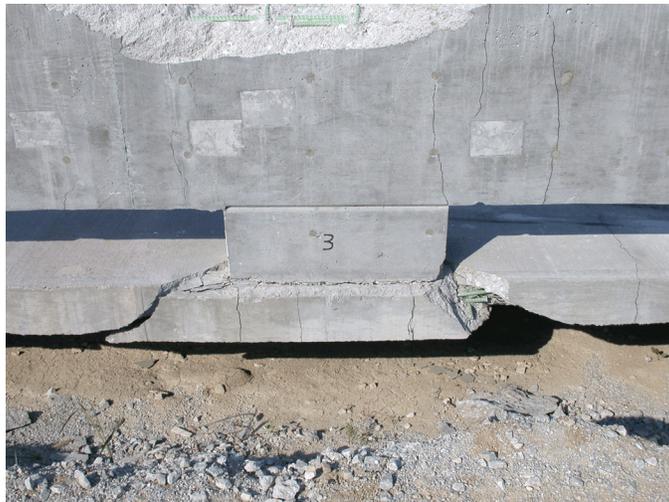
Figure 46. Back-Side Bridge Rail and Deck Damage at Post Nos. 1 through 3, Test ACBR-1

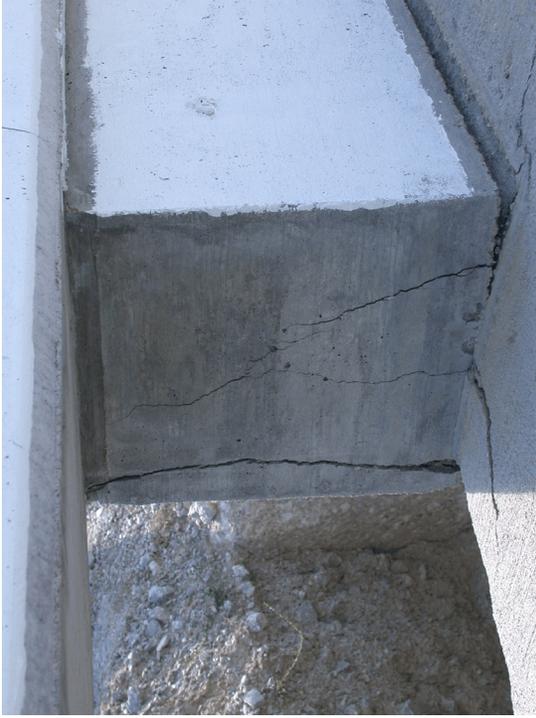
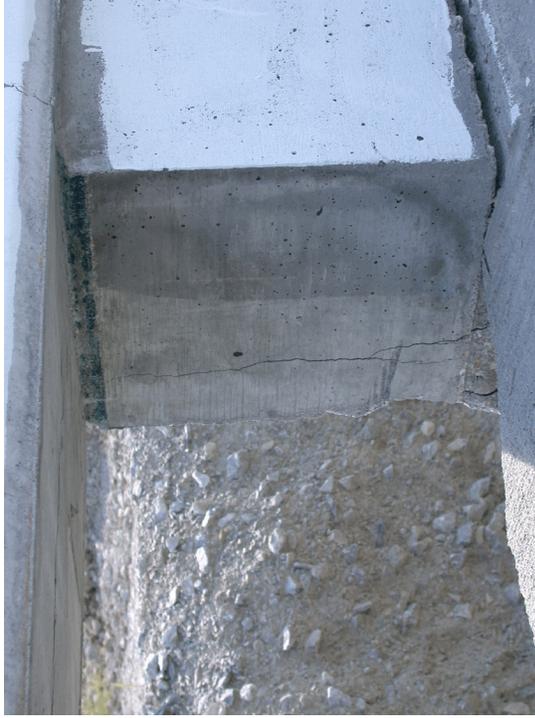
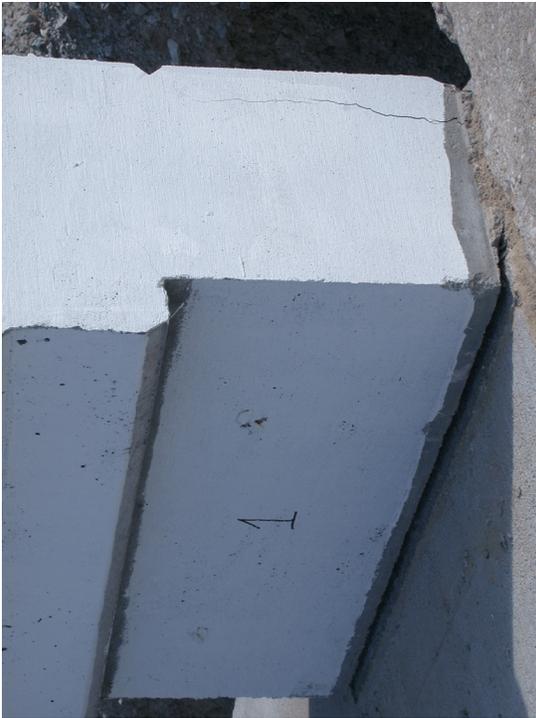
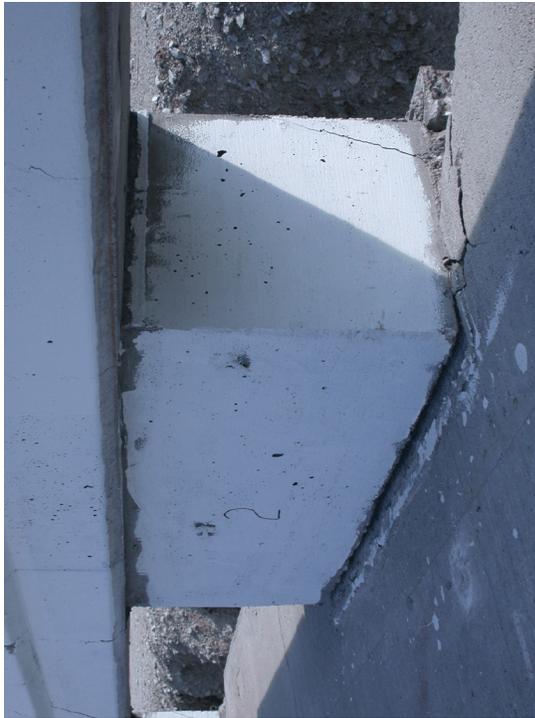
Figure 49. Bridge Post Nos. 1 and 2 Damage, Test ACBR-1

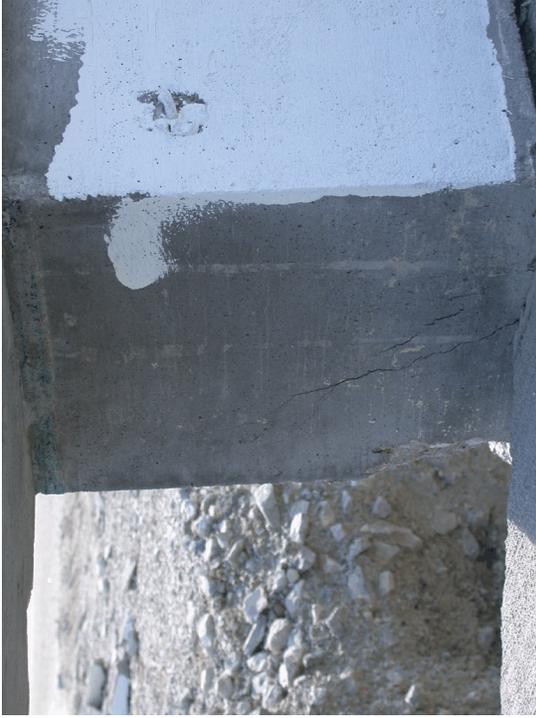
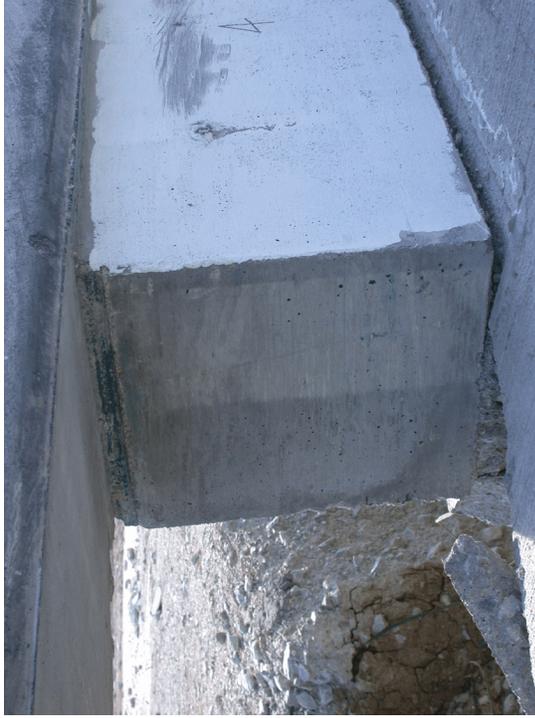
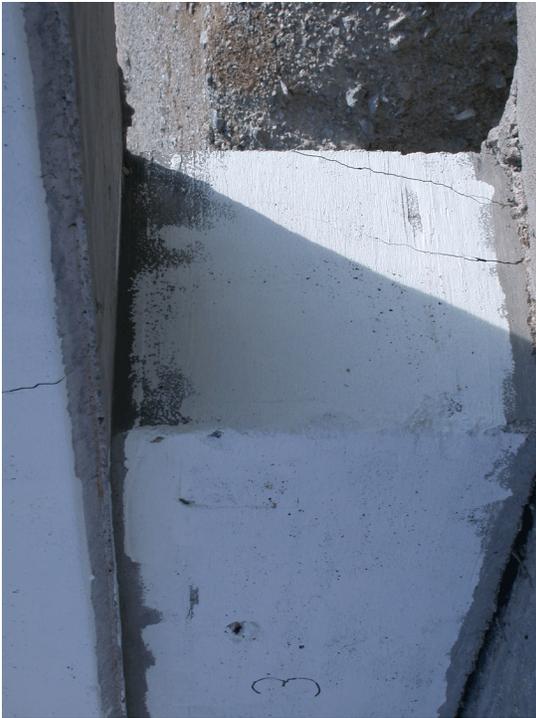
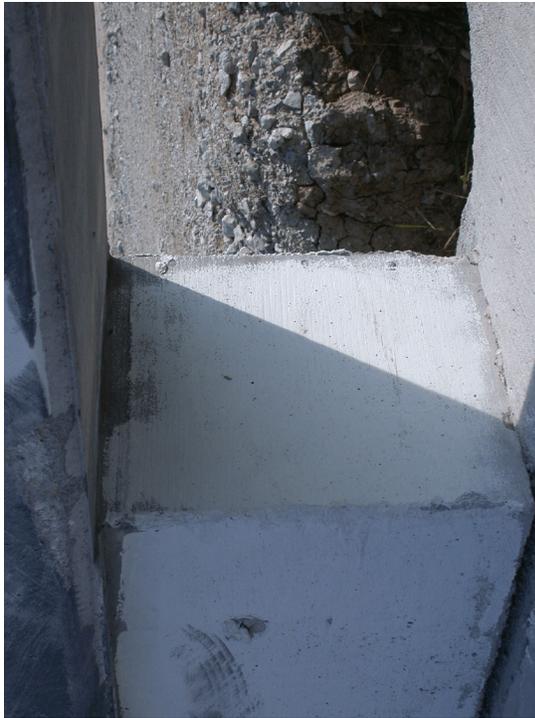
Figure 50. Bridge Post Nos. 3 and 4 Damage, Test ACR-1

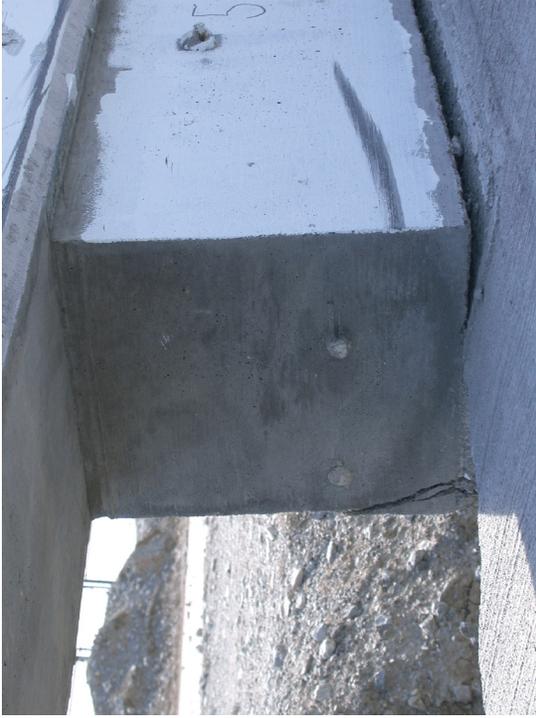
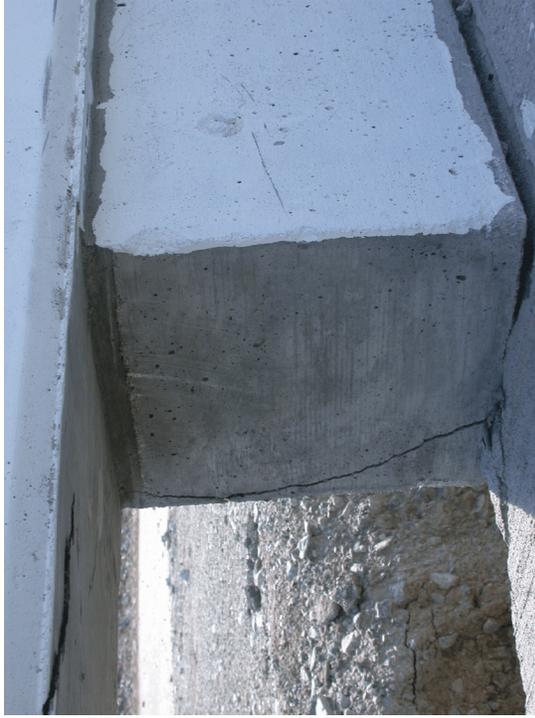
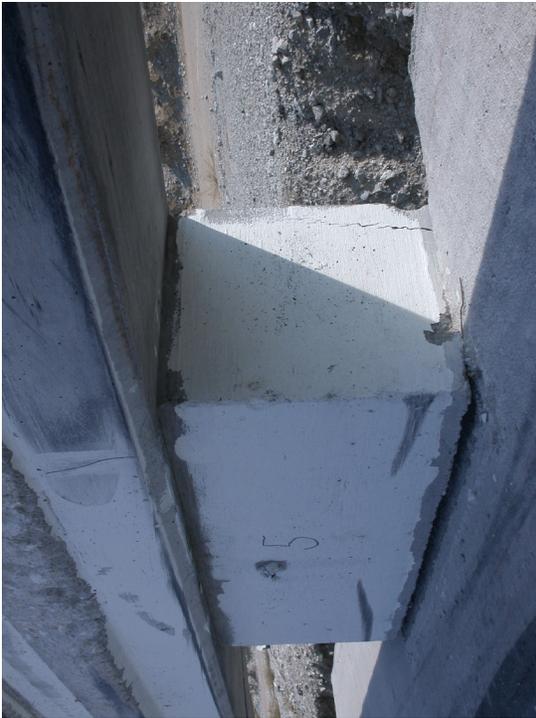
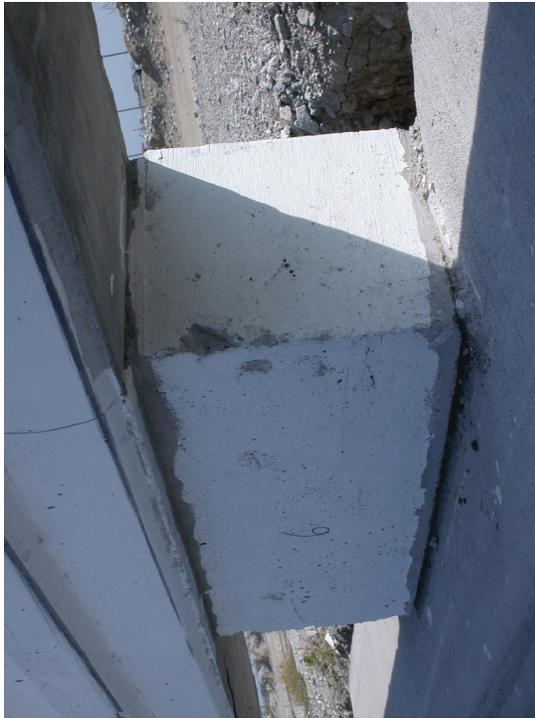
Figure 51. Bridge Post Nos. 5 and 6 Damage, Test ACBR-1

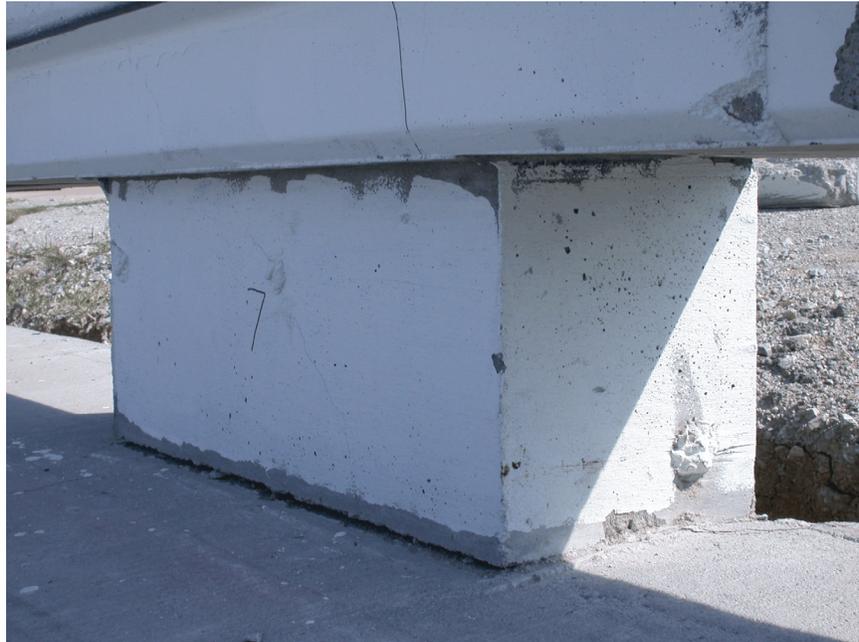
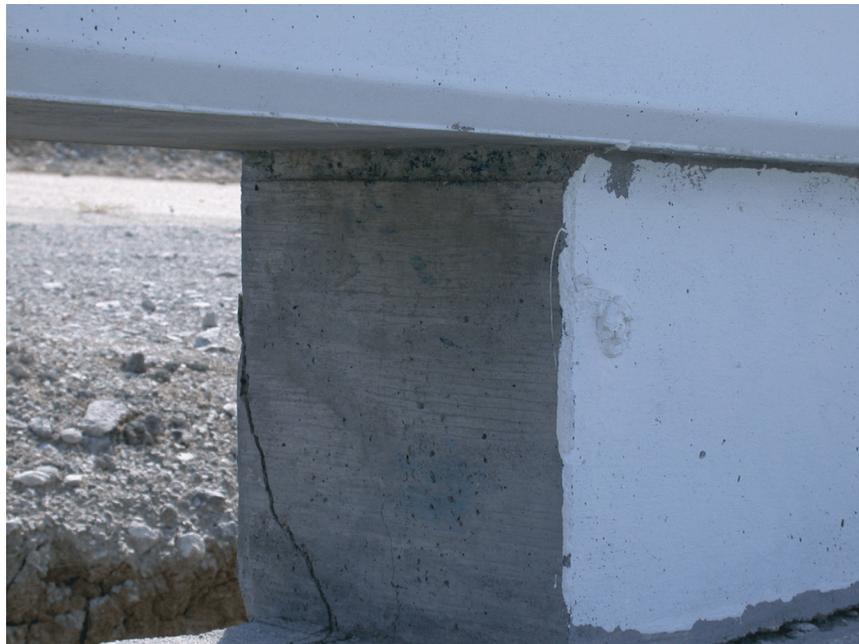
Figure 52. Bridge Post No. 7 Damage, Test ACBR-1

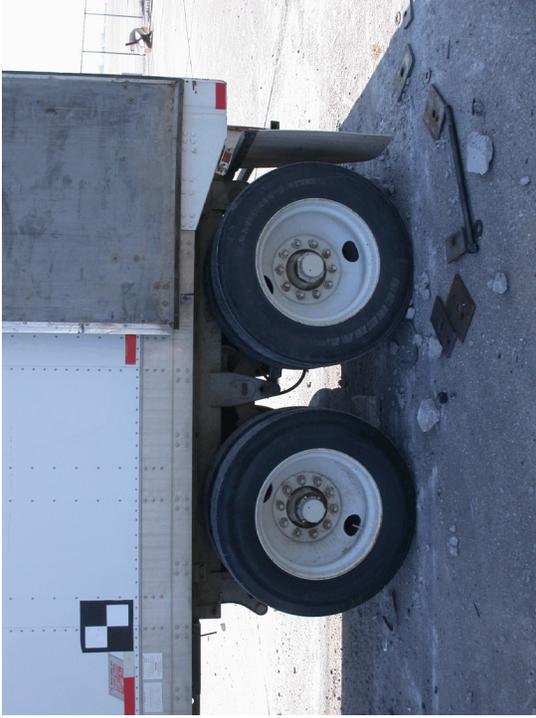
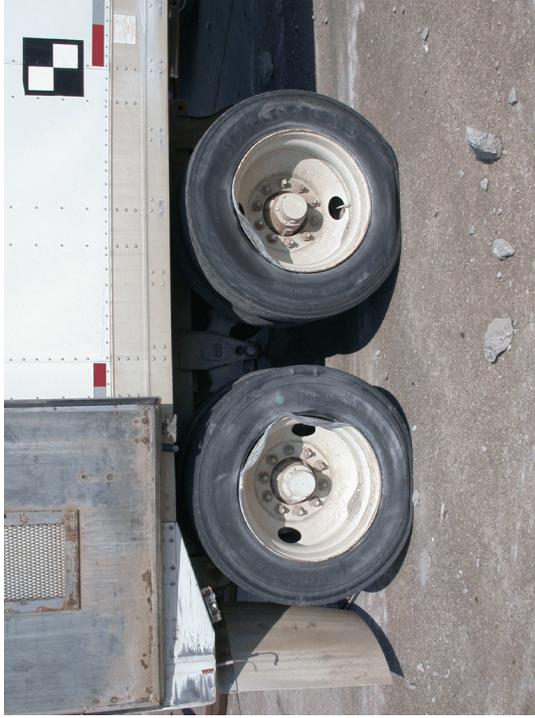
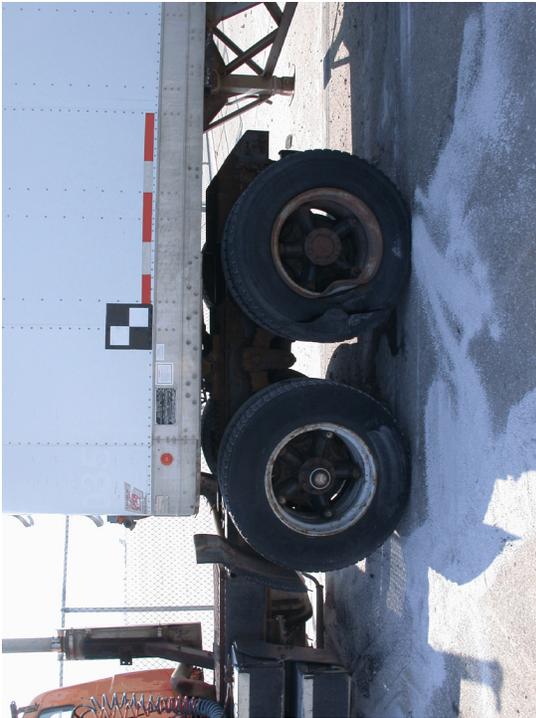
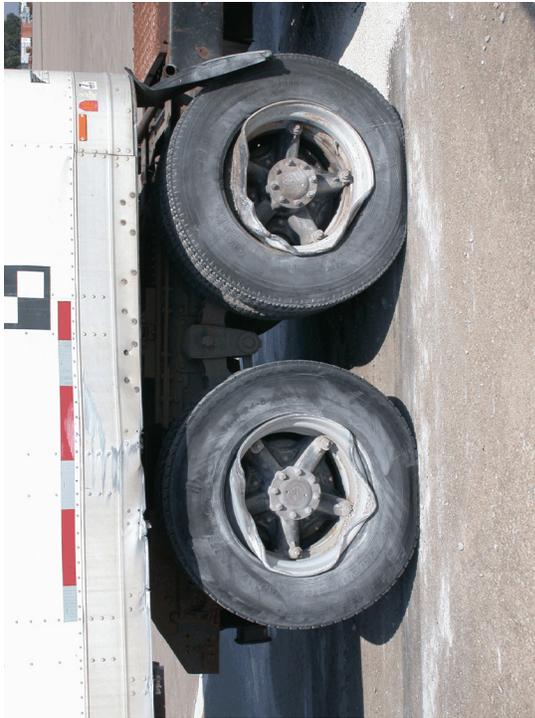
Figure 55. Vehicle Damage, Test ACBR-1

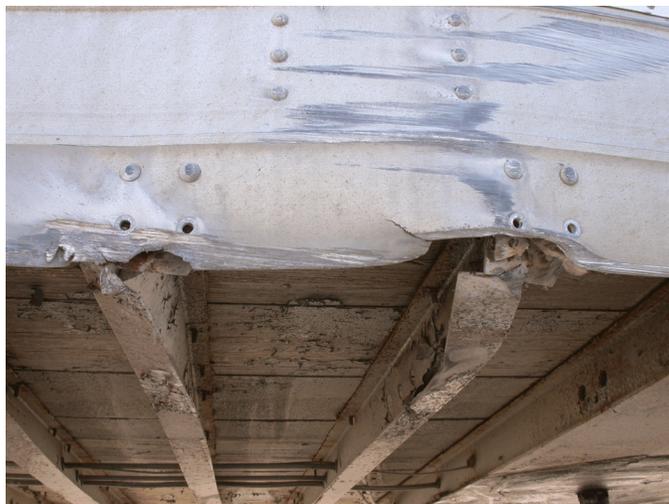
Figure 56. Vehicle Damage, Test ACBR-1

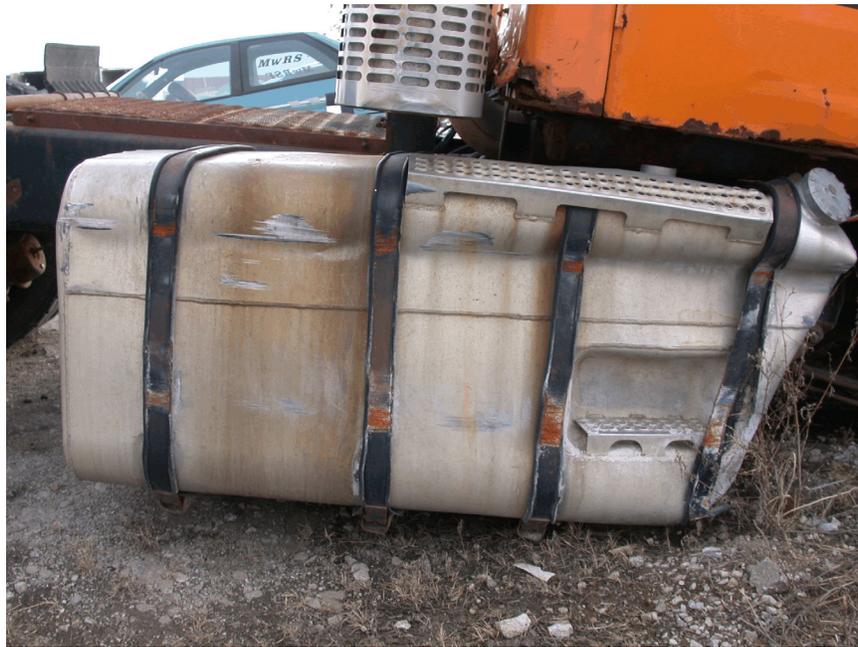
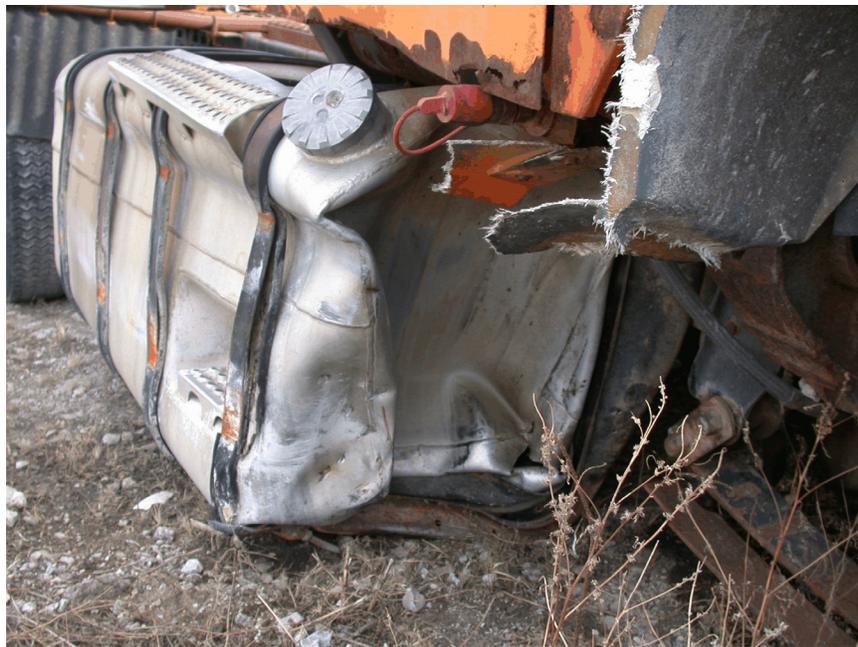
Figure 57. Vehicle Damage, Test ACBR-1

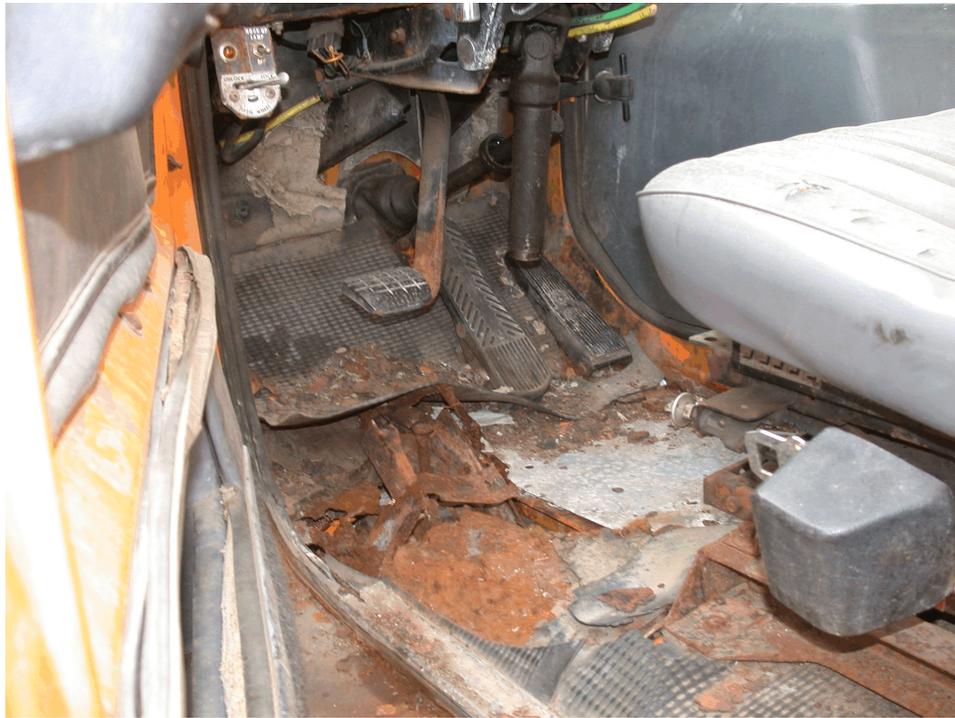
Figure 58. Occupant Compartment Damage, Test ACBR-1
