**Rapid Construction of Pacific Street Bridge**

**PROJECT: SPR-PL-1 (037) P587**

FINAL REPORT

The Pacific Street Bridge over I-680 in Omaha, Nebraska is the first bridge in the United States to use 0.7-in. diameter prestressing strands in pretensioned concrete girders. This project was funded by FHWA through NDOR under the Innovative Bridge Research and Deployment (IBRD) program. The bridge construction was completed in August 2008 as a replacement to an existing substandard bridge. The old bridge was 74-ft wide and had four spans that are 44-ft 6-in., 73-ft, 73-ft 6-in., and 30-ft-long. Each span consisted of 11 steel I-girders at 7 ft spacing. The new bridge consists of two identical spans, 98-ft-long each with 17 deg. skew angle.

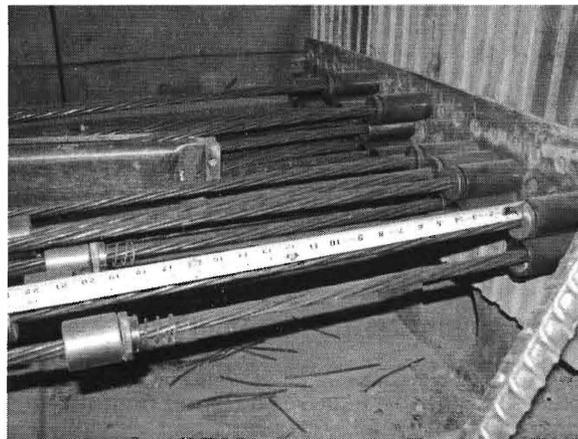
*Figure 2.4.1.4: Strand extension from jacking*

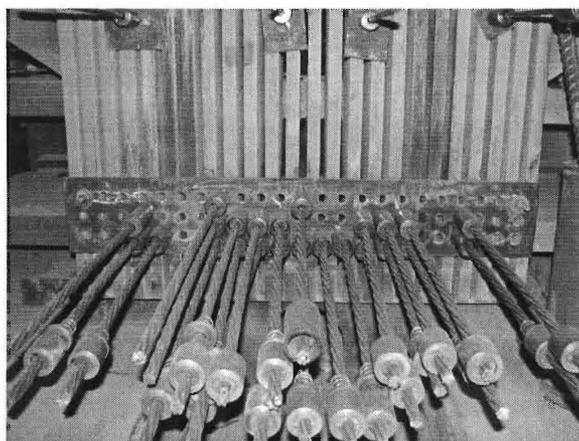
*Figure 2.4.2.1: Jacking end pretensioned strands*

representative of the strand pattern achieved in the precast piece. The patterns at the anchorage ends are governed by the jack head placement and the ability to fit the chucks next to one another as the strands pass through the vertical steel plates and then through the holes of the horizontal plate.

Since the chucks for 0.6" and 0.7" have the same outer diameter, this arrangement problem occurs with the 0.6" strand, too. Thus, this is not a new challenge to overcome. The strand pattern is adjusted to the section pattern required as the strands travel from the anchorage to the end section (see Figures 2.4.2.3 - 2.4.2.4). The end section has the desired pattern applied by passing the strands through a pre-fabricated guide. As long as the anchorage pattern is not significantly different, the desired pattern adjusts to the sectional pattern.

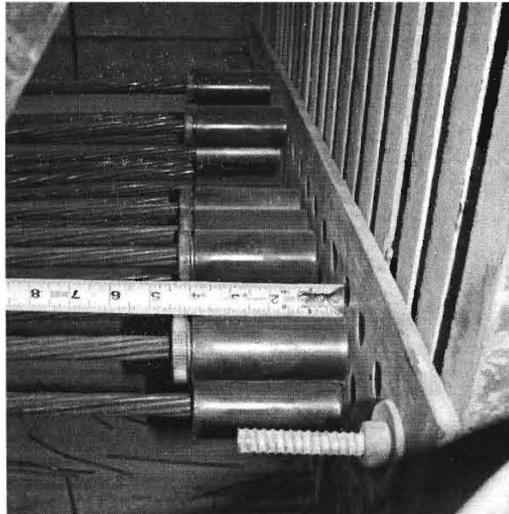
*Figure 2.4.2.6: Re-usable chucks*

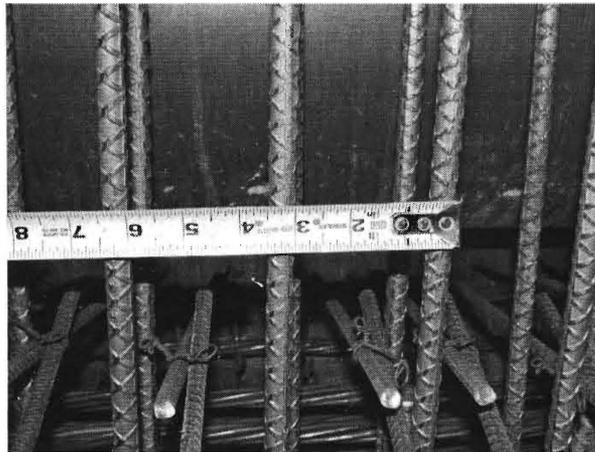
*Figure 2.5.2: Typical shear reinforcement, #4 at 3 in spacing*

After the strands were tensioned into the desired pattern, the remaining fabrication could begin. Fabrication did not provide any unusual difficulties with the use of the 0.7" strand. The shear, confinement, and end zone reinforcement are shown in Figures 2.5.1-2.5.3. The top reinforcement and pouring the girder using self consolidating concrete are shown in Figures 2.5.4 - 2.5.5.

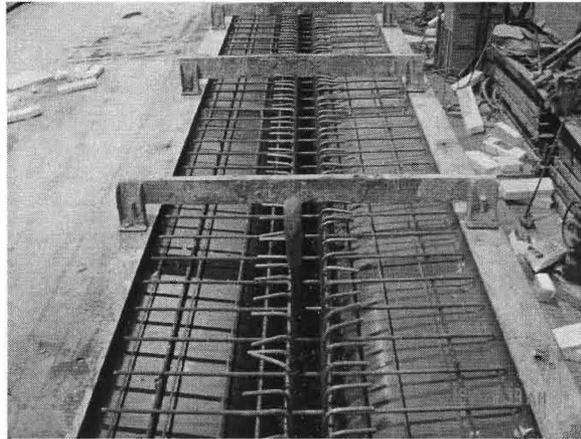
*Figure 2.5.4: Top reinforcement*

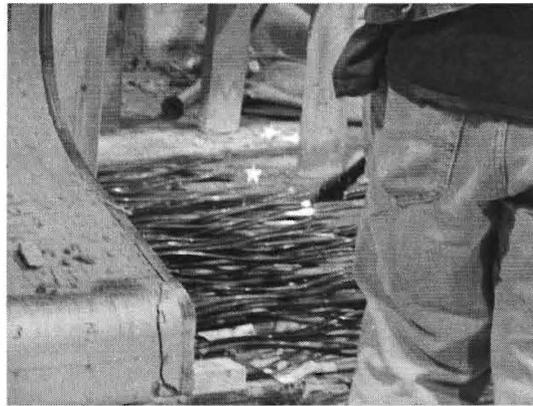
Figure 2.6.1 shows the strands being cut. As discussed, this short prestressing bed did not have the ability to release the strands gradually, so torch cutting had to be used. The strands were cut with two torches simultaneously on each end. The strands were cut from outside inwards, and the top four strands were released prior to the bottom strands.

*Figure 2.6.1: Strand release*

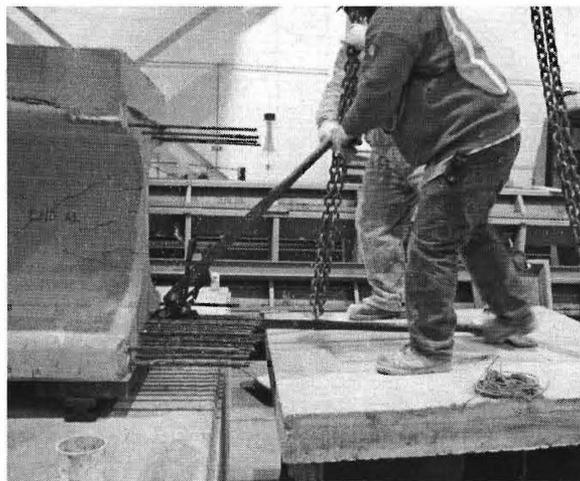
*Figure 2.10.1: First 45 degree strand bend*

A very good practice to develop longitudinal force required for shear is to leave the strands extended about 18 inches past the girder end, bend the strands into a 90 degree curve, and pour a diaphragm around reinforced strands. The center 8 strands of the top row were bent, and a reinforced diaphragm was constructed on each end of the girder to assure the longitudinal force required for shear was developed. The 90 degree bend is achieved in two successive 45 degree bends with a homemade reverse scissor tool.

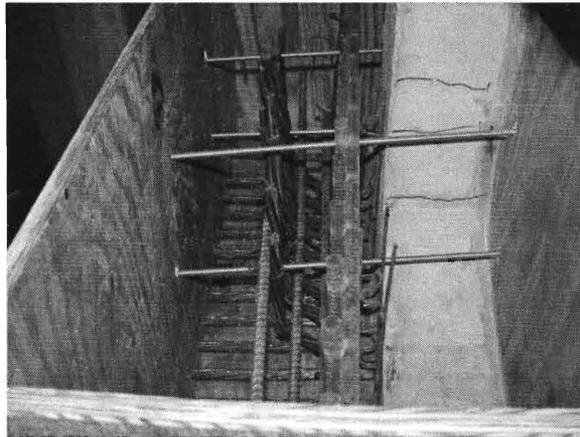
*Figure 2.10.4: Diaphragm reinforcement*

The upper strands were selected for bending because the lower strands will experience the highest ultimate strain out of the strand layers. Therefore, they are more critical in measuring strand slip for development length determination. Bending the 0.7" strands was not noticeably different than bending 0.6" strands and certainly can be done. Figures 2.10.1 - 2.10.3 illustrate the strand bending tool used and the 90 degree bend strands in the final state. Figure 2.10.4 shows the reinforcement placed in the diaphragm to anchor the bent strands and distribute the longitudinal force.

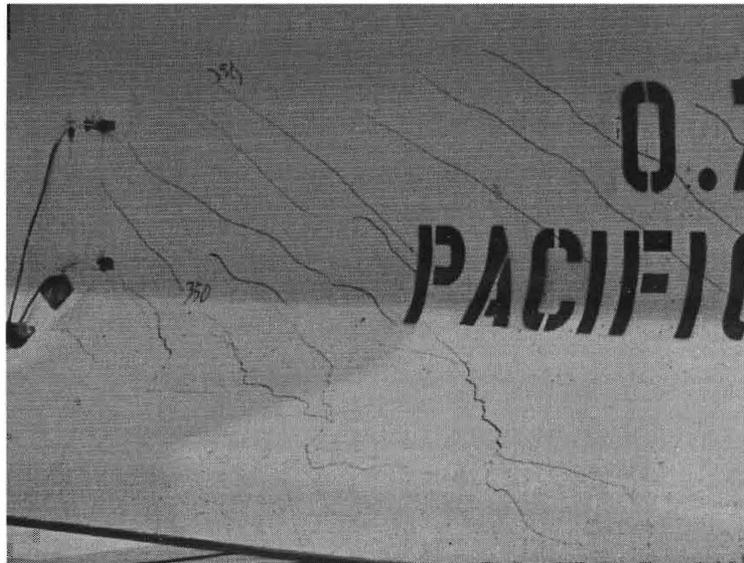
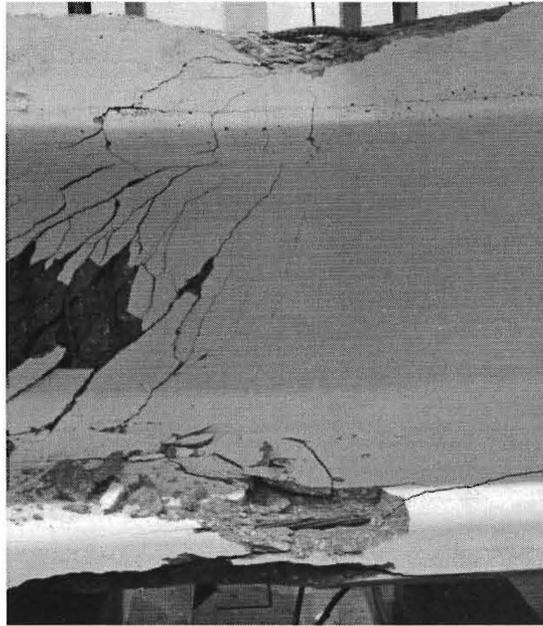
The progression of the test and results are shown in the following figures. Figure 2.11.4.3 shows shear cracking occurring in the web during the loading increments of 50 kips. The shear cracks are propagating through the flange as shown in Figure 2.11.4.4. The immediate shear failure is shown in Figure 2.11.4.5. Upon failure, the beam cambered upward and had a brittle explosion of the web and bottom flange. The shear distribution is shown in Figure 2.11.4.6. Flexure cracking was present at the load point and is shown in Figures 2.11.4.7. Another sign of flexural failure is the deck compression cracking at the load point and the buckling of the #5 bar in the deck shown in Figure 2.11.4.8. The deck cracked where the camber occurred and is shown in Figure 2.11.4.9.

*Figure 2.11.4.3: Shear cracking in the web*

*Figure 2.11.4.4: Shear cracks propagating through flange*

*Figure 2.11.4.5: Immediately after shear failure*

*Figure 2.11.4.6: Shear cracking in web and split flange*

*Figure 2.11.4.7: Flexure cracking at load point*

*Figure 2.11.4.8: Buckling of top deck #5 bar*

*Figure 2.11.4.9: Tensile deck cracking*

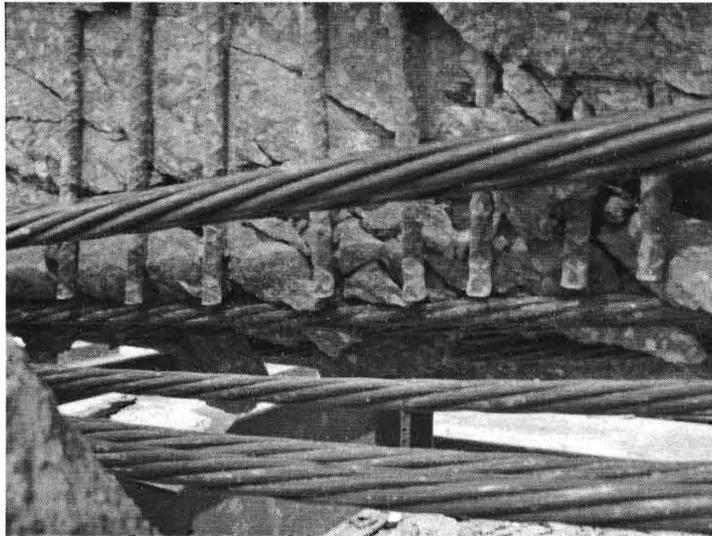
The shear reinforcement was not detailed with a 90 degree bend in the bottom flange. The reinforcement was underdeveloped and allowed the web to separate from the bottom flange which resulted in a shear failure. Figure 2.11.4.10 display the straight shear reinforcement bars.

*Figure 2.11.4.10: Shear reinforcement non-bent in bottom flange*

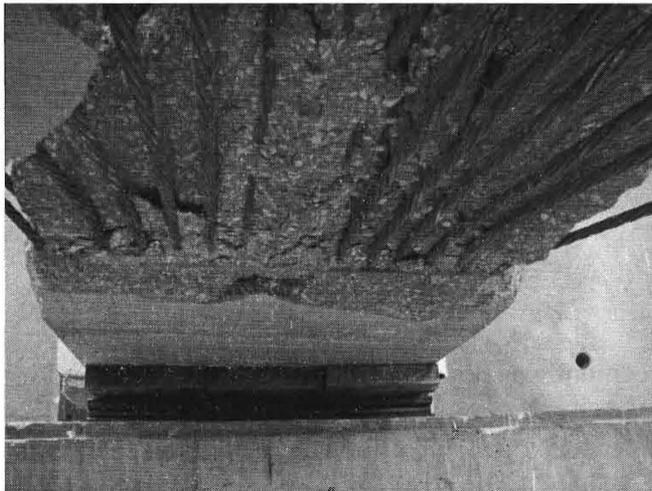
The hairpin confinement detail was effective throughout the transfer length. The hairpins were placed at 3" centers for 45 inches at each girder end. The confinement kept the bottom flange from splitting from the web. The unfailed portion of the web and hairpin are shown in Figure 2.11.4.11. Longitudinal bottom flange cracking and loose strands are shown in Figure 2.11.4.12 - 2.11.4.13.

*Figure 2.11.4.11: Confined flange non-failed*

*Figure 2.11.4.12: Longitudinal flange cracking*

*Figure 2.11.4.13: Loose strands after failure*

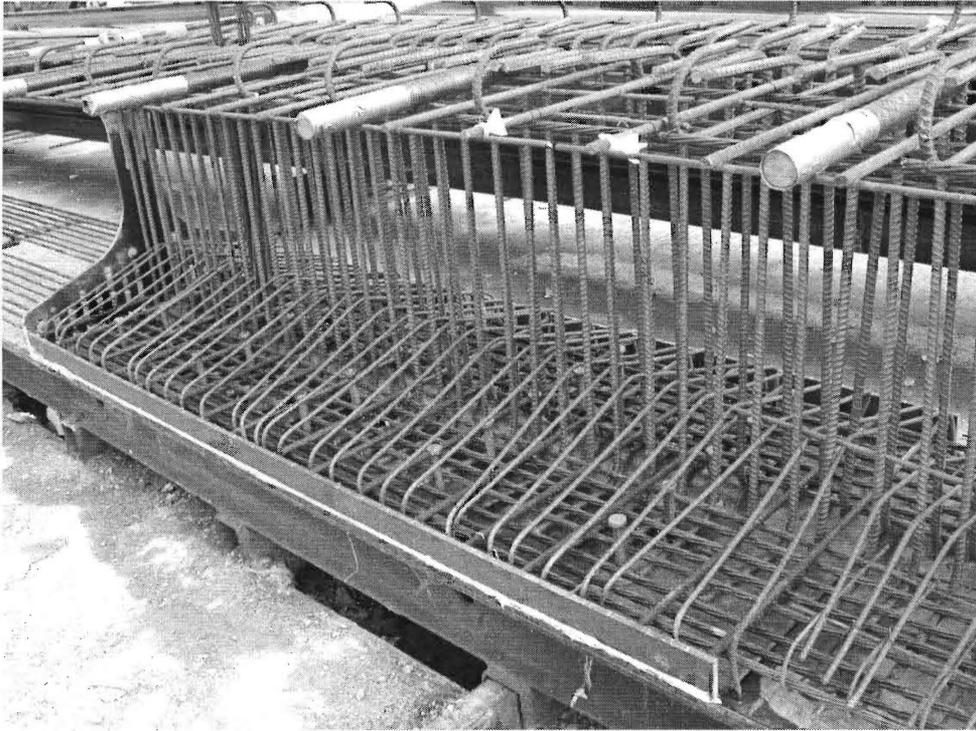
*Figure 3.3.1: Confinement at the End of the Girder and C shape Bar around TR*

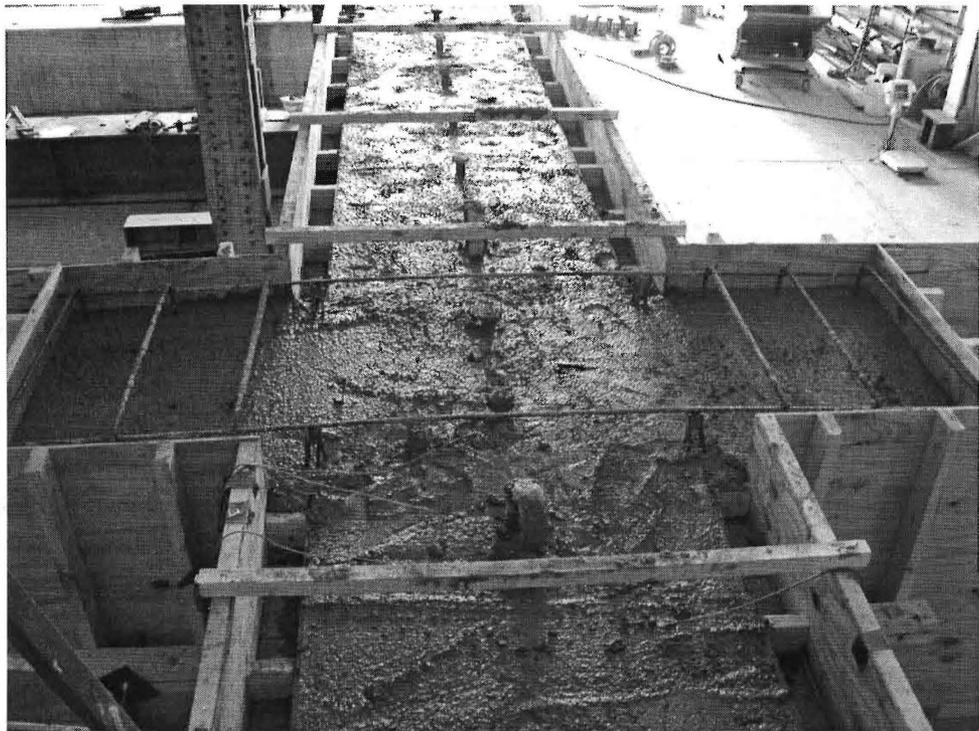
*Figure 3.3.14: Pouring 6.0 ksi Concrete for the Diaphragm and the 3.5" high Interface Block*

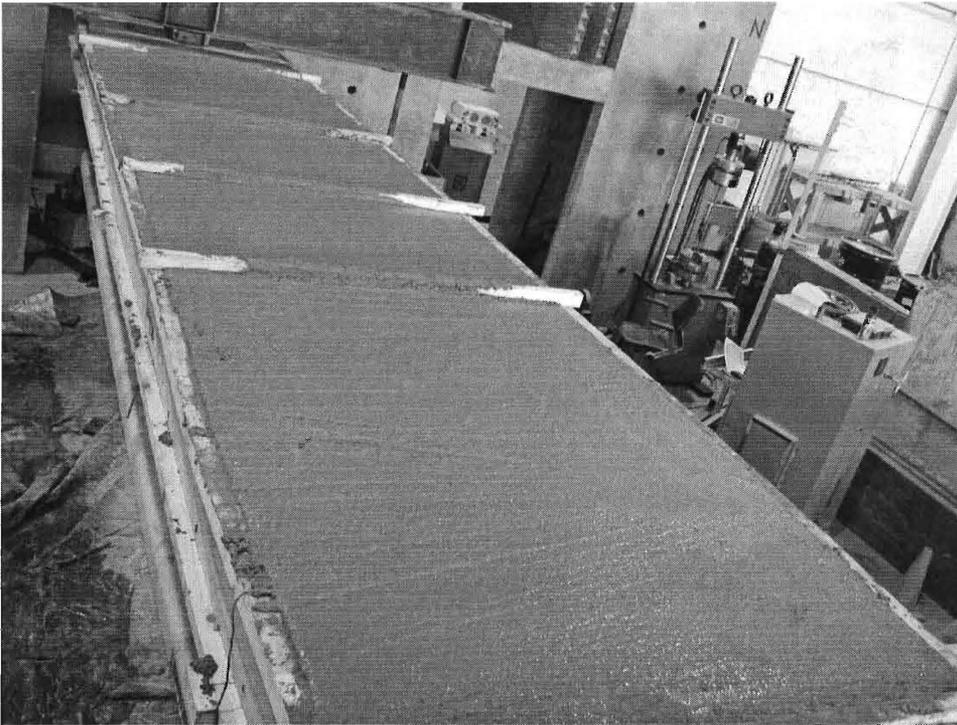
*Figure 3.3.16: Pour Deck Concrete*

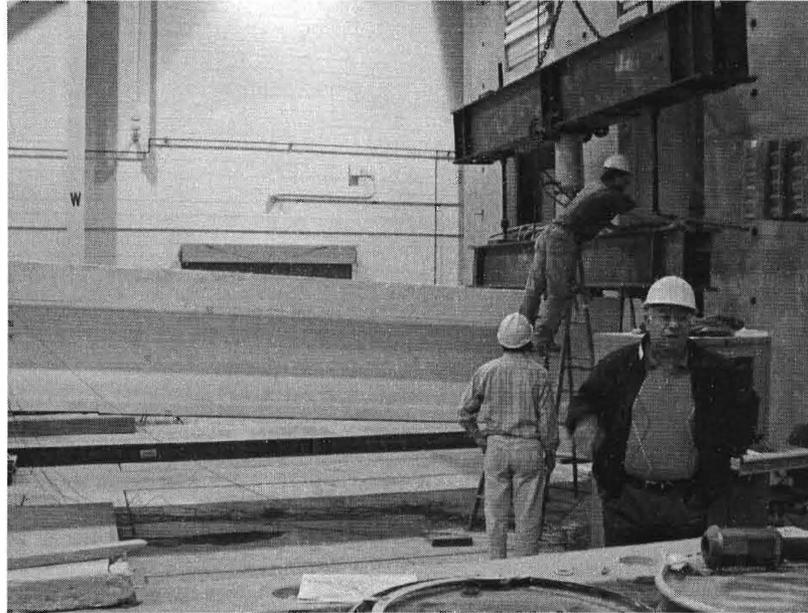
*Figure 3.3.21: Deflection at 324 k*

The maximum load is 324 kips. A large deflection was observed. The rotation at the loading end prevented further loading.

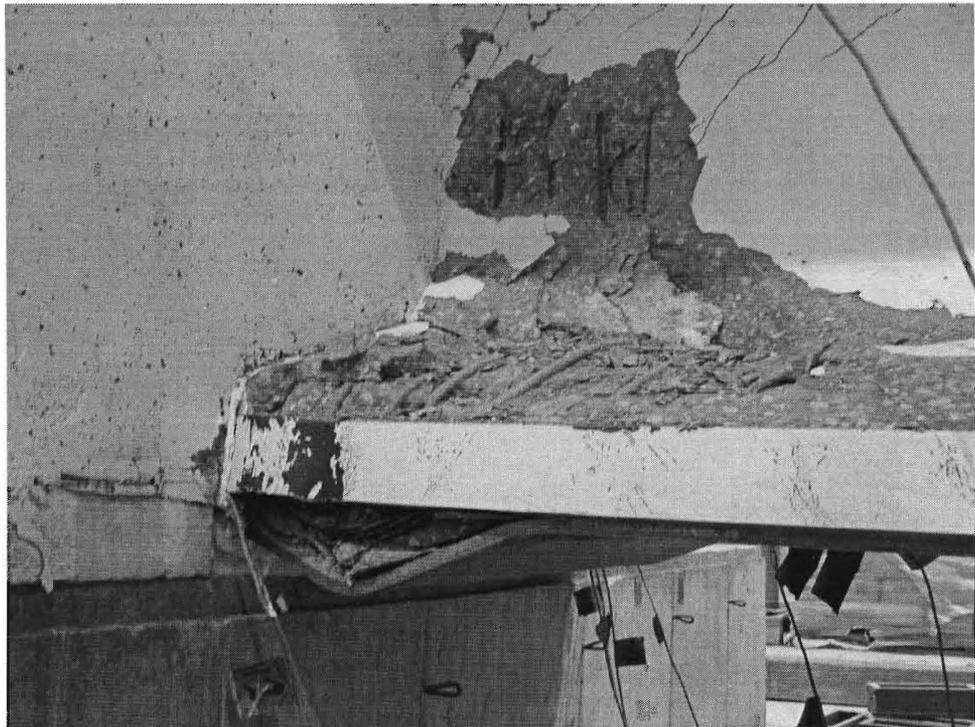
The authors added a roller underneath the steel beam to allow the end of the girder to freely rotate. Then the beam was reloaded again until the sole plate buckled at the face of the diaphragm when load was equal to 382 kips. Everything was fine in the deck.

*Figure 3.3.25: Add a Roller to Achieve Larger Rotation*

*Figure 3.3.27: Specimen Failure at 382 kips*

*Figure 3.3.28: Shoe Plate Buckled at the Face of Diaphragm*

*Figure 3.3.29: Crack on the Top at Failure*

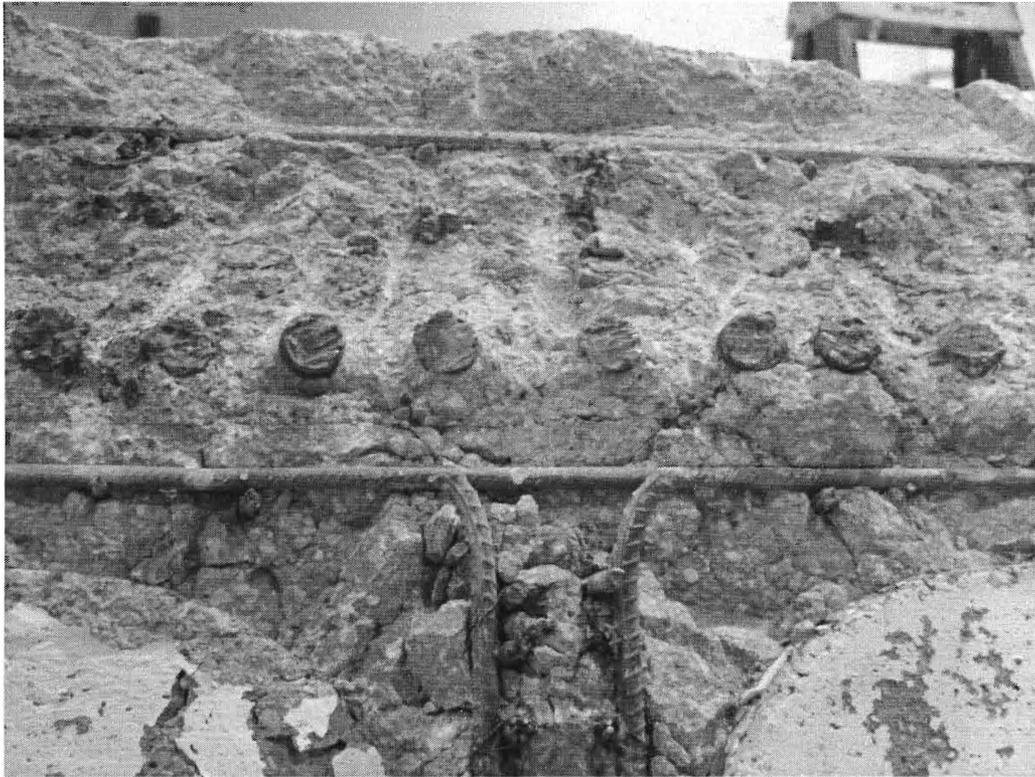
When the specimen was taken apart at the face of the diaphragm, there was no crushing of concrete around the TR or slippage between the concrete and the TR, as shown in Fig. 3-56.

Figure 3.3.30: No Slippage between TR and the Concrete around them

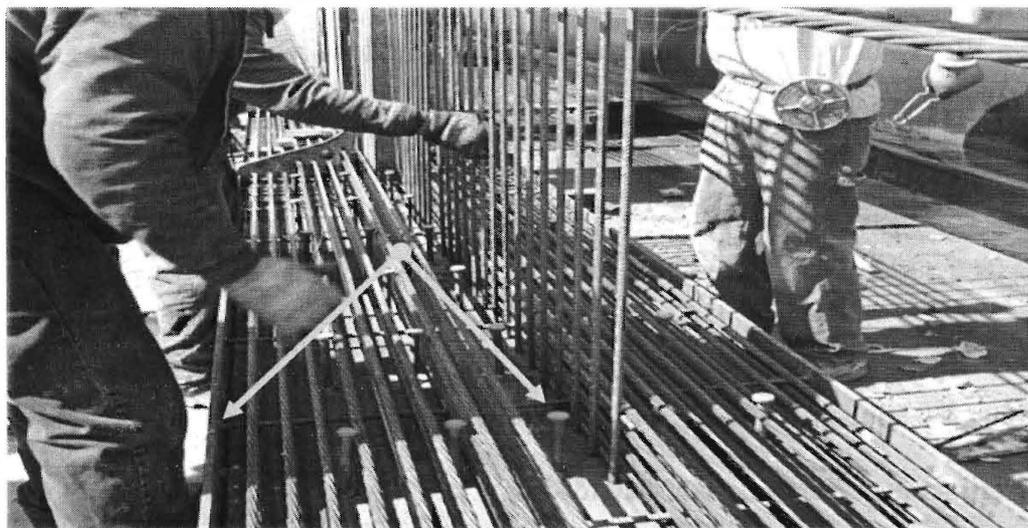
The side confinement plate was used to confine the girder and its elements over the negative moment pier section. However, the threads that connect the side plates on both ends are difficult to manage and thread through the prestressing strands and reinforcement. An example of the side confinement plates are shown in Figure 4.2.1. Elimination of these plates would save cost and would require more confinement reinforcement within the bottom flange of the girder.

*Figure 4.2.1: Side Confinement Plates*

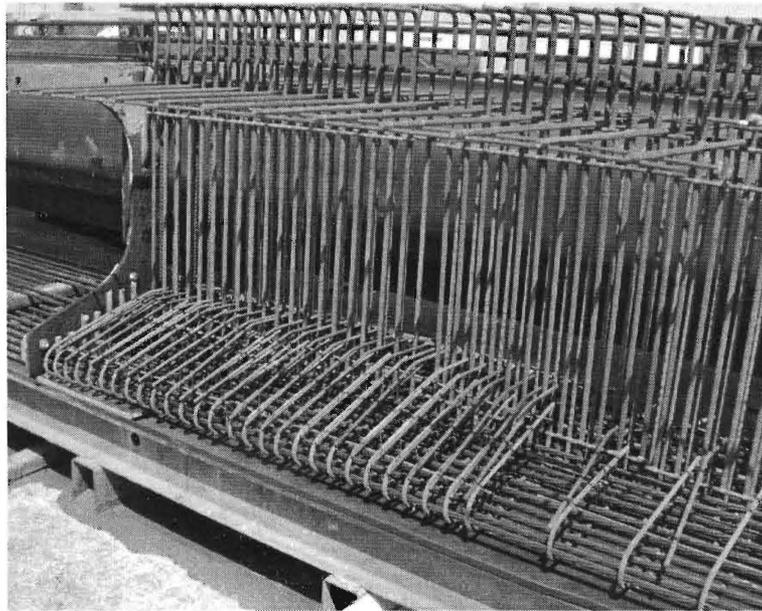
*Figure 4.3.7: Placement of web and top flange reinforcement*

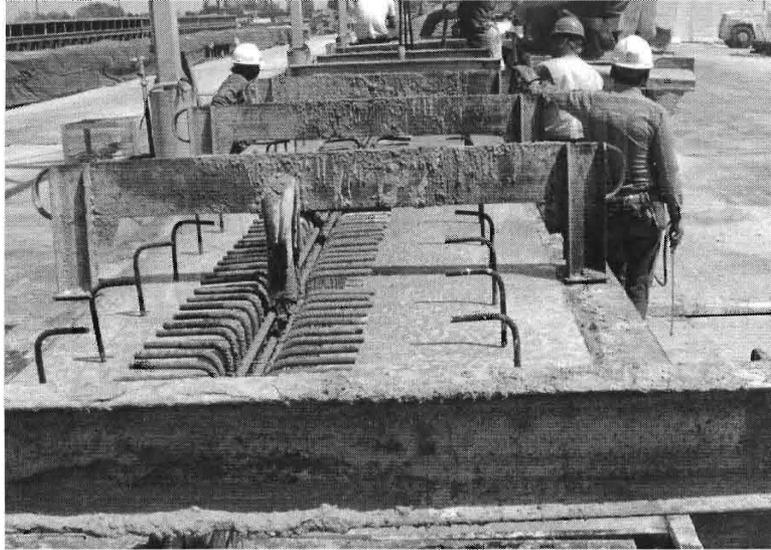
The side forms were then placed and the concrete was poured.

*Figure 4.3.8: Pouring of concrete*

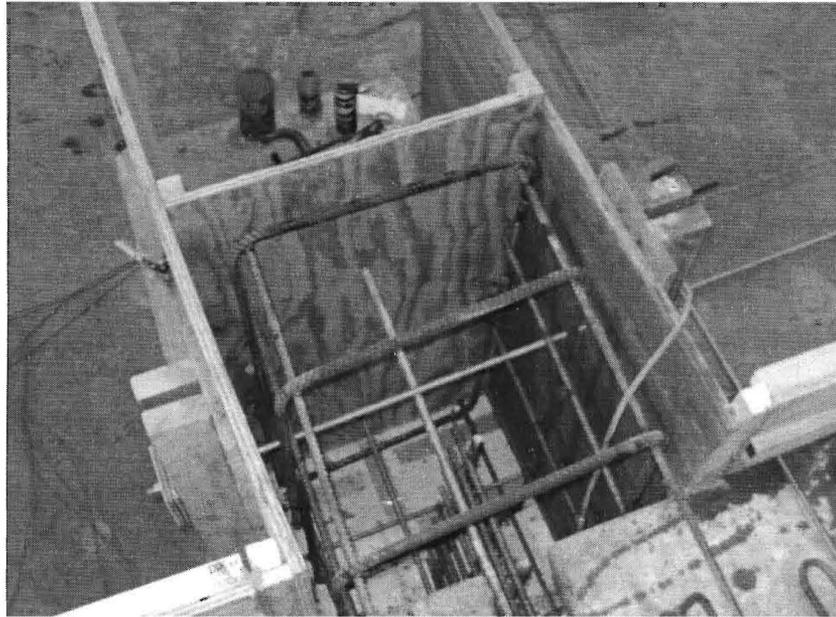
*Figure 4.4.11: Formwork around diaphragm*

After all of the reinforcement for interface block and diaphragm was placed, the formwork was built and the concrete was poured.

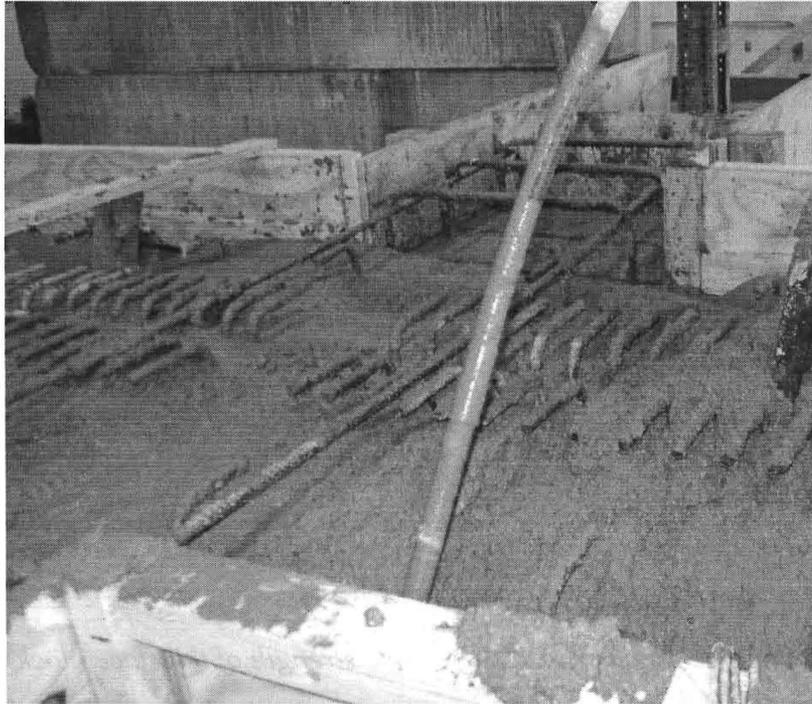
The concrete used for the interface block was a 4 ksi mix with 5 inch slump. The diaphragm was filled and vibrated, and a 3.5 inch layer of concrete was poured on the top flange (See Figures 4.4.13- 4.4.14).

*Figure 4.4.13: Pouring of diaphragm*

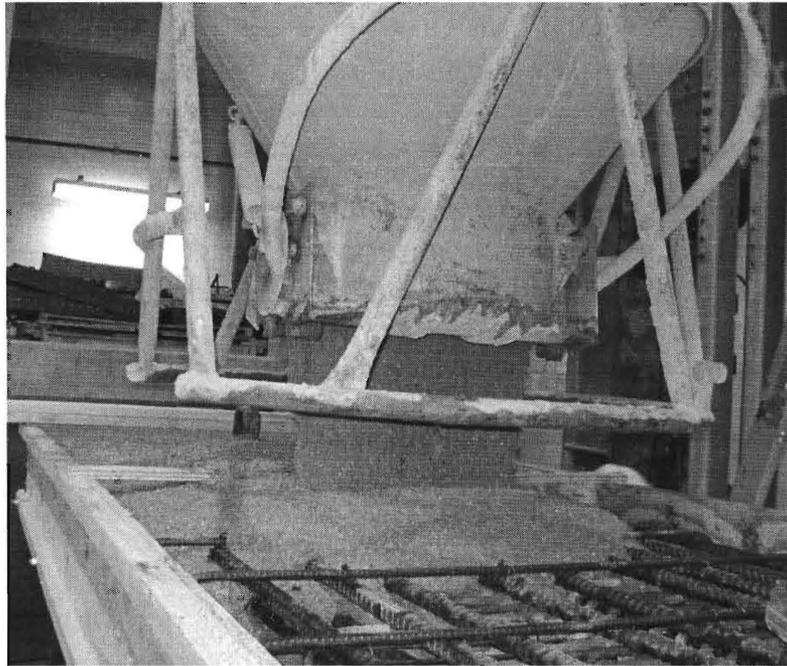
*Figure 4.5.4: Deck pour*

The deck was poured using an SCC mix with 23 inch slump flow. The compressive strength of the mix over time is shown in Figure 4.5.3.

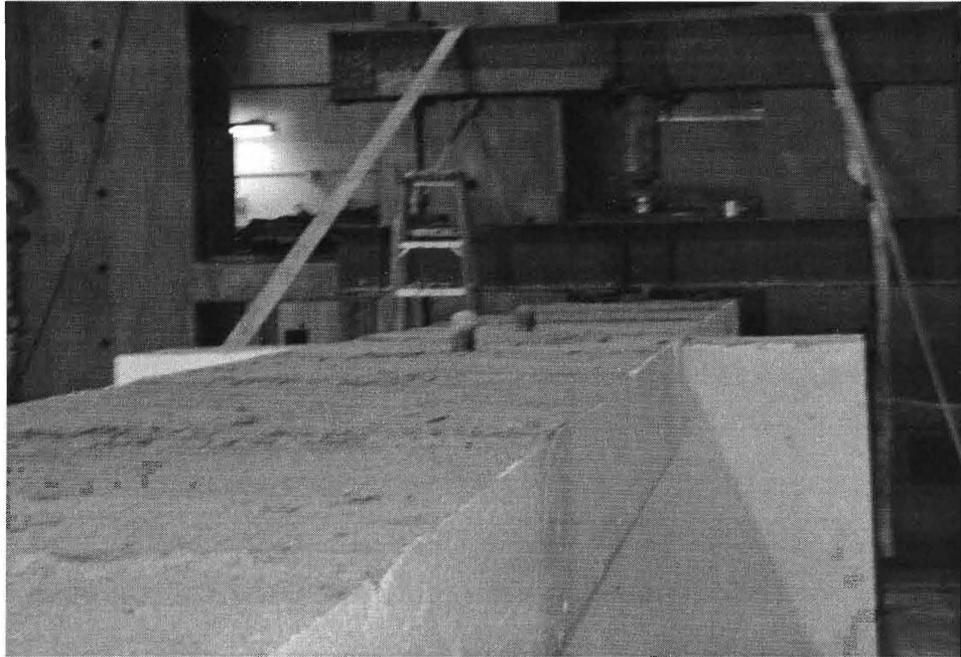
The third generation specimen was tested to determine the flexural capacity. The setup was a double cantilever supported at mid-span with two equal 25 ft spans on each side. Test frames were located 1 ft from each side. The north end was where the loading occurred. The south end had a frame supporting the top to prevent upward deflection from loading on the north end.

*Figure 4.6.1.1: North end*

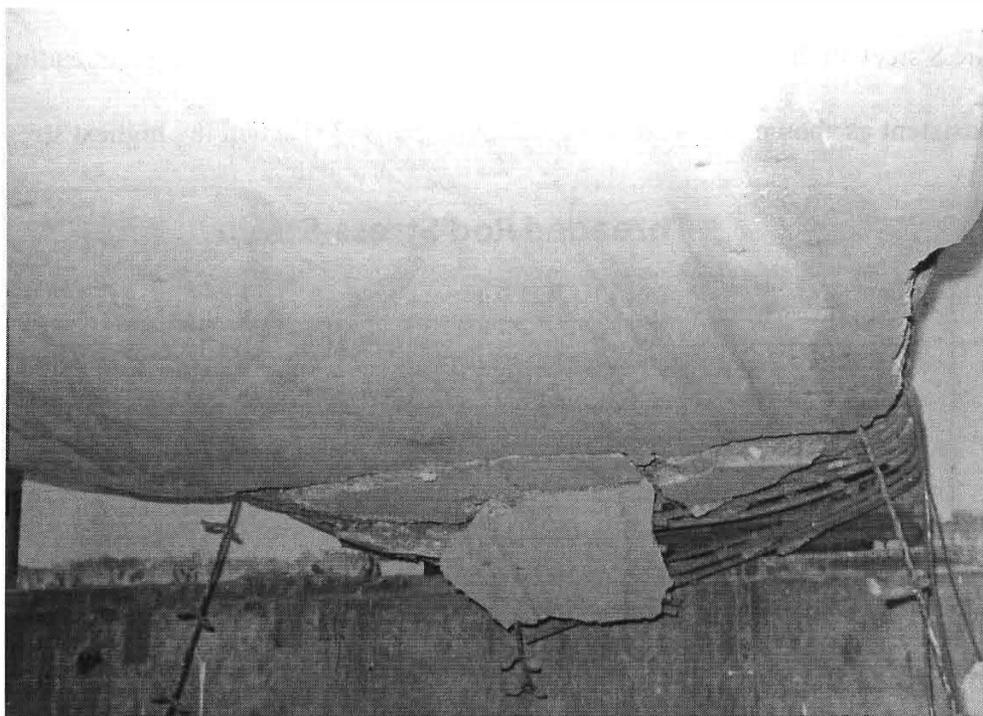
Predicted Failure Load	Tested Failure Load	Mode of Failure
260 kips	261,777 lb	Compression of bottom flange

*Figure 4.6.2.1: Failure near diaphragm*

*Figure 4.6.2.2: Failure near diaphragm*

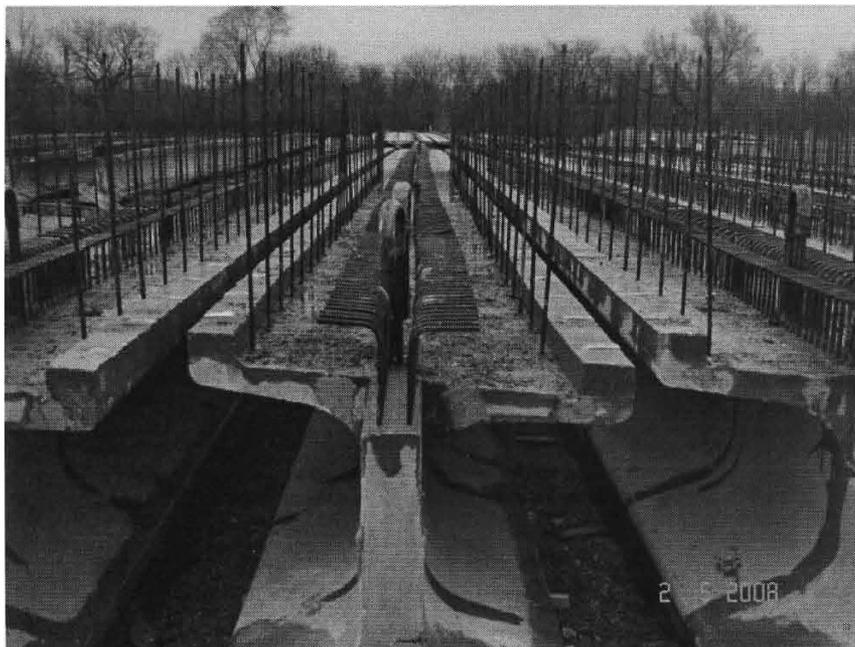
*Figure A.2: NU 900 Girders*

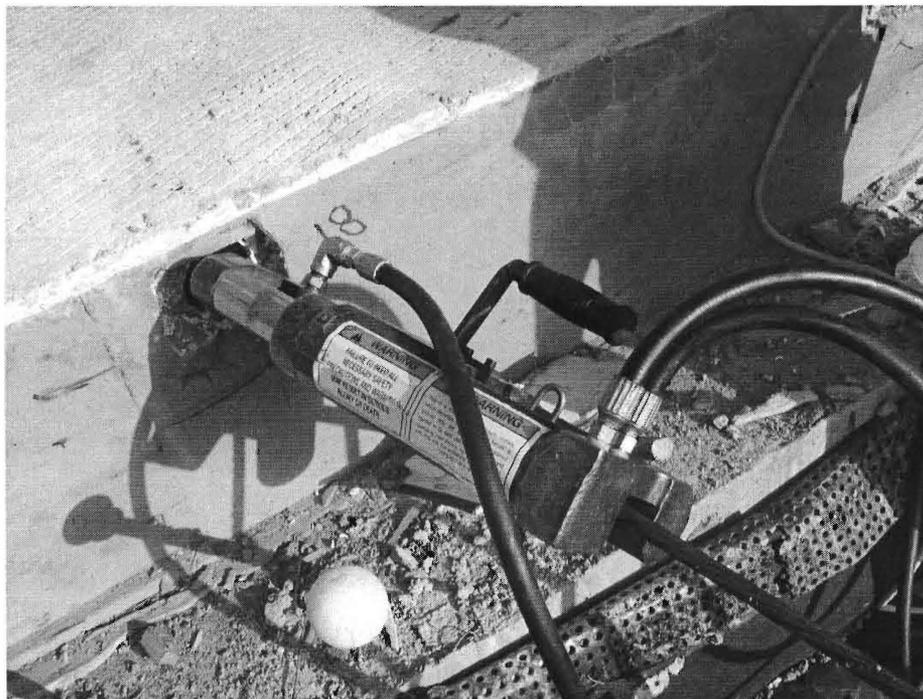
*Figure A.6: Post tensioning jack*

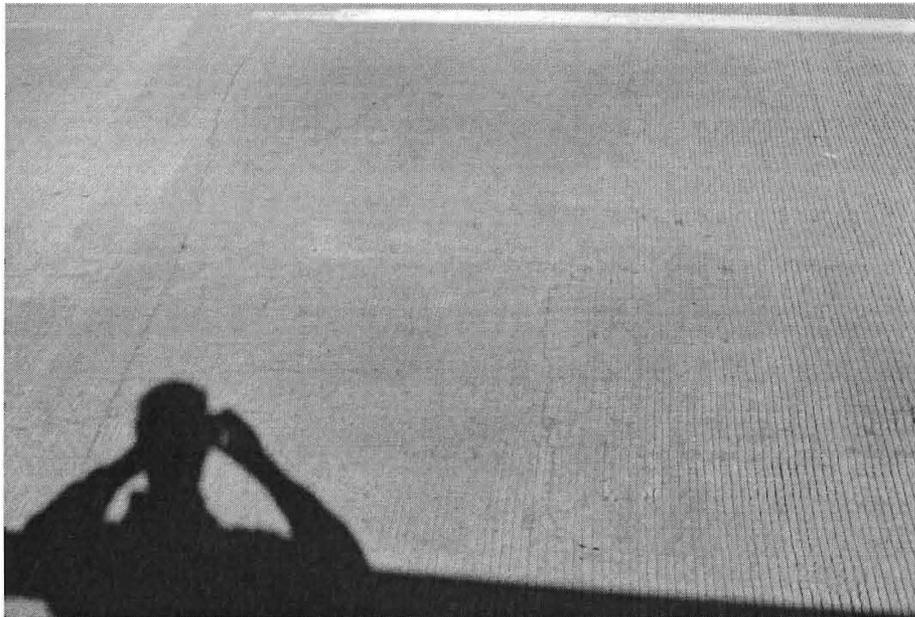
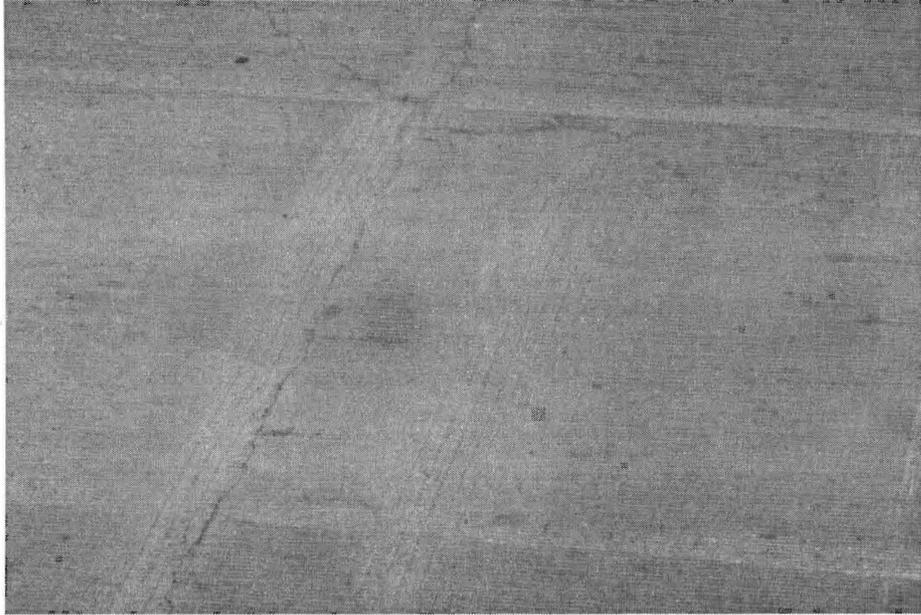
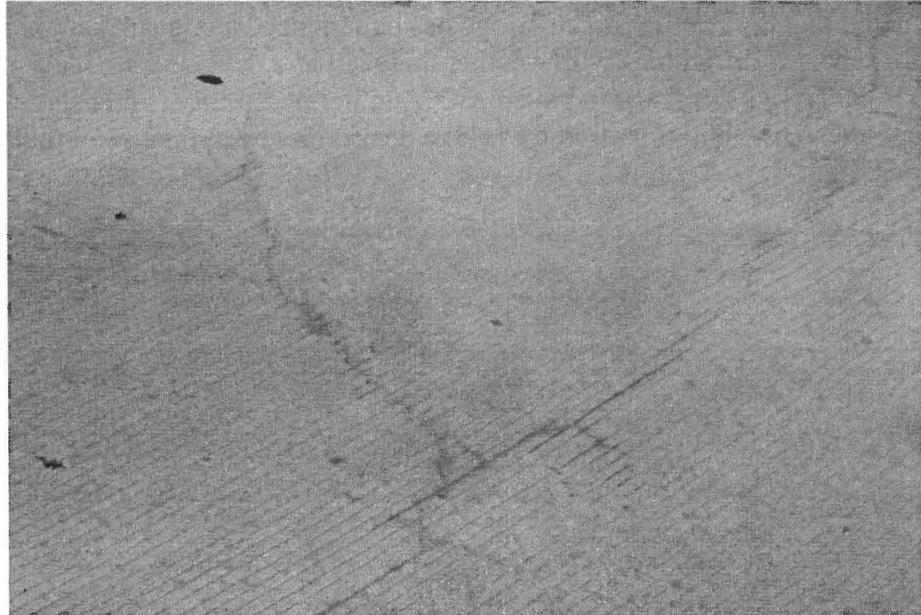
It should be noted that the Pacific Street Bridge has experienced an unusual amount of cracking. The contractor reported difficulties with weather that caused a delay during placement and probably led to increased shrinkage in pavement. Another possibility is that slag was added for the first time to the 7BD-4000 mix used for bridge decks; however, this is not thought to be a reason for cracking.

*Figure A.15: Shrinkage Cracking*

*Figure A.16: Shrinkage Cracking*

*Figure A.17: Shrinkage Cracking*
