Report # MATC-UI: 371

Final Report

Automated Erosion System to Protect Highway Bridge Crossings at Abutments

June 2010

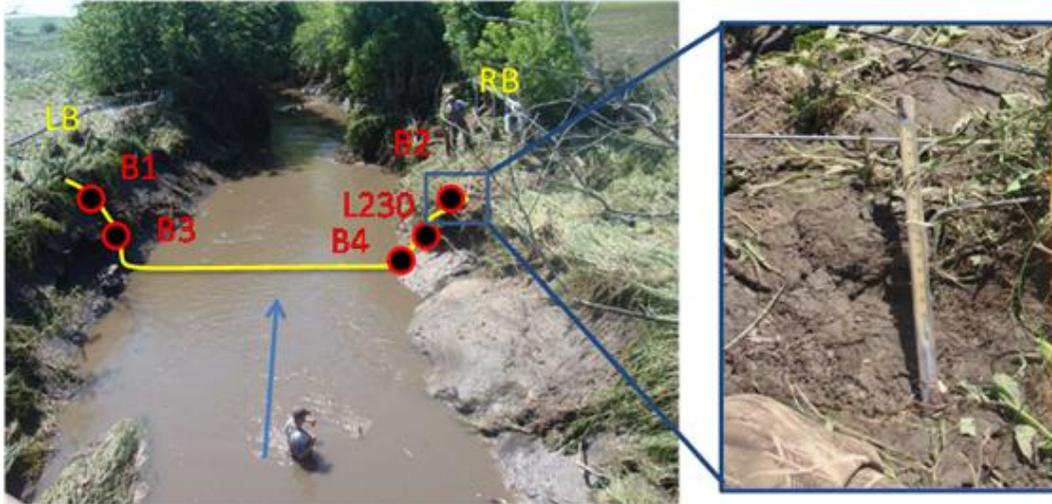
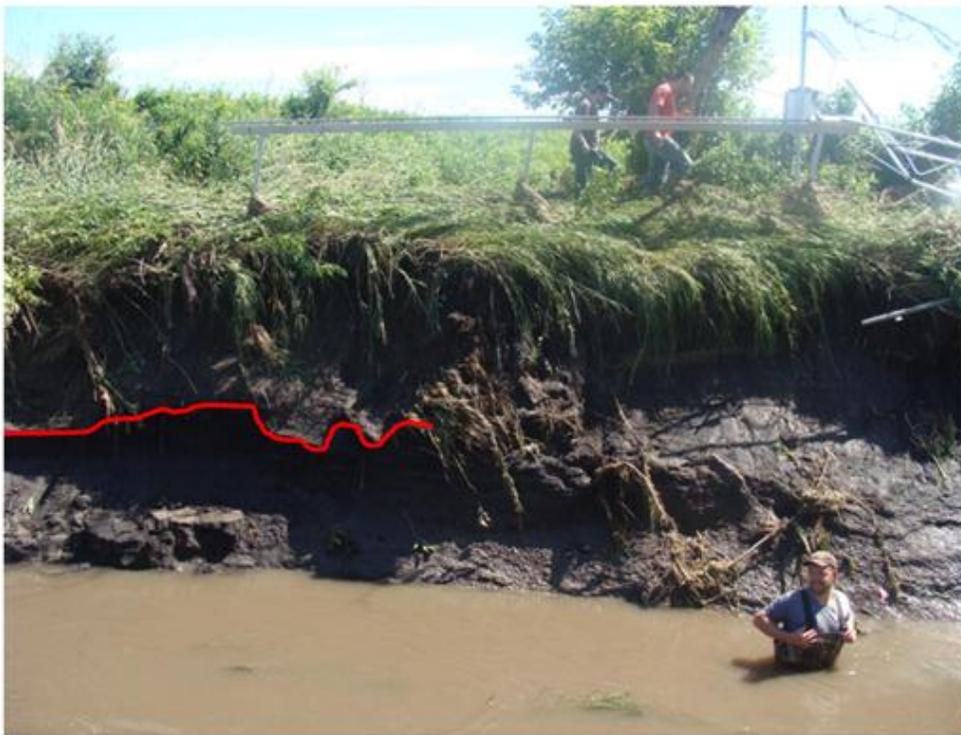
LB: Left bank RB: Right bank
● PEEPs — Cross-section
— Flow direction

Top PEEP B2 completely exposed

— Slumping of materials at the left bank

Figure 3.4 Site 1 Study Reach Showing the Location of the Peeps

At Site 1, five photo-resistance PEEPs (B1, B2, B3, B4, and B5) and one photovoltaic PEEP (L230) were installed on May 18, 2009. For the photo-resistance PEEPs, B5 was considered as the reference PEEP and secured at the flood plain as shown in figure 3.6d. On the right bank (looking downstream), PEEPs B2, L230, and B4 were respectively inserted into the bank face from the top of the bank to the toe, while on the left bank B1 and B3 were installed at the top and bank toe, respectively (see fig. 3.4). These PEEP sensors were removed shortly after the high event of June 19, 2009. The left bank experienced significant mass failure and PEEPs B1 and B3 were completely exposed. No data were recorded for these PEEPs due to a substantial battery drain. The PEEPs on the right bank remained in-place, but significant erosion had also occurred. The reference PEEP, B5, was moved from its original location due to over bank water flow.

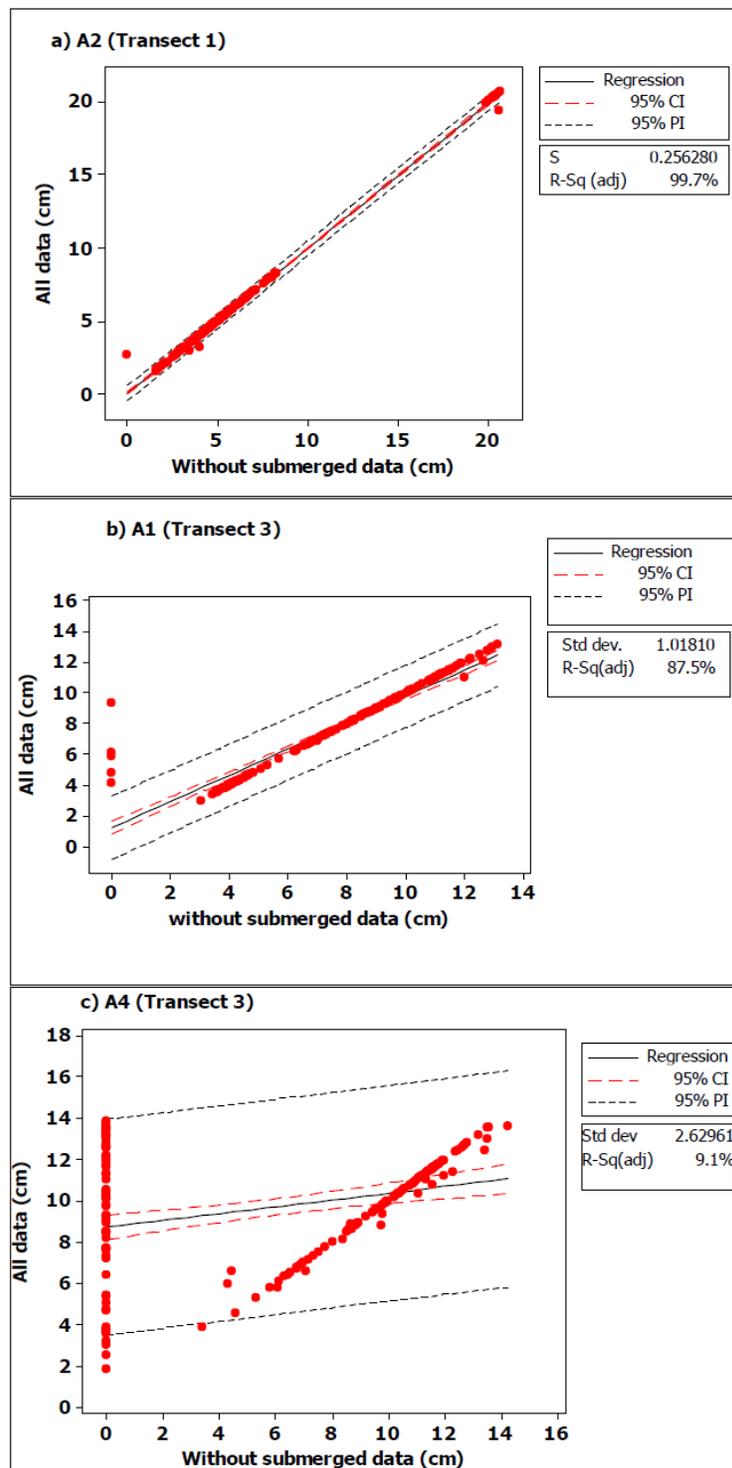
The statistical tests performed to evaluate the performance of PEEPs A1, A2, and A4 located at the three transects at Site 2 are summarized in figure 4.1. On the vertical axis all the data were plotted, when the PEEPs were submerged and unsubmerged. To determine the impact of submergence on the instrument's performance, we correlated all data defined earlier with unsubmerged data. Figure 4.1 reveals that there is a positive correlation between unsubmerged condition and all data with the poorest performance exhibited by PEEP A4 located near the stream bed (see fig. 3.5). Figure 4.1 incorporates regression lines and confidence intervals for the best fit lines of the real data. The closer the PEEPs were to the free water surface, the poorer the performance of the PEEP. This was reflected with the correlation coefficient R^2 value recorded for the three PEEP transects. The higher the elevation of the sensor, the higher the R^2 obtained from the best fit analysis. We believe PEEPs located near the toe of the bank perform poorer than the remaining PEEPs for the following reasons: (1) light availability and penetration corresponding to the submergence period of the PEEPs, and (2) disturbance caused by the bank inundation and the formation of forbay areas in the proximity of the bank toe.

Figure 4.1 Examination of Peeps Performance for Periods that Peeps are Submerged to the Flow and Unsubmerged. The datasets are recorded from PEEPs: a) A2; b) A1; and c) A4 located at Camp Cardinal (Site 2) for summer and fall of 2009. The x-axis includes data when PEEPs A2, A1, and A4 are fully submerged. The y-axis includes all the data without removing the data when PEEPs A2, A1, and A4 are submerged.

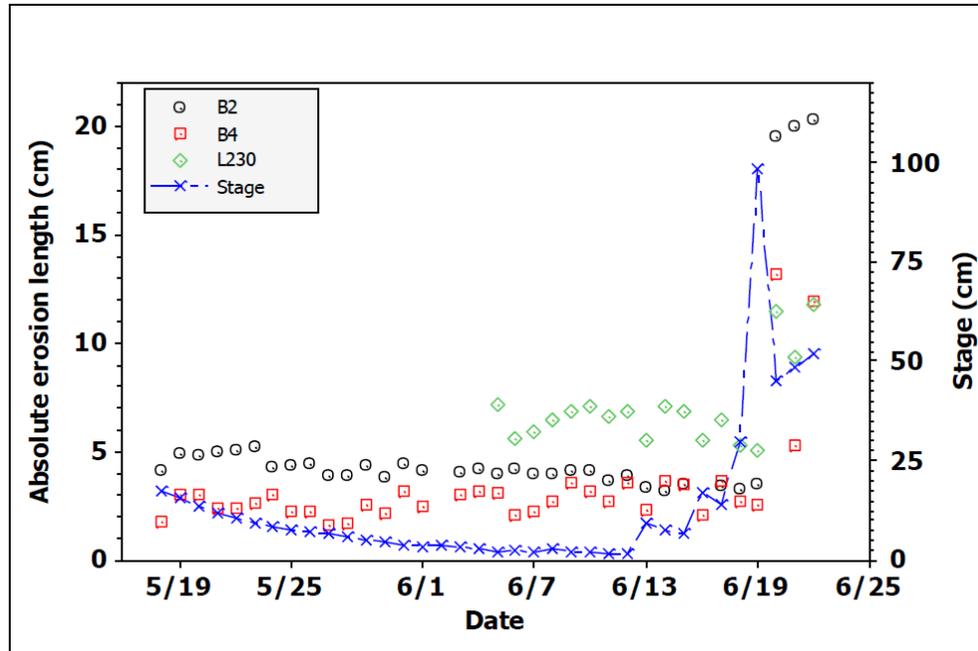
The daily time series data for the PEEPs records are presented along with the stage measured in figure 4.3 for Site 1 during the period of May 18 to June 22, 2009. The figure shows continuous toe erosion activity for the period of observation. Bank toe erosion has been observed to occur on a continuous basis and presents high variability that is attributed to the variability in the stress exerted by the flow. According to Simon and Collison (2001), and Papanicolaou et al (2007), bank toe erosion is triggered due to significant excess or apparent shear stress, which can lead to bank undercutting near the toe region. Therefore, it is most probable that bank toe erosion at Site 1 is triggered by the fluvial shear stress.

Figure 4.3 Times Series of Daily Interval, Stage and Bank Erosion Measurements Using the Sensors B2, B4, L230 at South Amana (Site 1)

As the stage increased and we approached closer to the June 19th event, the erosion rates increased at all locations. A maximum retreat of 20.5 cm was recorded along the bank face (see fig. 4.3). This was an indication that mass failure occurred during the rising and falling limbs of the hydrograph. In other words, the erosion process at the bank boundary lost its spatial randomness and occurred simultaneously at the same rate for all locations.

In addition, figure 4.3 provides unique information about the time lag between the peak of the hydrograph and the highest erosion rate for all locations. The maximum retreat was observed roughly 21 hours after the occurrence of the hydrograph peak. It was clear that swelling and subsurface flow within the bank soil have contributed to the delayed response of the bank to the June 19th event. Both subsurface flows and swelling are key components of subaerial processes confirming our earlier suggestion that mass erosion remains the controlling agent during and after the June 19th event at Site 1. A similar trend to the one observed at site 1 was also observed at Site 2.

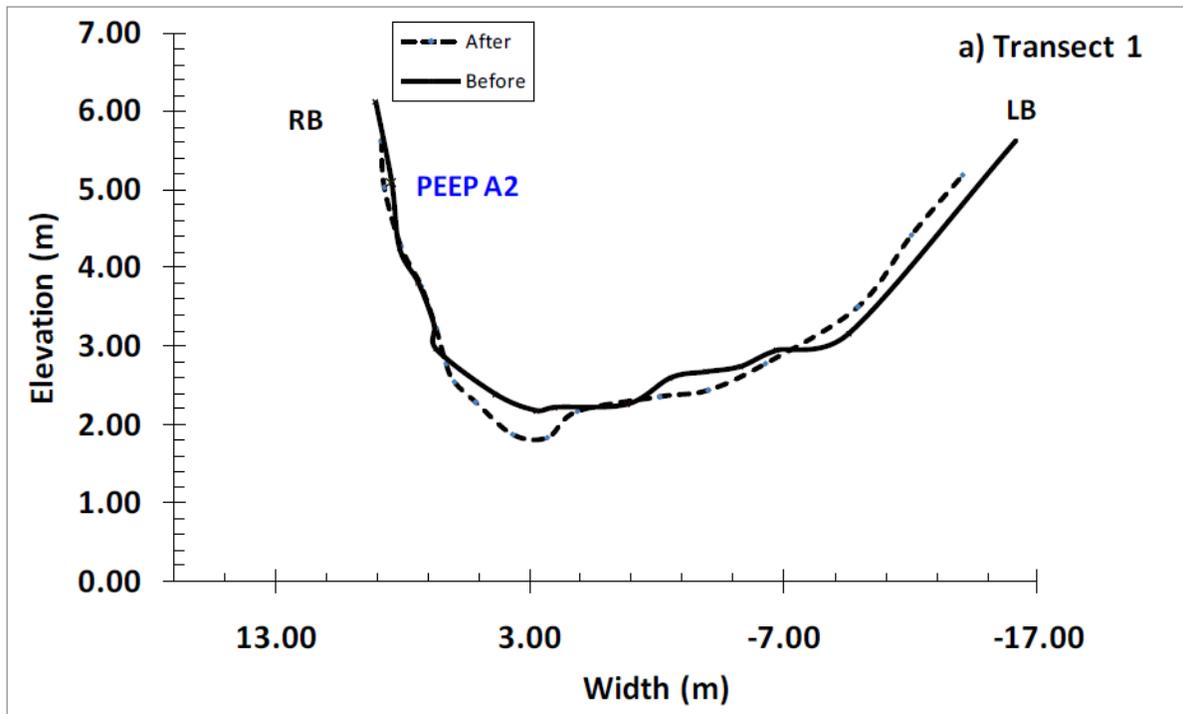
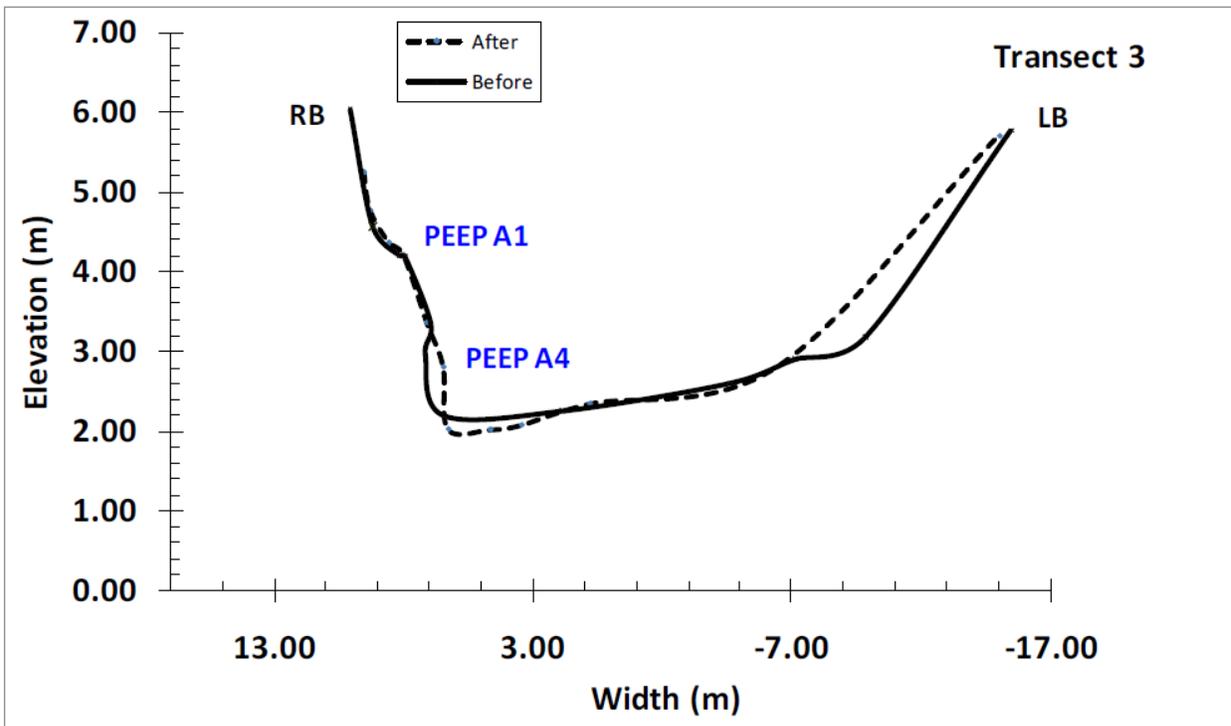
Figure 4.5 Bank Profile Delimitation before and after the August 27th Event Using the PEEP Data: (a) Transect 1 and (b) Transect 3. The bank profile is delimited using the survey data of July 30th and September 30th 2009. If positioned facing downstream, “RB” stands for Right bank and “LB” for left bank.
