FULL-SCALE VEHICLE CRASH TESTS ON THE IOWA BOX-ALUMINUM BRIDGE RAIL

TRANSPORTATION RESEARCH REPORT TRP-03-013-88

November, 1988

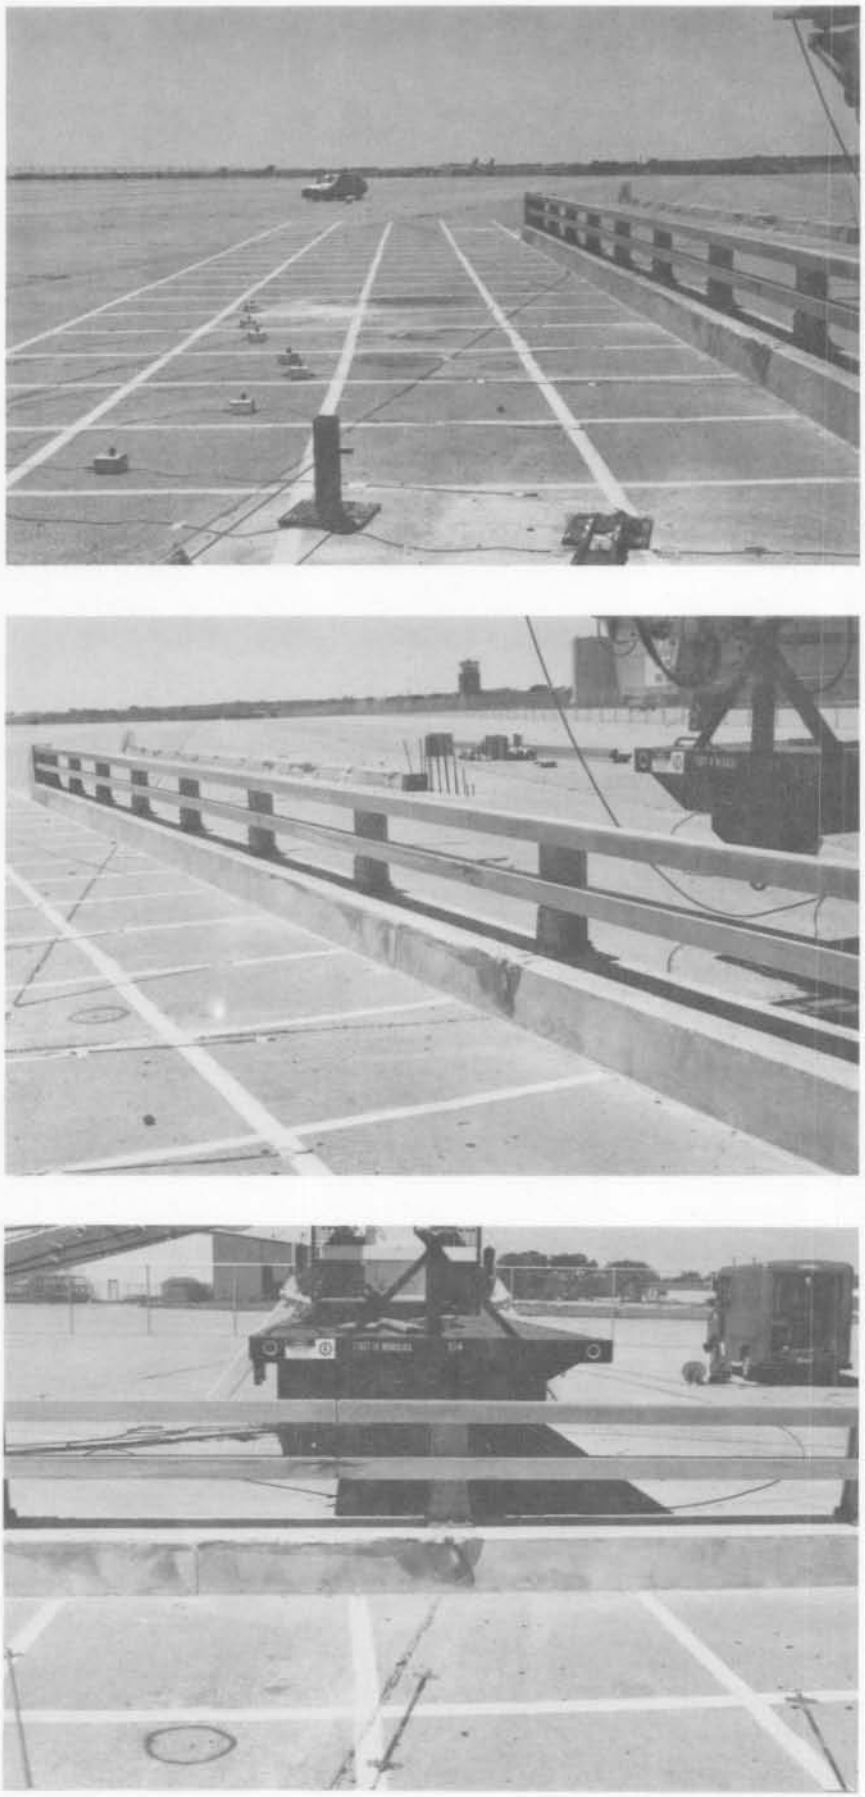
FIGURE 16. PHOTOGRAPHS OF BOX-ALUMINUM BRIDGE RAIL DAMAGE, TEST I1-1

Photographs of the vehicle damage are shown in Figure 15. As evident, the vehicle damage was extensive. The TAD and VDI damage classifications are shown in Figure 14. Photographs of the minimal damage to the bridge rail are shown in Figure 16. From the overhead high-speed camera, the dynamic deflection of the upper rail member was determined to be approximately 2 1/4-in. No permanent set had occurred in the lower and upper rail members.

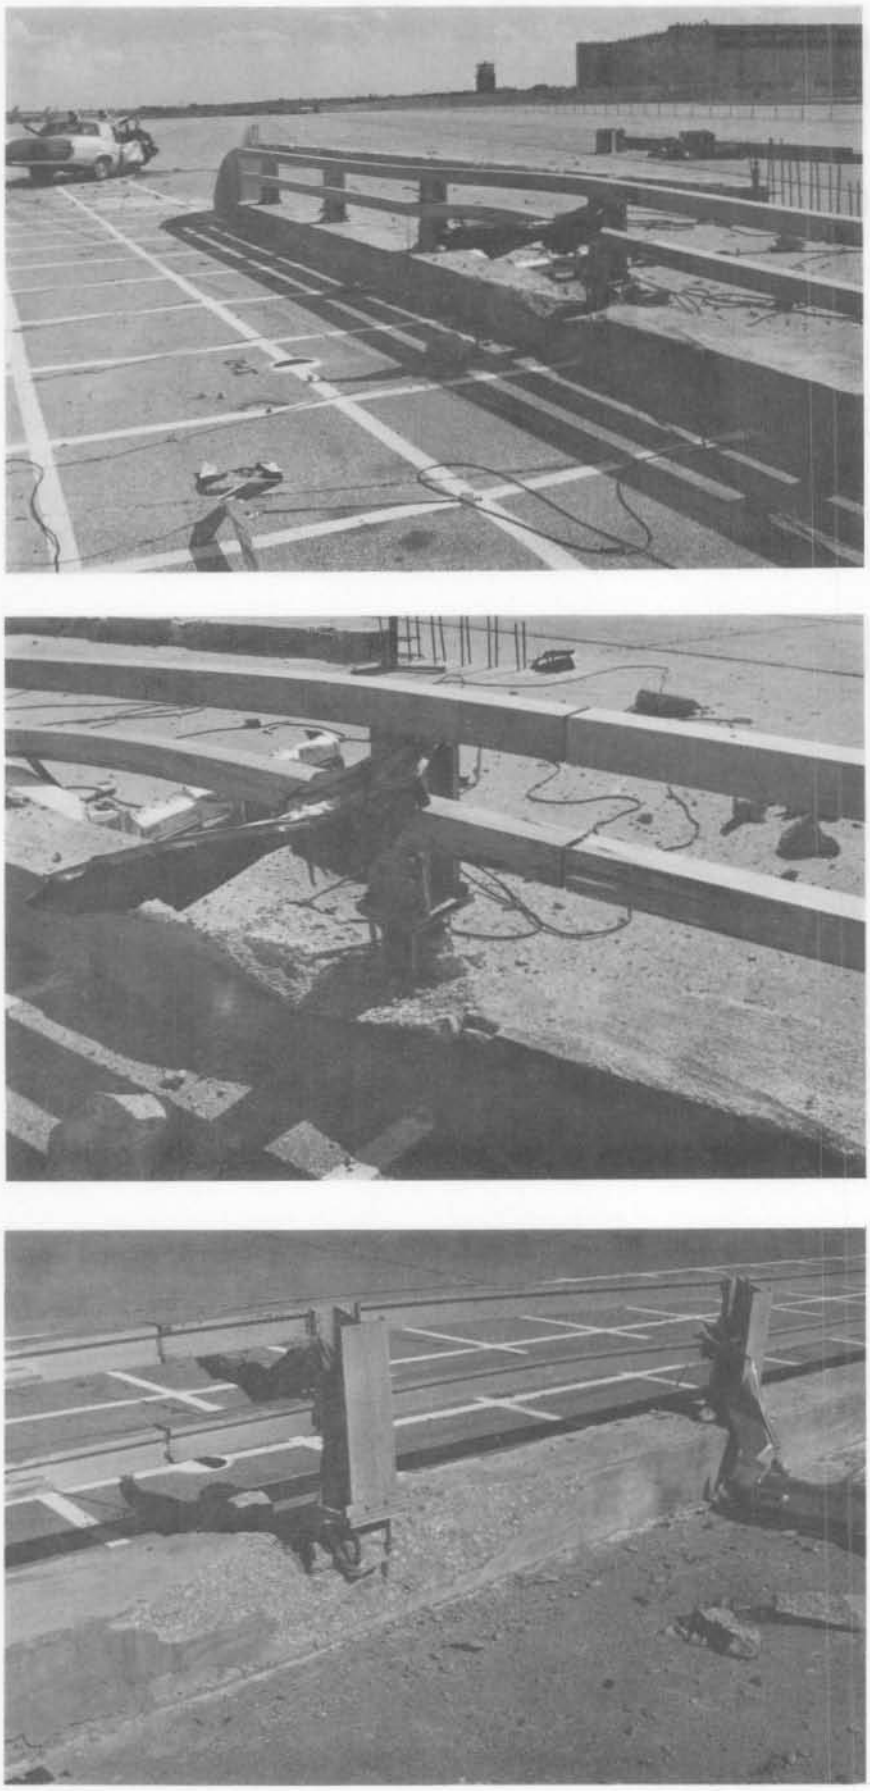
FIGURE 19. PHOTOGRAPHS OF BOX-ALUMINUM BRIDGE RAIL DAMAGE, TEST I1-2

Upon impact with the bridge rail, the right-front corner of the vehicle became wedged between the concrete curb and the lower aluminum bridge rail. The vehicle continued to travel forward until the right front corner and bumper of the vehicle snagged on post No. 8. That, plus the force from the horizontal rail, caused the post with the attached base post assembly to break away from the concrete curb. When the vehicle began to travel past post No. 8, the front section of the vehicle (including the engine portion) buckled to the right. At that stage, the majority of the right-front side had been crunched inward due to the severe snagging. The vehicle continued to travel down the bridge rail to the next rail post (No. 9). At post No. 9, the front bumper finally detached from the car due to snagging. The vehicle then was redirected off the bridge rail after being in contact for approximately 14 ft.

with the concrete curb. The TAD and VDI damage classifications are shown in Figure 17. Photographs of the extensive damage to the bridge rail are shown in Figure 19.

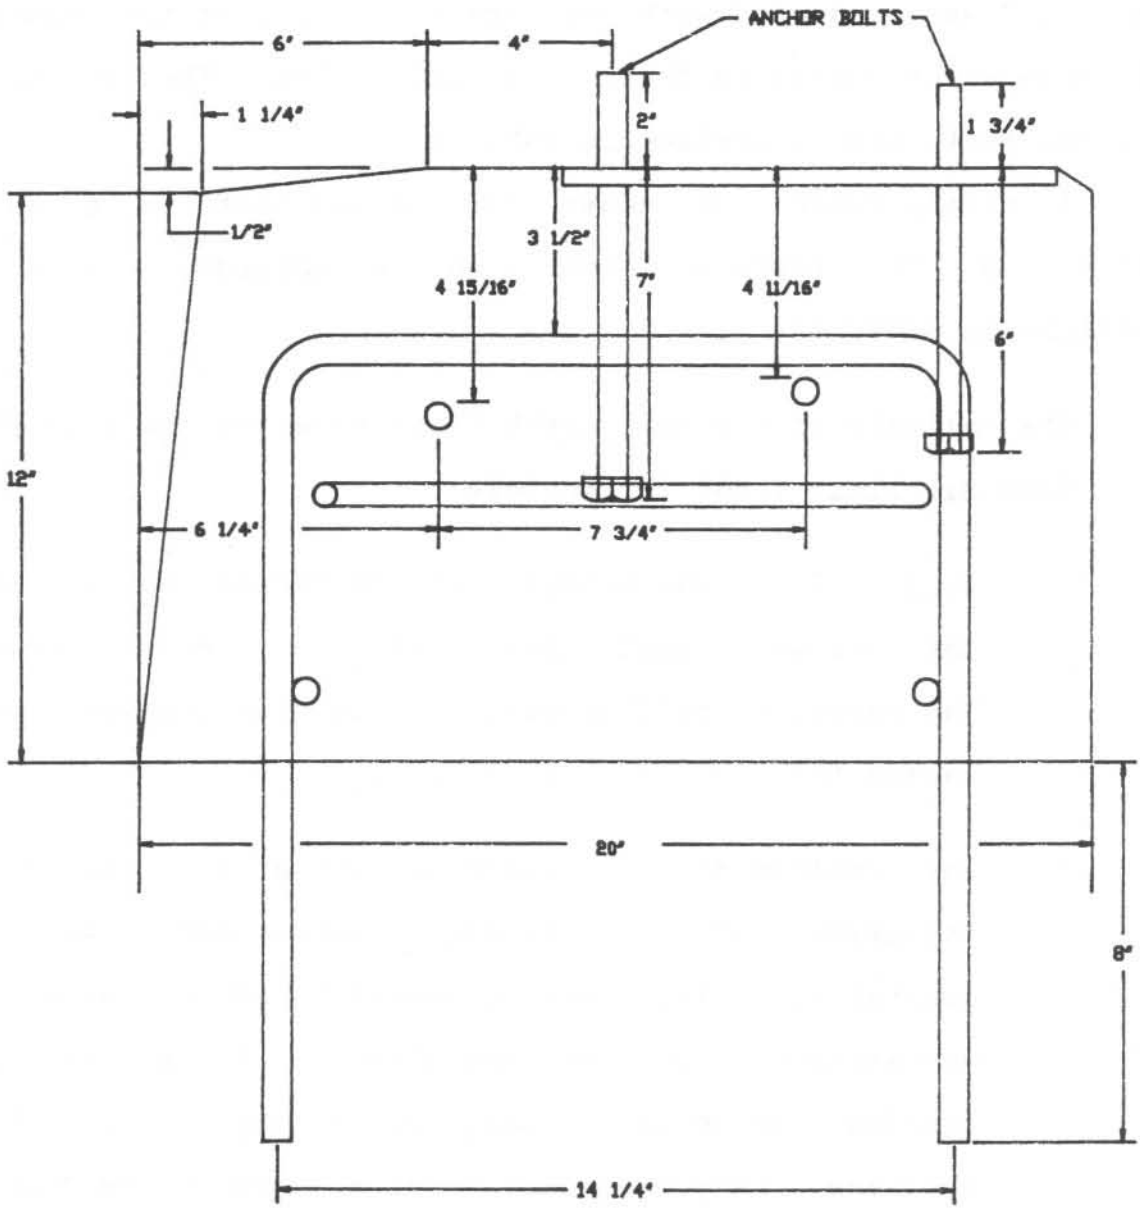
FIGURE 21.
Sketch Of Reinforcement Steel For Task 1

After Test I1-2, it was observed that the placement of the reinforcement steel was improperly placed. The bars misplaced were the top two longitudinal bars, the horizontal bent No. 6 bar, and the vertical dowels which were bent off too short. Thus, it created 3 1/2-in. of concrete cover. A sketch of the misplaced curb reinforcement steel is shown in Figure 21.

Note: This is the actual location of the rebar which differs from the original construction plans.

Inspection of the damage to the rail and curb section due to Task I testing indicated that all of the reinforcing bars for the curb were not placed in accordance with the plan.
