# FULL-SCALE 18,000 LB. VEHICLE CRASH TEST ON THE IOWA RETROFIT CONCRETE BARRIER RAIL

TRANSPORTATION RESEARCH REPORT TRP-03-19-90

January, 1990

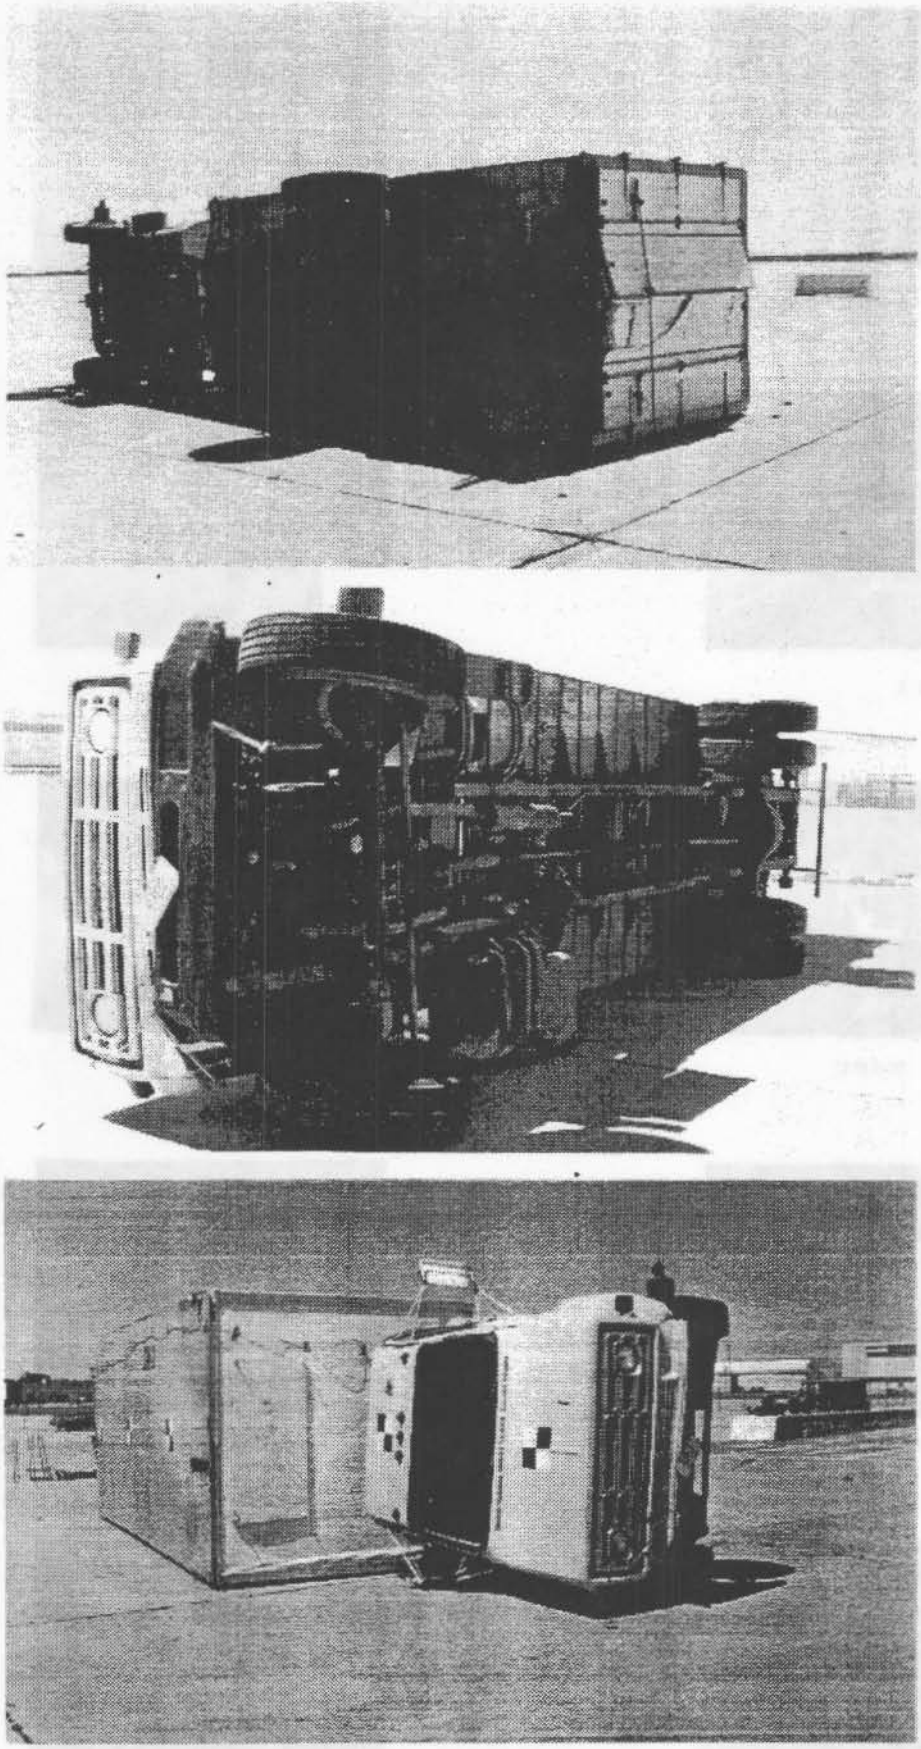
Figure 21. Photographs of vehicle damage, Test I4-1.

Upon impact with the retrofit concrete barrier rail, the right front corner of the vehicle was crushed and the wheel was bent inward. After the initial impact, the vehicle rode up on the barrier and slid along the remaining length. There was significant clockwise rolling motion as the vehicle slid along the barrier with a maximum roll angle of 31.4 degrees. After the vehicle exited from the barrier, it rolled in the counterclockwise direction for a short period of time. Hence, the momentum of the vehicle caused it to roll in the clockwise direction and tip over onto the passenger side of the vehicle. The vehicle came to rest on the passenger side of the vehicle approximately 160 ft. downstream from the point of impact.

Photographs of the vehicle damage are shown in Figure 21. The TAD (7) and VDI (8) damage classifications are shown in Figure 19. Photographs of the minimal damage to the retrofit concrete barrier rail are shown in Figure 22. Some concrete spalling occurred due to the initial impact of the vehicle.

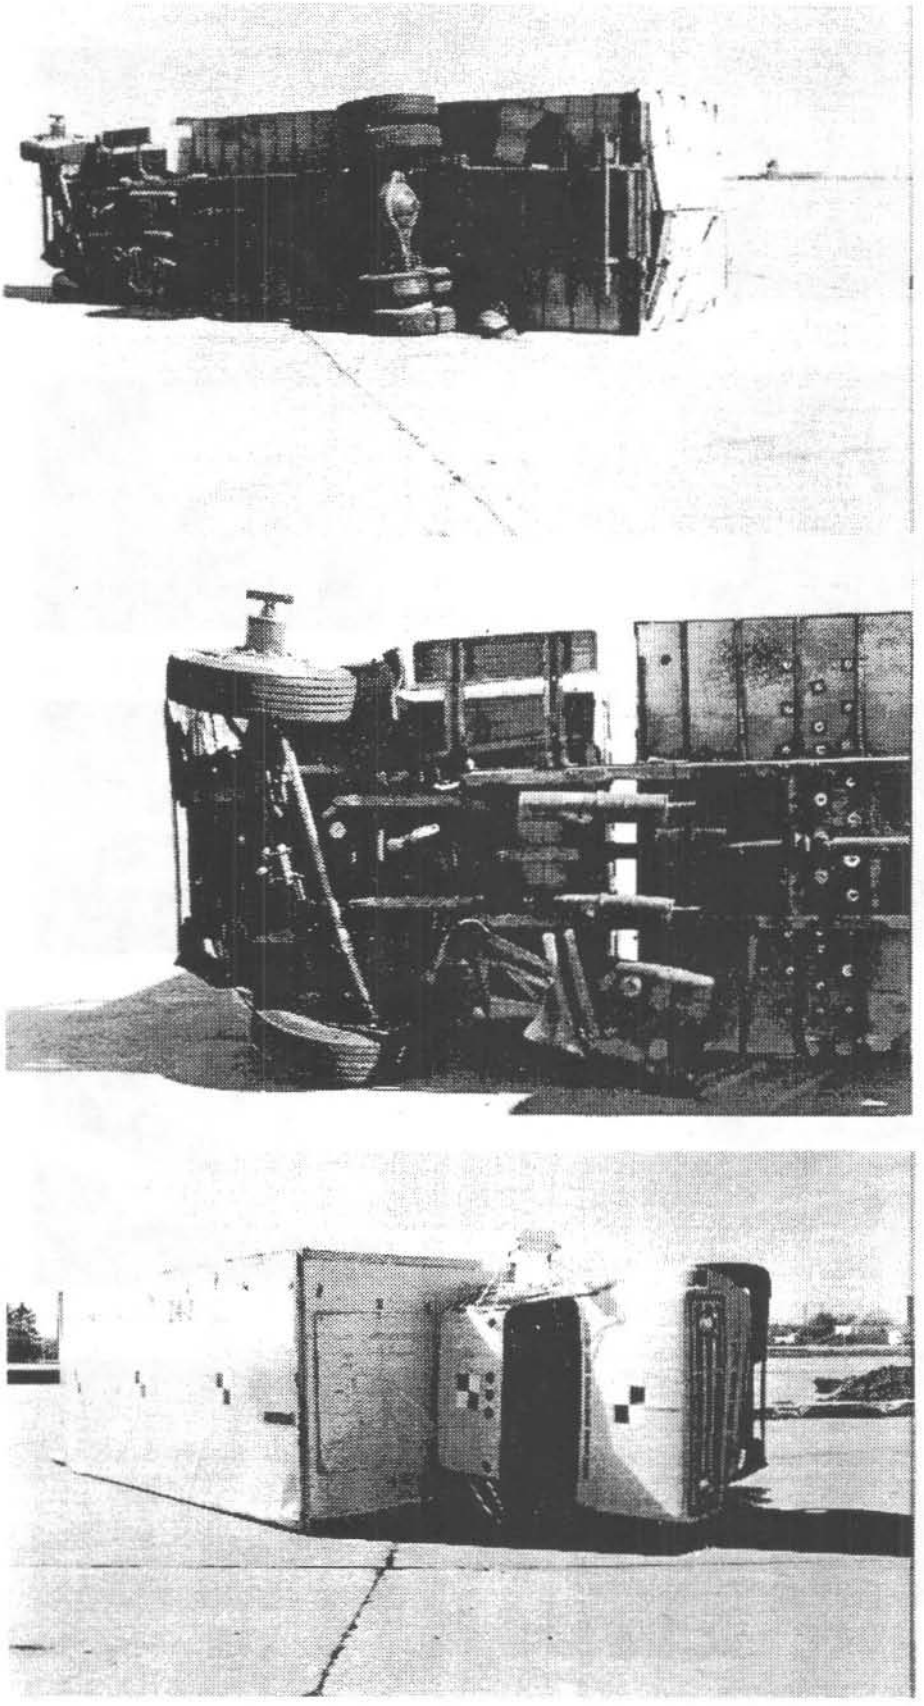
Figure 25. Photographs of vehicle damage, Test I4-2.

Upon impact with the retrofit concrete barrier rail, the right front corner of the vehicle was crushed and the wheel was bent inward. After the initial impact, the vehicle rode up on the barrier and slid along the remaining length. There was significant clockwise rolling motion as the vehicle slid along the barrier with a maximum roll angle of 28.7 degrees. After the vehicle exited from the barrier, it rolled in the counterclockwise direction for a short period of time. Hence, the momentum of the vehicle caused it to roll in the clockwise direction and tip over onto the passenger side of the vehicle. The vehicle came to rest on the passenger side of the vehicle approximately 160 ft. downstream from the point of impact.

Photographs of the vehicle damage are shown in Figure 25. The TAD (7) and VDI (8) damage classifications are shown in Figure 23. Photographs of the minimal damage to the retrofit concrete barrier rail are shown in Figure 26. Some concrete spalling occurred due to the initial impact of the vehicle.
