FULL-SCALE 18,000 LB. VEHICLE CRASH TEST ON THE KANSAS 32 INCH CORRAL RAIL

Project RES1 (0099) P450
TRANSPORTATION RESEARCH REPORT TRP-03-26-91

July 1991

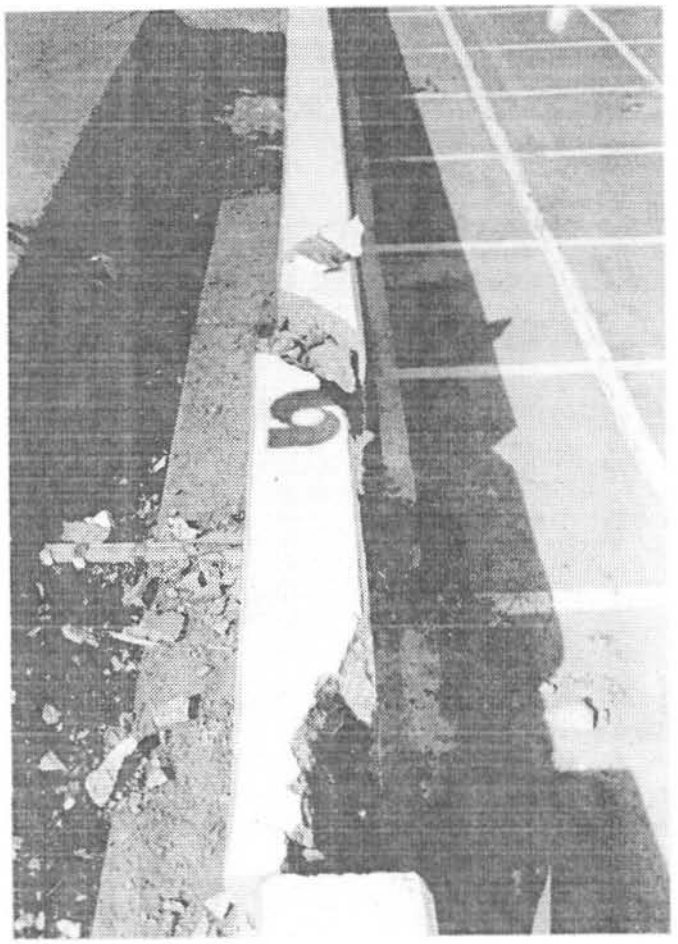
Figure 22. Rail Damage Between Posts No. 4 and No. 5

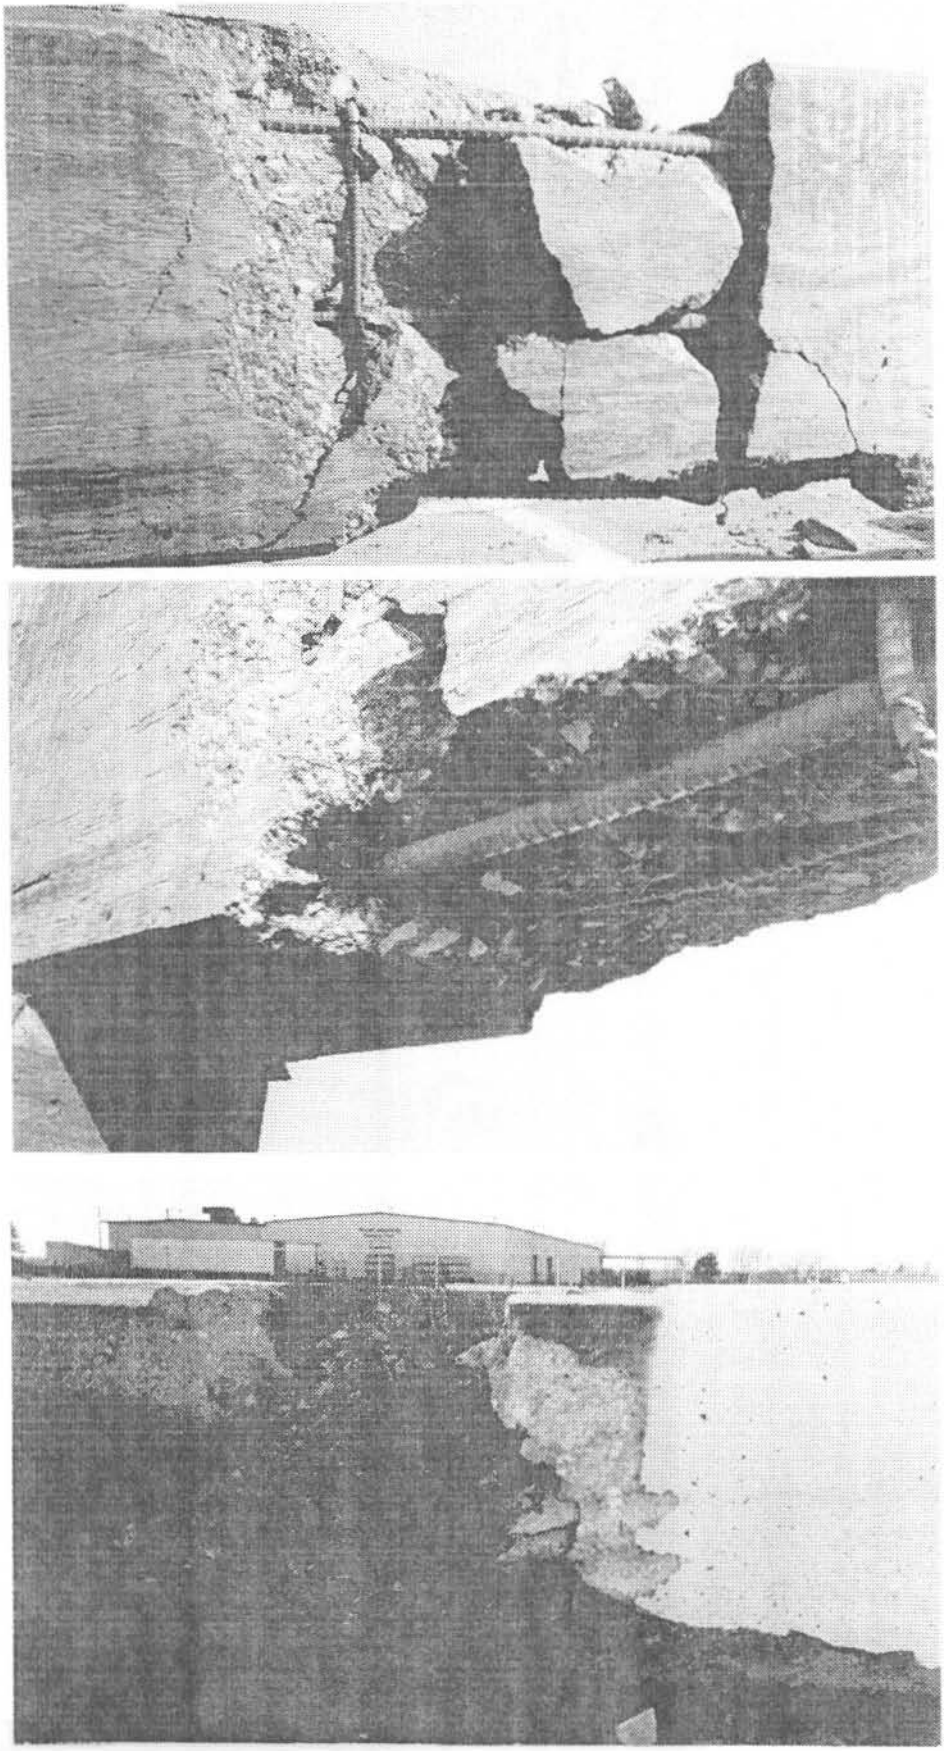
Figure 23. Rail Damage at point of impact

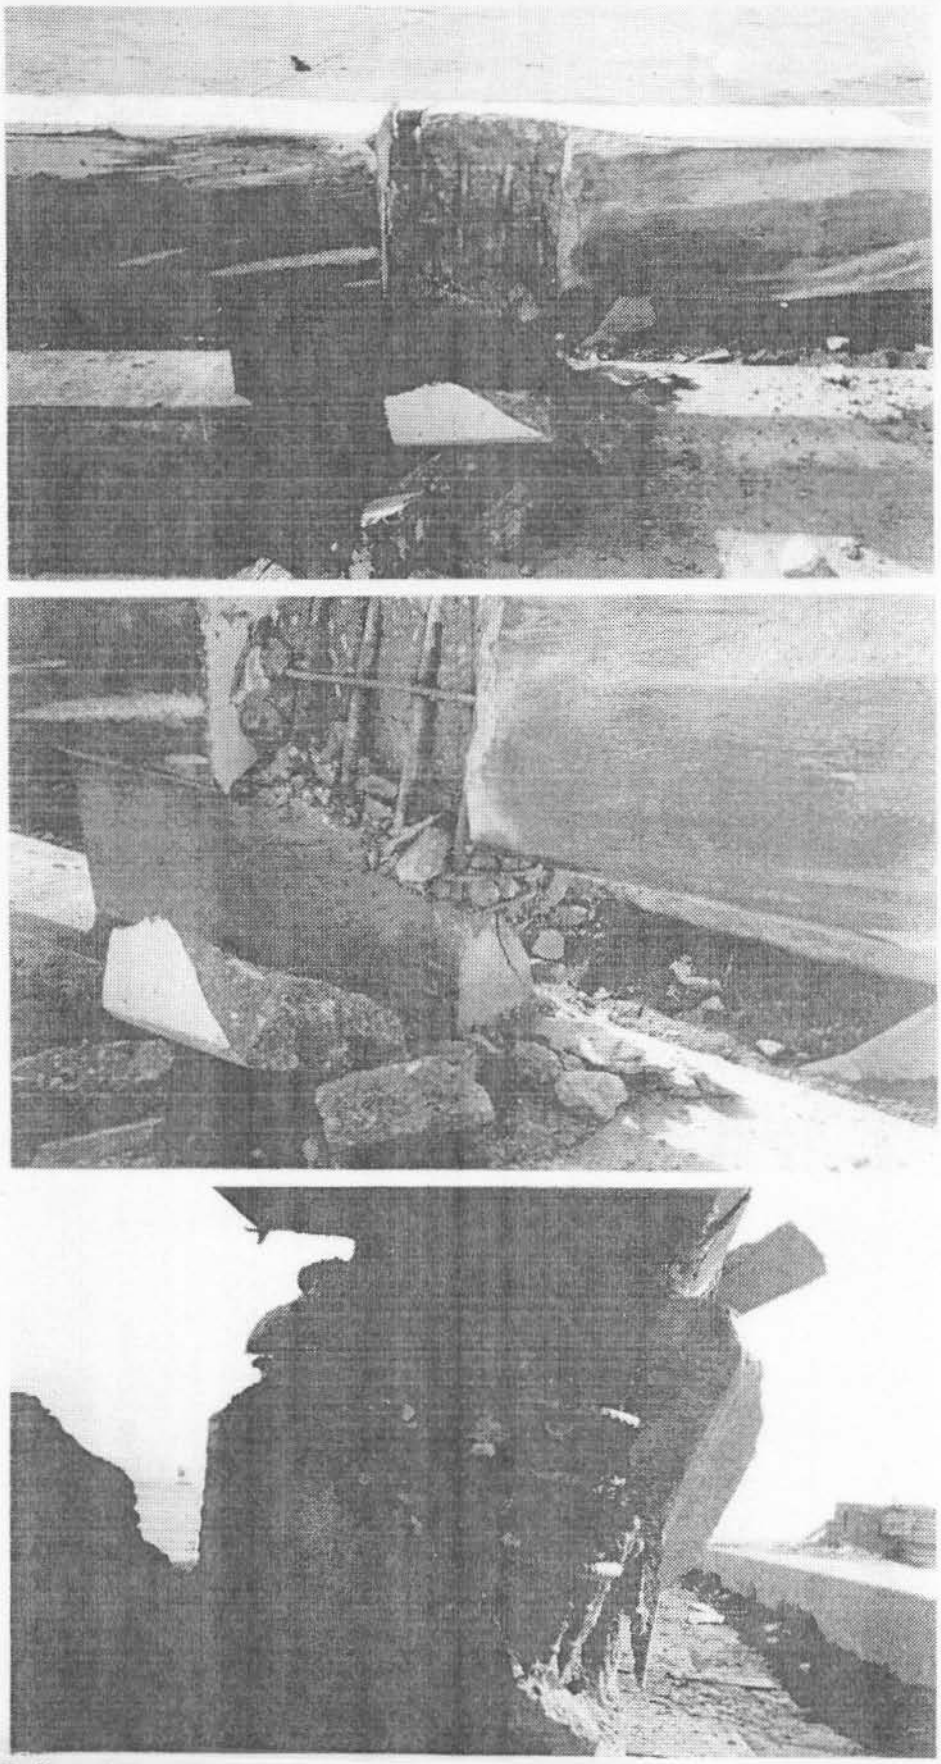
the traffic face of the rail at post No. 5 is shown in Figure 24. The total amount of concrete that was removed from this failure was 18.5 in. wide, 19 in. high (entire rail height), and 5 in. deep. The same failure viewed from the backside of the rail is shown in Figure 25. This failure occurred before the gap in the rail at midpoint of Post No. 5. A vertical crack in the deck also occurred near the location of the post on the upstream end. Deck cracking also occurred at post No. 4. These deck cracks continued underneath the deck to the support.

Figure 24. Rail and Post damage at Post No. 5

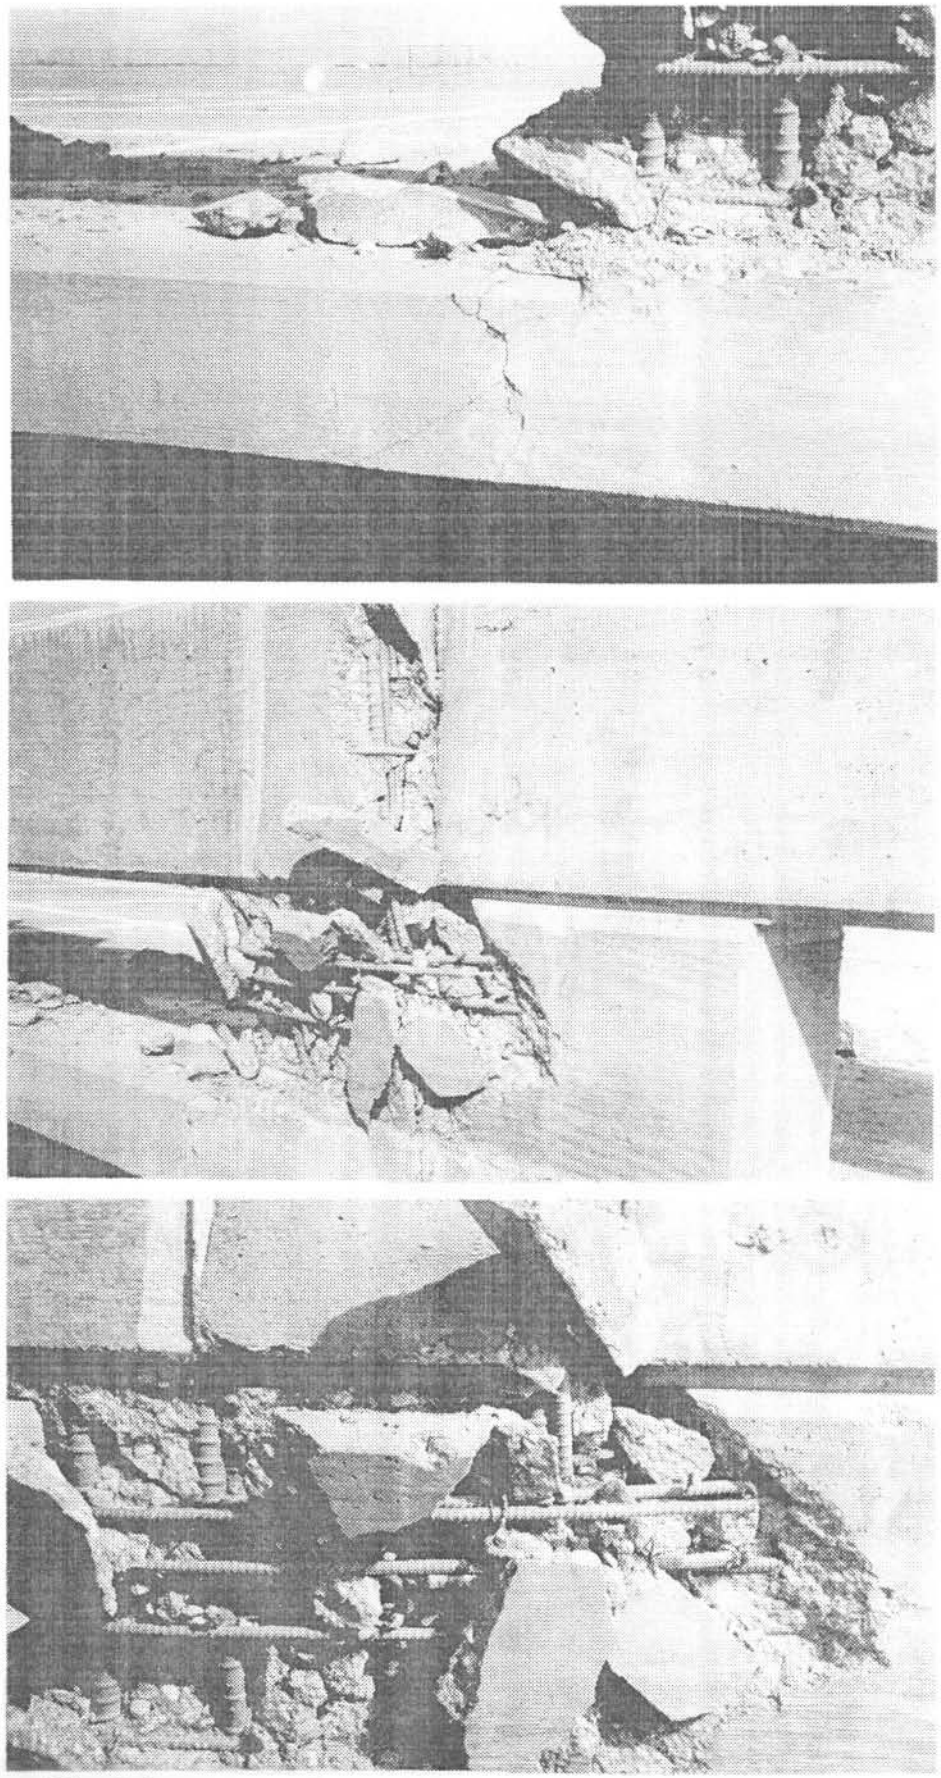
Figure 25. Post No. 5 damage at splice and deck cracking

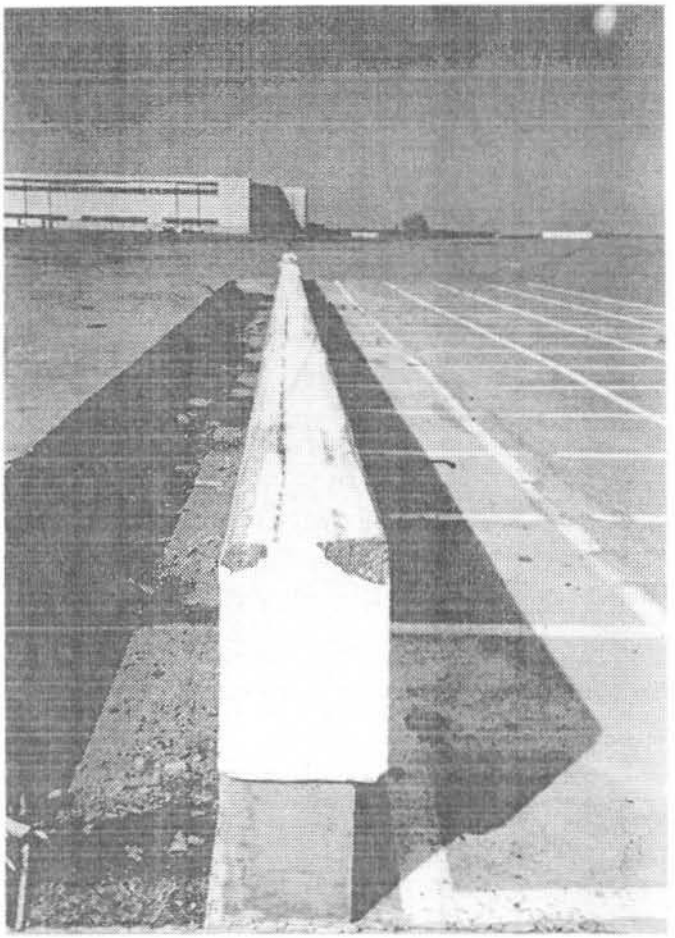
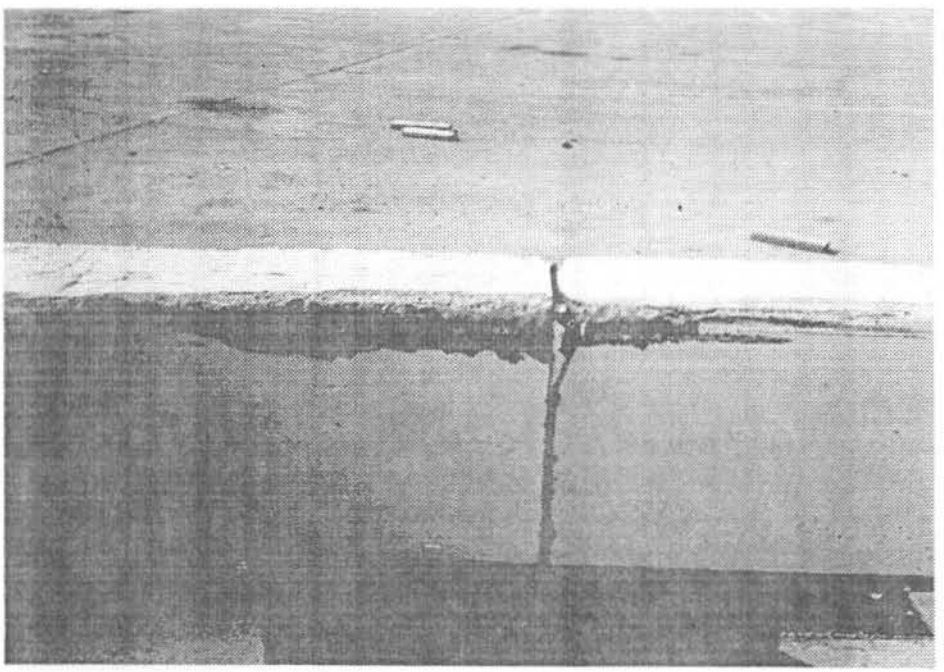
The third major damage area resulted from the vehicle riding along the rail (Figure 26). Spalling and concrete chipping occurred continuously until the end of the rail. This damage occurred to the traffic face, the top and the back face of the rail.

Figure 26. Damage from vehicle riding along the rail

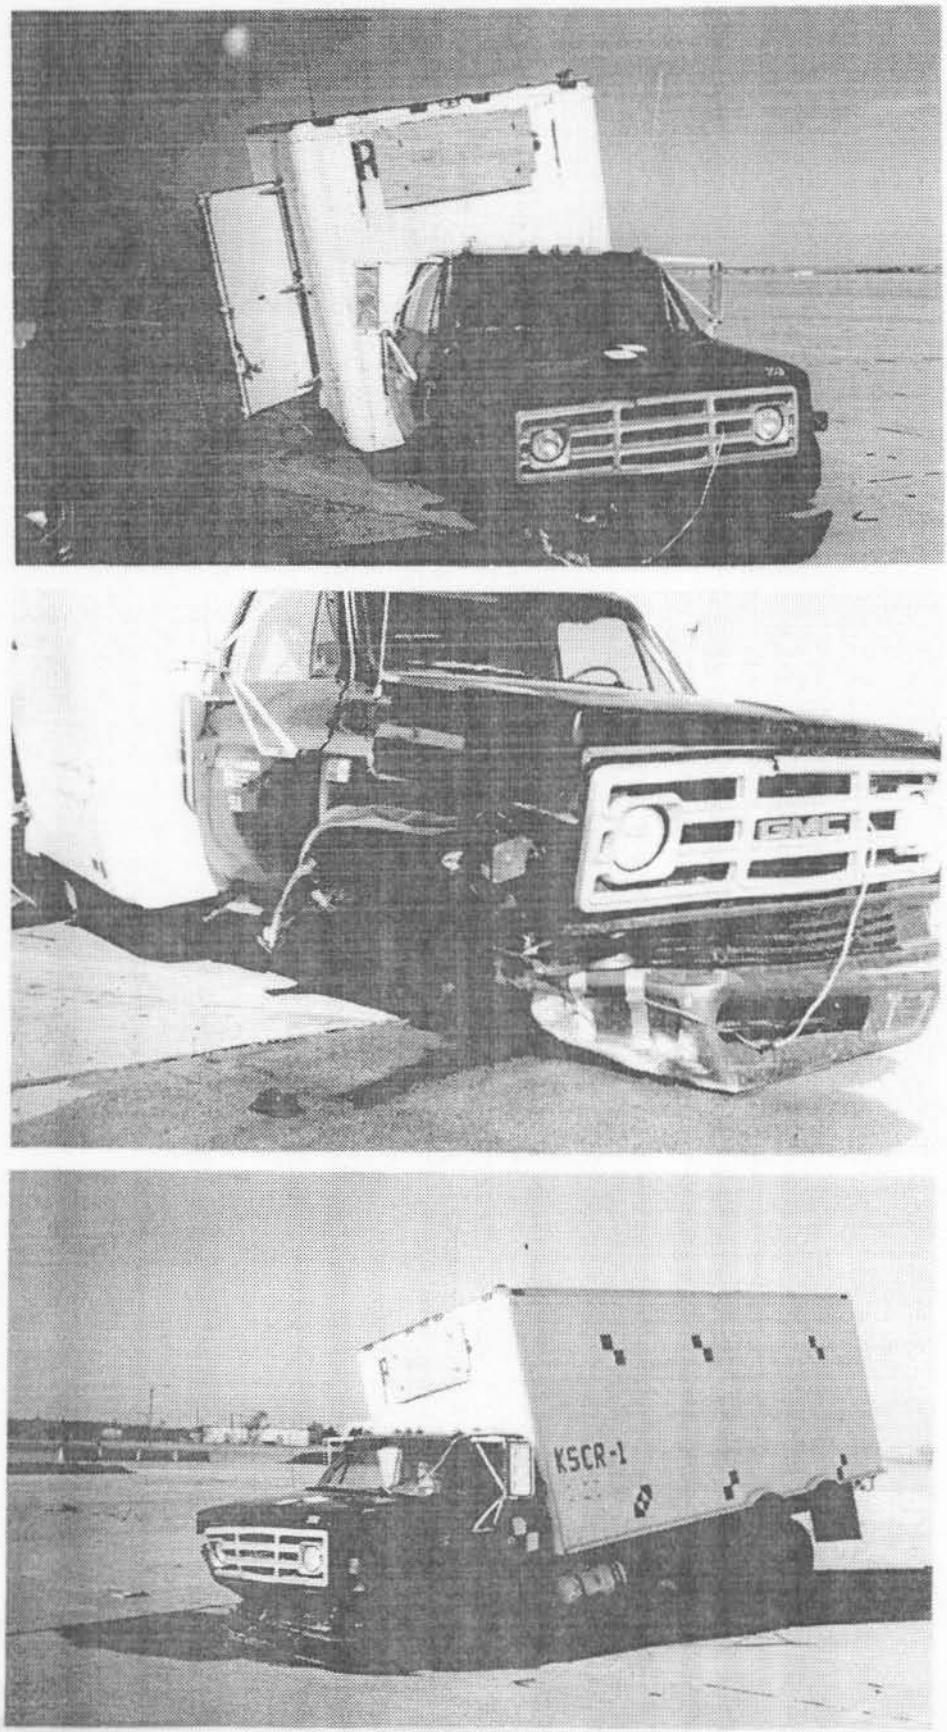
The vehicle damage is shown in Figure 27. The damage included crushing of the passenger side bumper and grill. The front wheels and axle were totally removed from their [illegible] and ended up lodged underneath the truck which may have contributed to the damage was minimal. The TAD (5) and VDI (6) damage classifications are shown in Figure 18.

Figure 27. Vehicle Damage
