SAFETY PERFORMANCE EVALUATION OF THE STEEL-BACKED LOG RAIL

Transportation Research Report No. TRP-03-35-92

December 1992

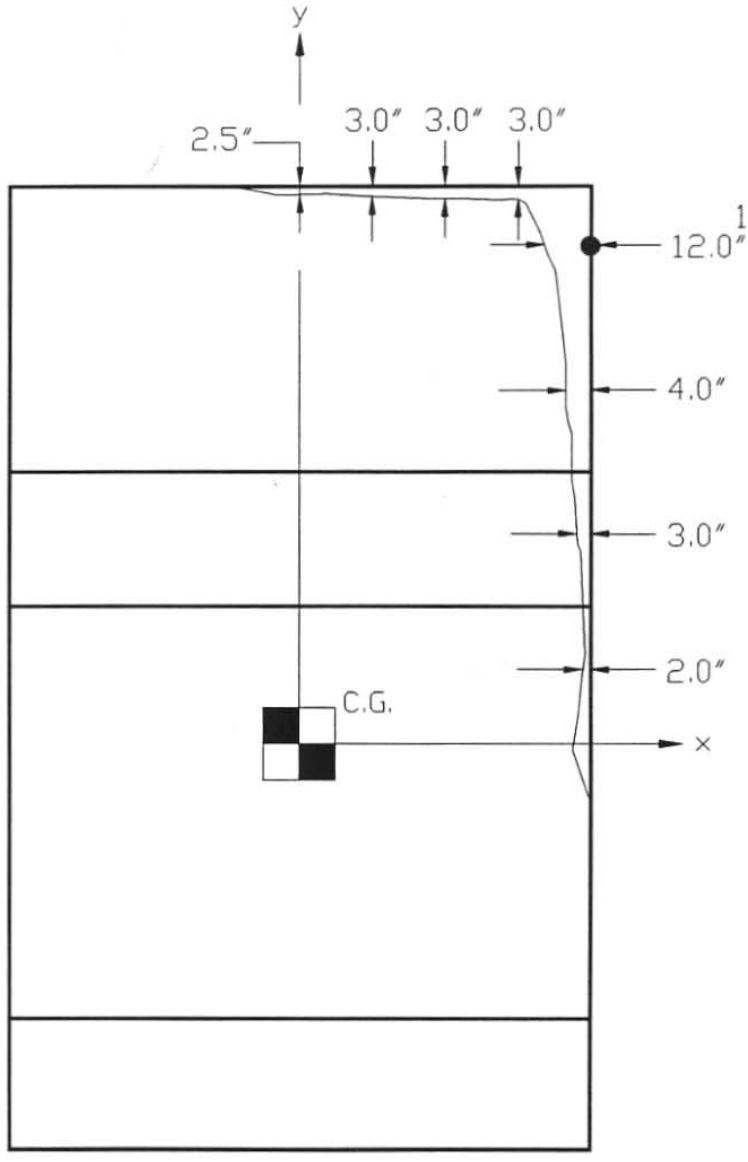
FIGURE 17. Vehicle Crush Measurements, Test SBLR-1

Test vehicle damage was relatively minor and was largely limited to the right-front quarter panel and passenger door, as shown in Figure 16. There was no intrusion or deformation of the occupant compartment. Vehicle crush measurements are shown in Figure 17.

[1] -Maximum static crush distance of 12" occurred at (24",54") marked by the point.

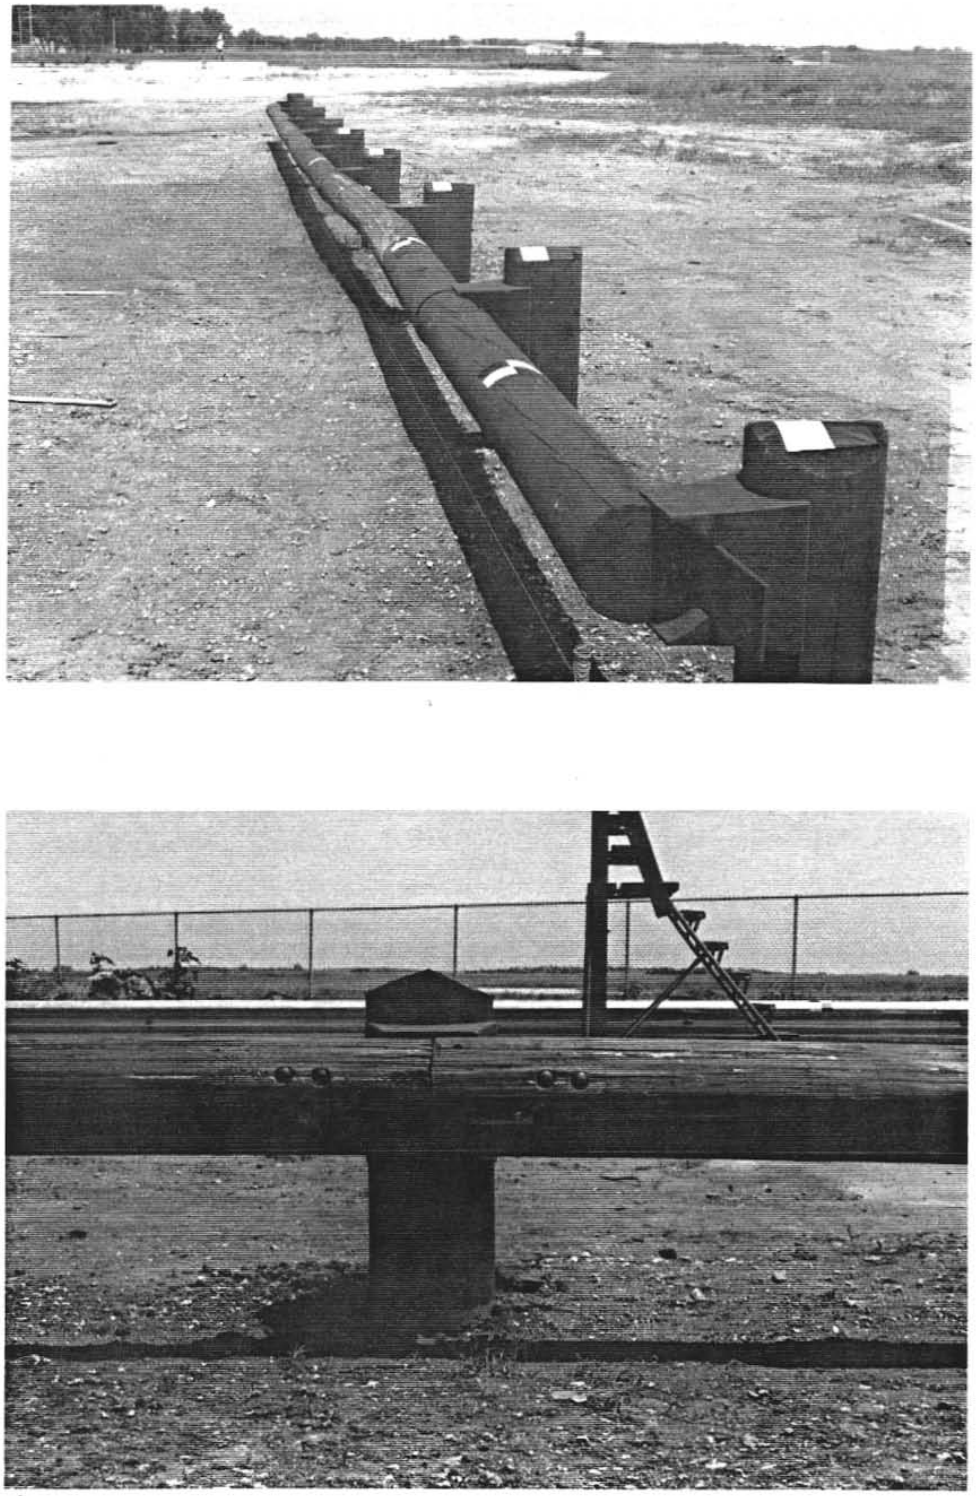
FIGURE 18. Log Rail Damage, Test SBLR-1

Damage to the Log Rail consisted of minor scrapes on the surface of the rail and a maximum permanent deflection of 2 15/16 in. at the first post after impact. This damage can be seen in Figure 18. The effective coefficient of friction was found to be 1.02 and would be classified as "marginal" according to the AASHTO Guide Specifications for Bridge Railings (5).

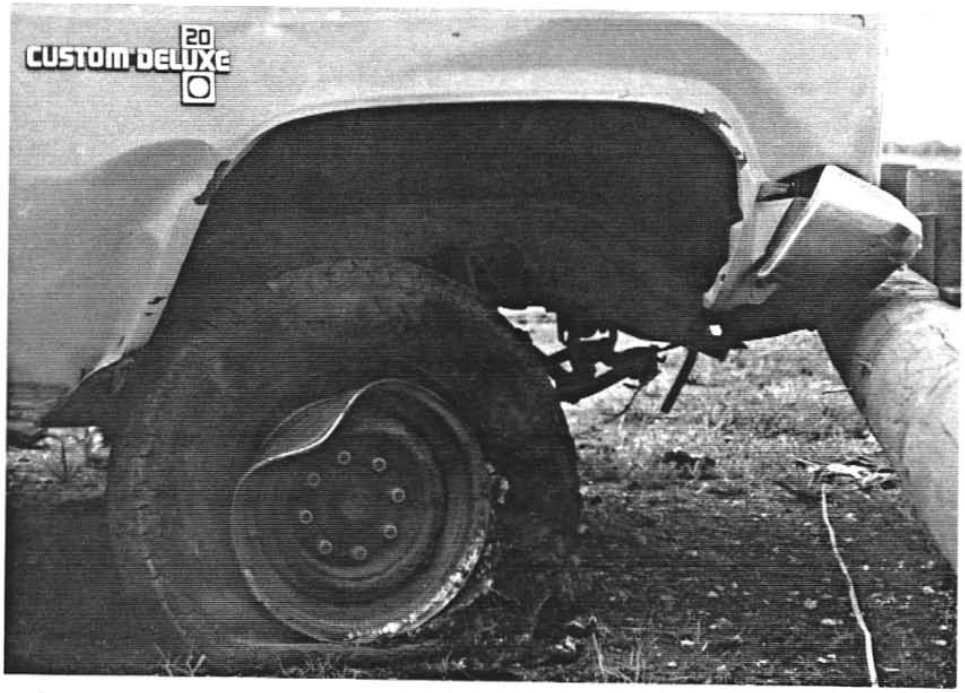
FIGURE 24. Vehicle Damage, Test SBLR-2

Test vehicle damage, shown in Figure 24, was limited to the undercarriage on the right-front corner and along the right side. Vehicle crush measurements are shown in Figure 25. The vehicle remained upright both during and after the test, and there was no intrusion of the occupant compartment.

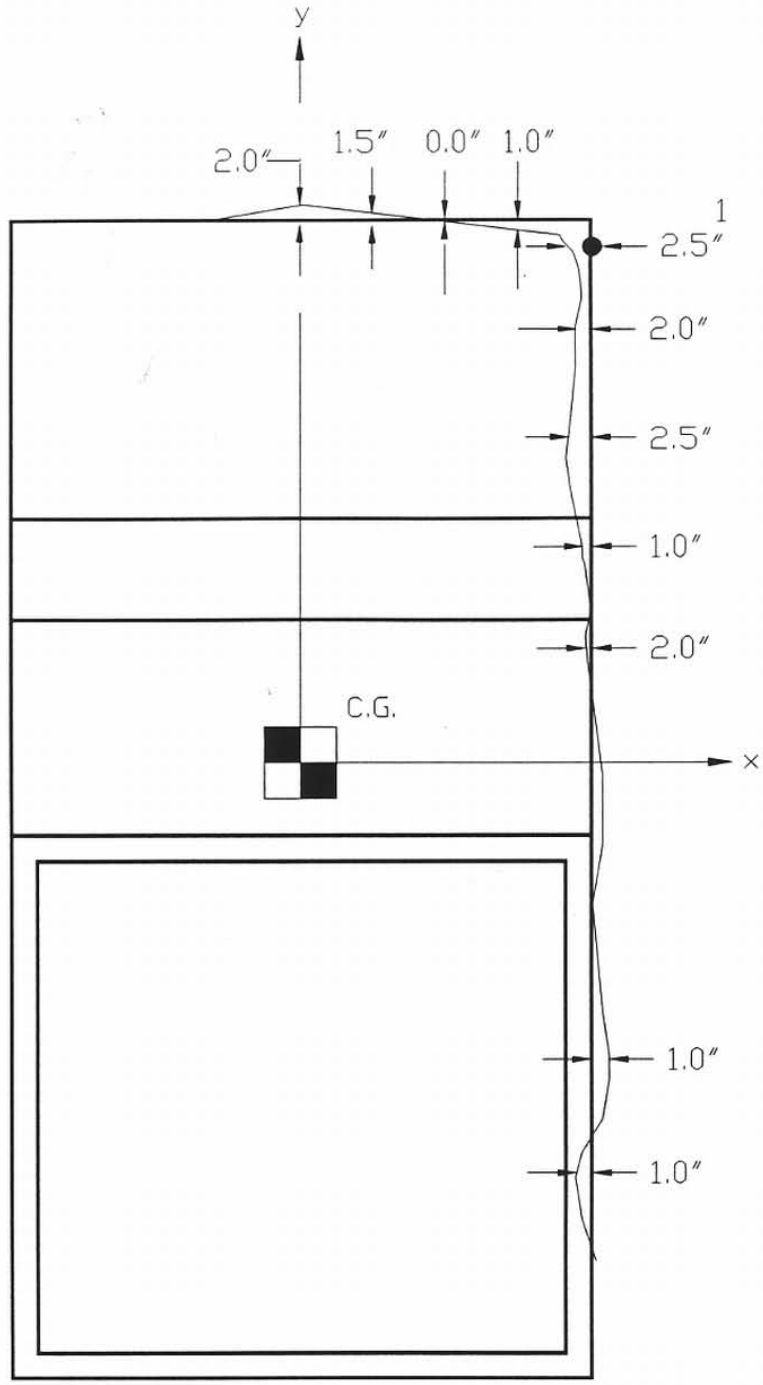
FIGURE 25. Vehicle Crush Measurements, Test SBLR-2

[1]-Maximum static crush distance of 2.5″ occurred at (36″,96″) marked by the point.
