Safety Performance Evaluation of the George Washington Memorial Parkway Bridge Rail

Transportation Research Report TRP-03-45-94

FHWA Contract No. DTFH71-90-C-00035

June, 1995

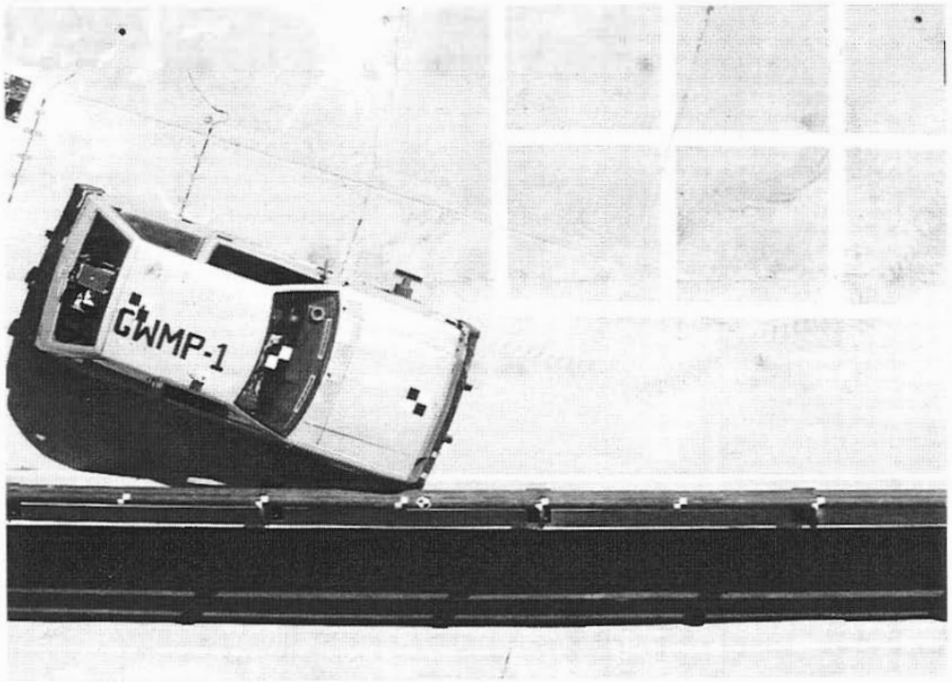
Figure 13. Impact Location, Test GWMP-1.

The 1984 Dodge Colt was directed into the George Washington Memorial Parkway Bridge Rail using a reverse tow and cable guidance system (5). The vehicle was released from the tow cable and guidance system and was free wheeling at impact. The speed of the vehicle at impact was 54.4 mph (87.5 km/h) and the angle of impact was 21.0 degrees. As shown in Figure 13, the impact point was located midway between the 3rd and 4th posts from the upstream end of the installation. A summary of the test results and sequential photographs are shown in Figure 14. Additional sequential photographs are shown in Figure 15.

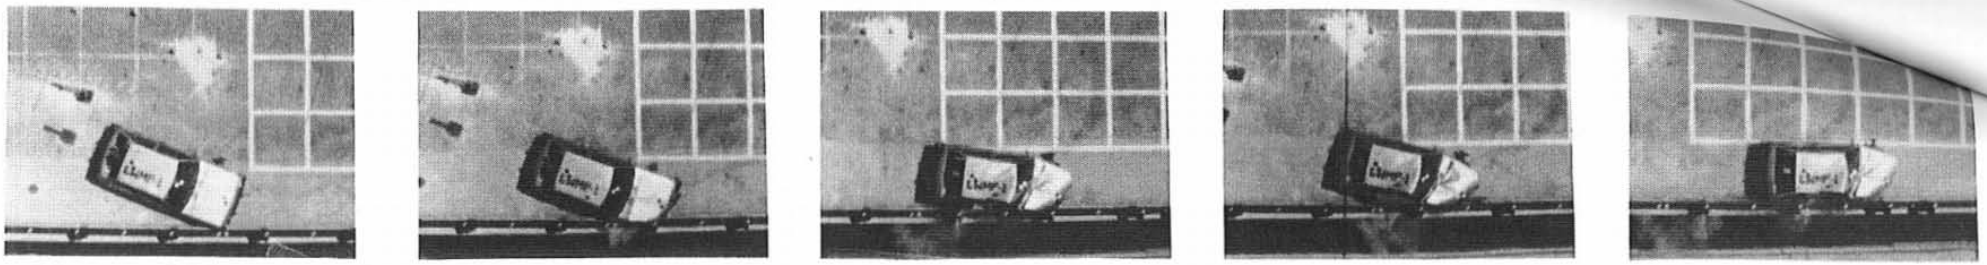
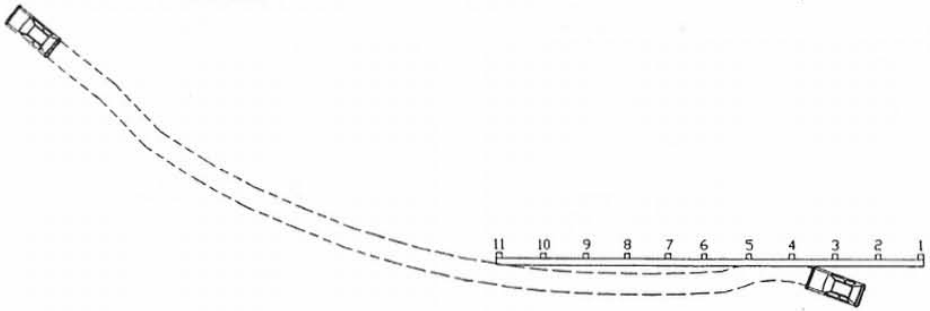
Figure 14. Summary of Test GWMP-1.

As a result of technical problems, the accelerometer data was not acquired for this test. It was therefore necessary to analyze the high-speed film to determine the values of the occupant risk criteria. The longitudinal and lateral occupant impact velocities as determined from this high speed film analysis were 24.6 and 8.2 fps, respectively. The maximum occupant ridedown decelerations were 12.0 g's (longitudinal) and 22.4 g's (lateral). The results of this analysis are summarized in Figure 14 and Table 1.

Test Number	GWMP-1
Federal Contract No.	DTFH71-90-C-00035
Date	8/04/93
Installation	George Washington Memorial Parkway
Bridge Rail	
Length	75 ft.
Height from curb	2 ft.- 10 in.
Post spacing	7 ft.- 9.5 in.
Material	
Post	ASTM - A588
Rail	ASTM - A53, Grade B ESSP, 4.5 O.D.
Curb	
Height	8 in.
Top width	1 ft.- 4.5 in.
Bottom width	1 ft.- 6 in.
Vehicle Model	1984 Dodge Colt
Vehicle Weight	
Curb	1700 lb
Test Inertia	1850 lb
Gross Static	2010 lb
Speed	
Impact	54.4 mph
Exit	38.9 mph
Angle	
Impact	21.0 deg
Exit	3.8 deg
Occupant Impact Velocity	
Longitudinal	24.6 fps
Lateral	8.2 fps
Occupant Ridedown Deceleration	
Longitudinal	12.0 g's
Lateral	22.4 g's
Vehicle Damage	
TAD	1-RFQ-6
VDI	01RFES3
Vehicle Rebound Distance	22 in. @ 40 ft.
Bridge Rail Damage	Superficial
Maximum Permanent Set Deflection	0 in.

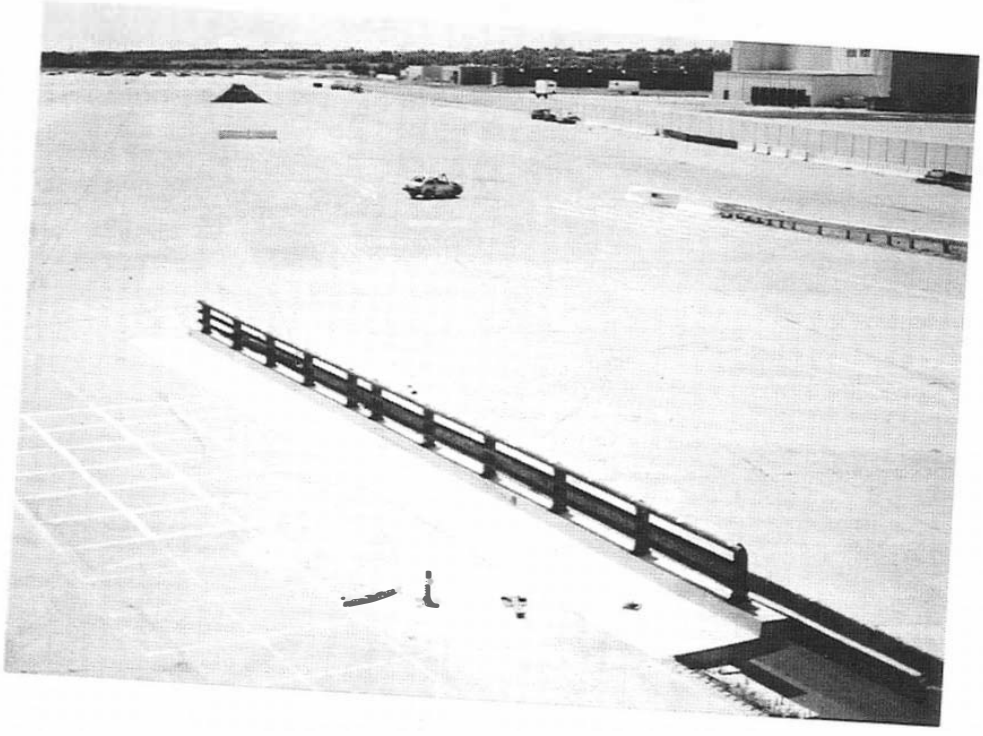
Figure 16. Vehicle Trajectory, Test GWMP-1.

Upon impact with the steel bridge rail, the right front quarter panel was crushed inward and the bumper was pulled to the right and pushed back causing the front end of the vehicle to bend toward the right side of it's longitudinal centerline. 42 ms after impact the bumper began to contact post number 4 and was crushed into the front right tire. With the bumper pushing the tire into the firewall, the vehicle began to buckle at the door post. This caused the windshield frame and roof to buckle. At 116 ms the car lost contact with post number 4 and continued down the rail with no further snagging. There was no rolling motion detected throughout the collision, and the vehicle was redirected, coming to rest 170 ft. (51.8 m) downstream and 90 ft. (27.4 m) behind a line parallel to the rail face, as shown in Figure 16.

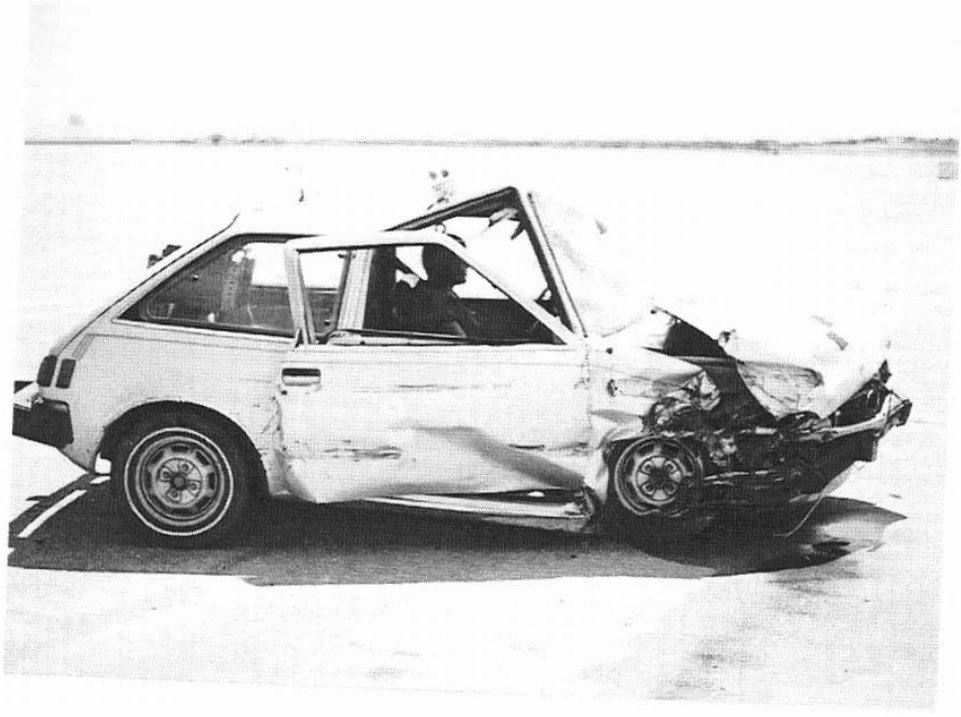
Figure 18. Vehicle Damage, Test GWMP-1 (cont.).

The vehicle damage, shown in Figures 17 and 18, included the crushing of the right front corner of the vehicle, twisting of the car to the right of its longitudinal centerline, buckling of the hood, roof, windshield frame, firewall, passenger compartment floor and the passenger side door. The front right tire was deflated and the rim was deformed. The maximum crush deformation of 21

As is evident in the vehicle damage shown in Figures 17 and 18, there was significant occupant compartment damage in the test vehicle. This damage was caused by the snagging of the vehicle on the system posts and, along with the excessive lateral ridedown decelerations, caused the system to fail this compliance test. In order to alleviate this snagging problem, the rail size was increased from 4.5 in. O.D. to 5.0 in. O.D. (114 mm to 127 mm), and it was moved further out from the post. The details of this change can be seen in Figures 3 and 4.

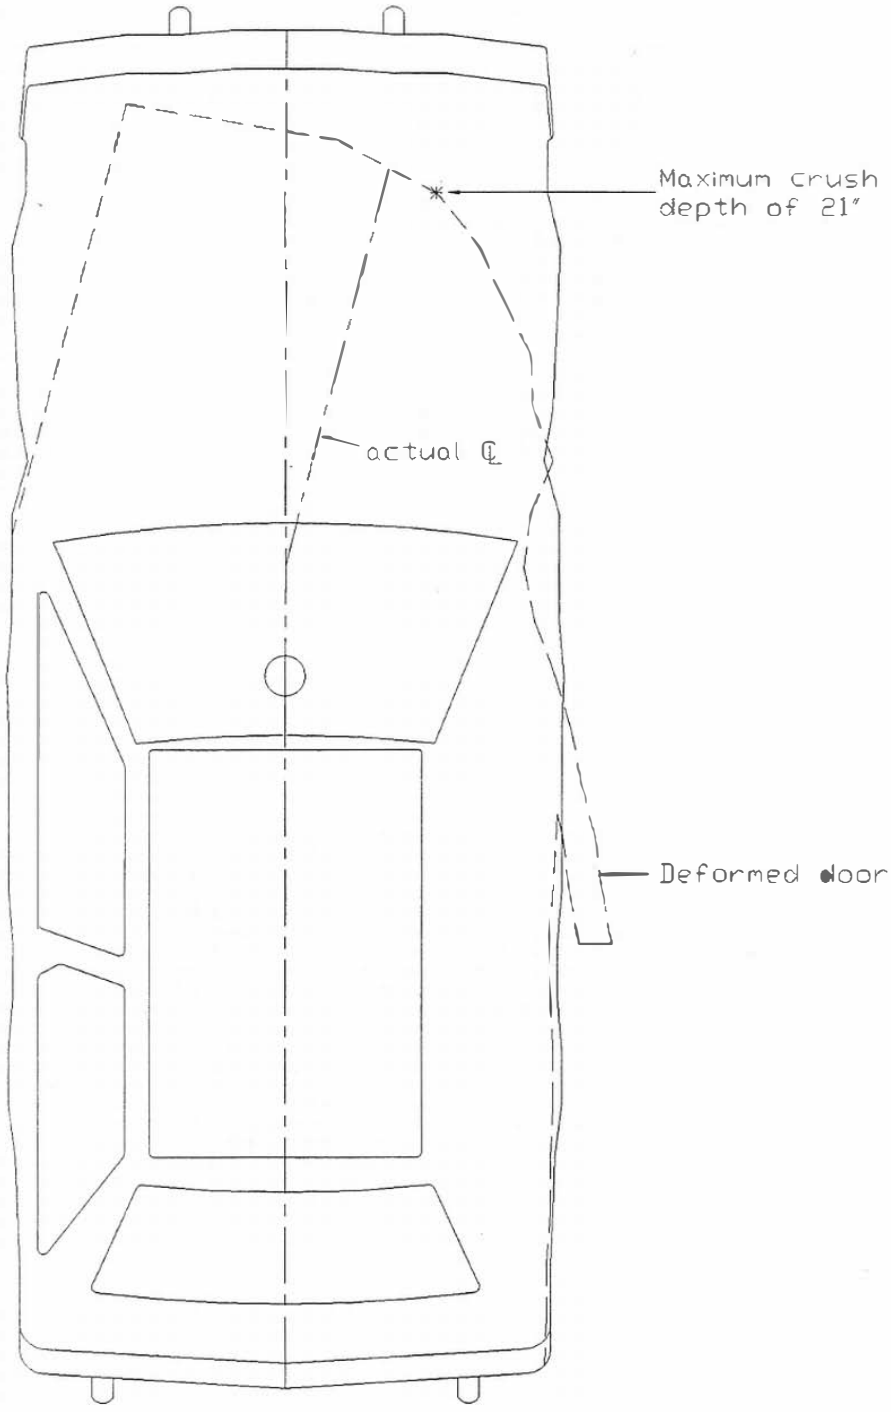
Figure 19. Vehicle Crush Measurements, Test GWMP-1.

in. (53.3 cm) is shown in Figure 19.

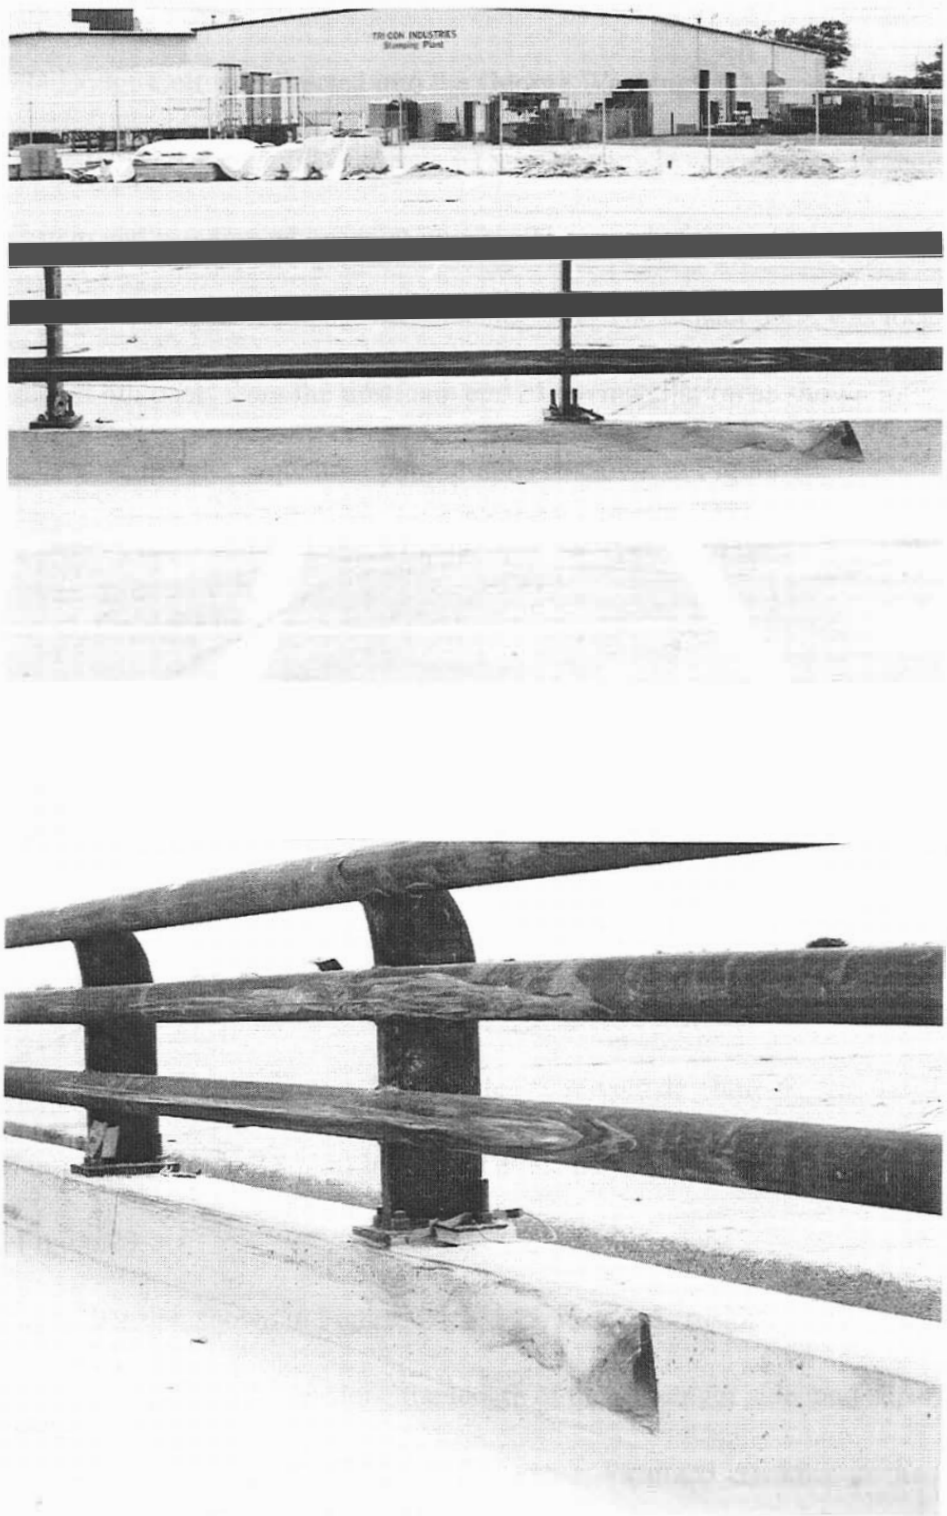
Figure 20. Bridge Rail Damage, Test GWMP-1.

The damage to the bridge rail was minor, with superficial scrapes on the curb, rail and posts as shown in Figure 20. There was no permanent set deflection in the bridge rail. The contact marks on the curb started at impact, 4 ft. - 5 in. (1.35 m) before post 4, and continued for 11 ft. - 8 in. (3.56 m). Contact with the lower rail began 4 ft. - 0 in. (1.2 m) before post 4 and continued for 19 ft. - 6 in. (5.94 m), and contact with the middle rail began 3 ft. - 8 in. (1.12 m) before post 4 and continued for 17 ft. - 0 in. (5.18 m).

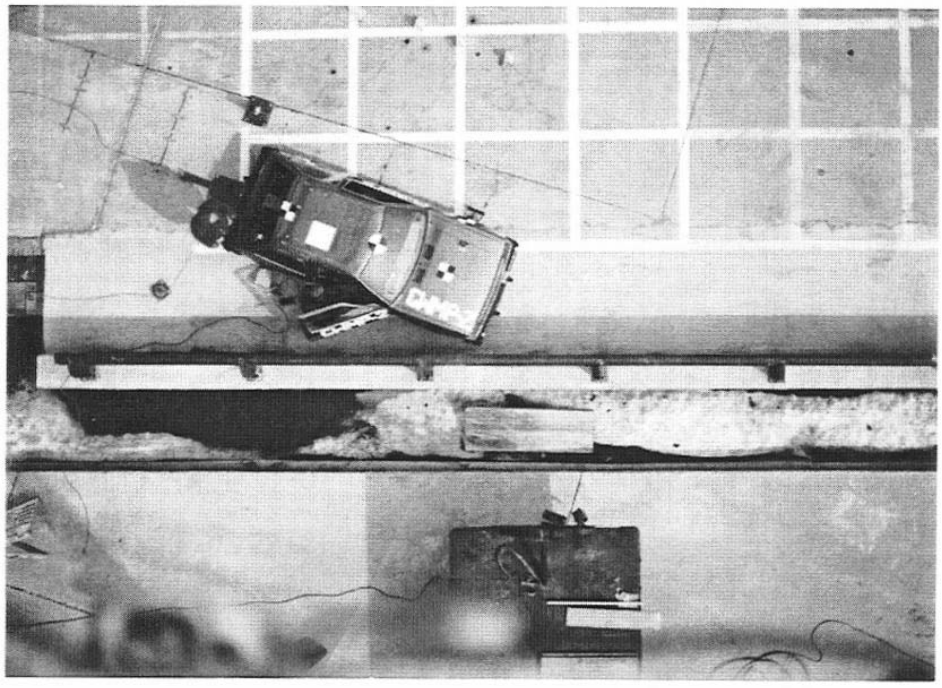
Figure 21. Impact Location, Test GWMP-2.

The 1984 Dodge Colt was directed into the George Washington Memorial Parkway Bridge Rail using a reverse tow and cable guidance system (5). The vehicle was released from the tow cable and guidance system and was free wheeling at impact. The speed of the vehicle at impact was 52.6 mph (84.65 km/h) and the angle of impact was 22.6 degrees. The impact point was located midway between the 3rd and 4th posts from the upstream end of the installation as shown in Figure 21. A summary of the test results and sequential photographs is shown in Figure 22.

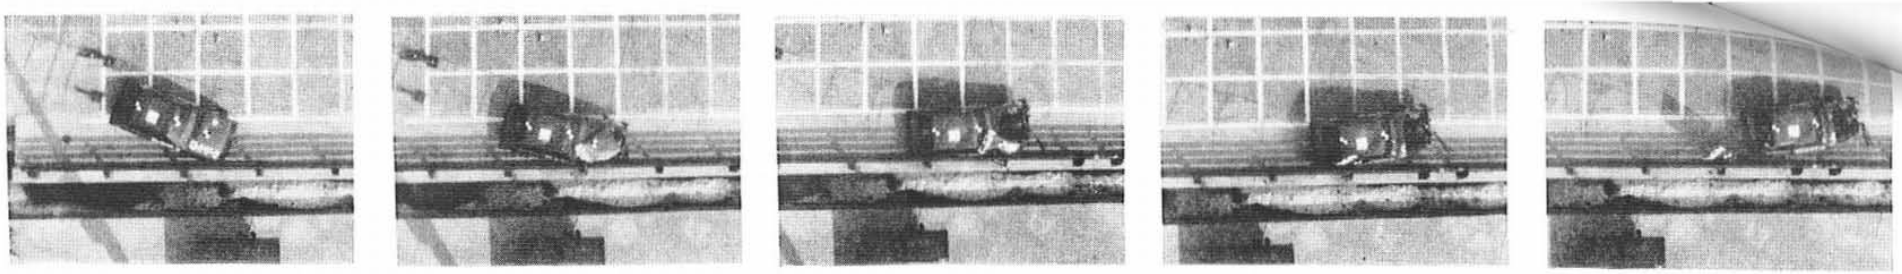
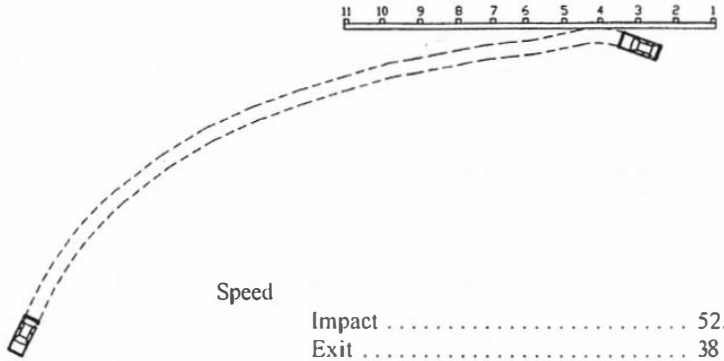
Figure 22. Summary of Test GWMP-2.

The longitudinal and lateral occupant impact velocities were 17.0 fps and 25.7 fps, respectively. The maximum occupant ridedown decelerations were 5.2 g's (longitudinal), and 9.6 g's (lateral). The results of this analysis are summarized in Figure 22 and Table 1. As can be seen, the only criteria which wasn't met in this test was the one which required that the vehicle move no more than 20 ft. (6.1 m) from the line of the traffic face of the railing. However, it was judged that failure of this criteria alone did not warrant failure of the entire test.

Speed	
Impact	52.6 mph
Exit	38.9 mph
Angle	
Impact	22.6 deg
Exit	6.3 deg
Occupant Impact Velocity	
Longitudinal	17.0 fps
Lateral	25.7 fps
Occupant Ridedown Deceleration	
Longitudinal	5.2 g's
Lateral	9.6 g's
Vehicle Damage	
TAD	1-RFQ-4
VDI	01FRES2
Vehicle Rebound Distance	39 ft. @ 115 ft.
Bridge Rail Damage	Minor
Maximum Permanent Set Deflection	0.125 in.

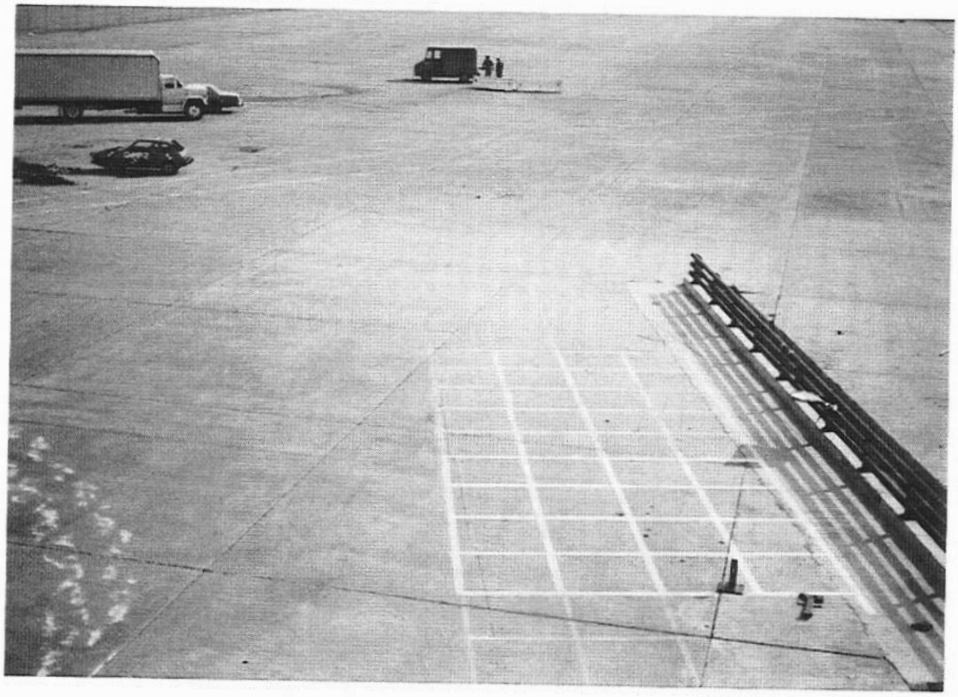
Figure 23. Vehicle Trajectory, Test GWMP-2.

Upon impact with the bridge rail system, the right front corner of the car was crushed inward. 68 ms after impact, the right front corner of the hood contacted post 4 causing the hood to rotate about its right front mount in a clockwise manner, approximately 90 degrees. The vehicle continued down the rail without the tire mounting the curb. When the vehicle approached post 5, 174 ms after impact, the left front corner of the hood contacted post 5 separating it from the vehicle. The hood remained at post 5 between the upper and middle rails as the vehicle proceeded down the rail. The hood then made contact with right front windshield support and the lower right corner of the windshield and was forced up and over the vehicle. The vehicle came to rest 120 ft. (36.5 m) downstream of impact and 61 ft. (18.6 m) In front of a line parallel with the front face of the bridge rail as seen in Figure 23.

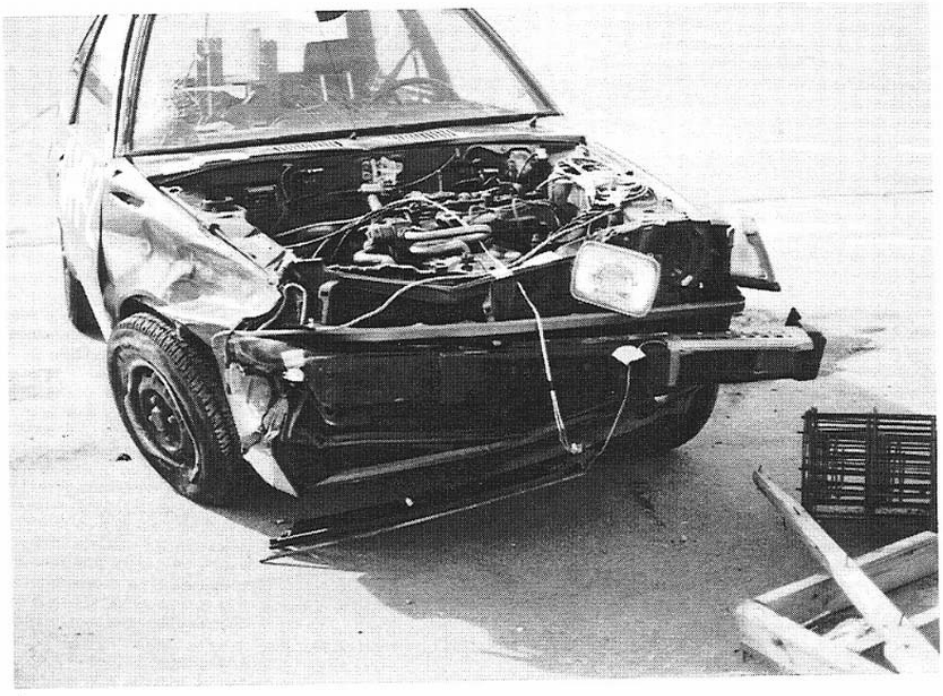
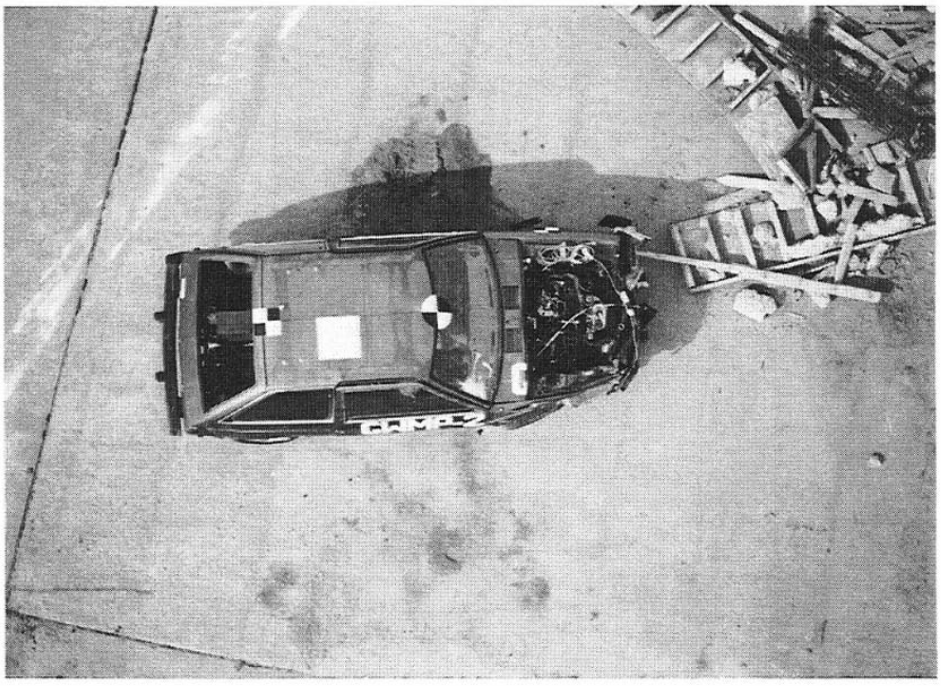
Figure 25. Vehicle Damage, Test GWMP-2 (cont.).

The vehicle damage, shown in Figures 24 and 25, included crushing of the front right corner of the vehicle, minor scrapes and dents along the length of the passenger side, and separation of the hood. The windshield was not penetrated but did sustain localized cracking in the lower right corner. The front right tire was blown out and the rim was bent outward at the top. The occupant compartment floor sustained minor buckling in the front passenger side floor area. The maximum

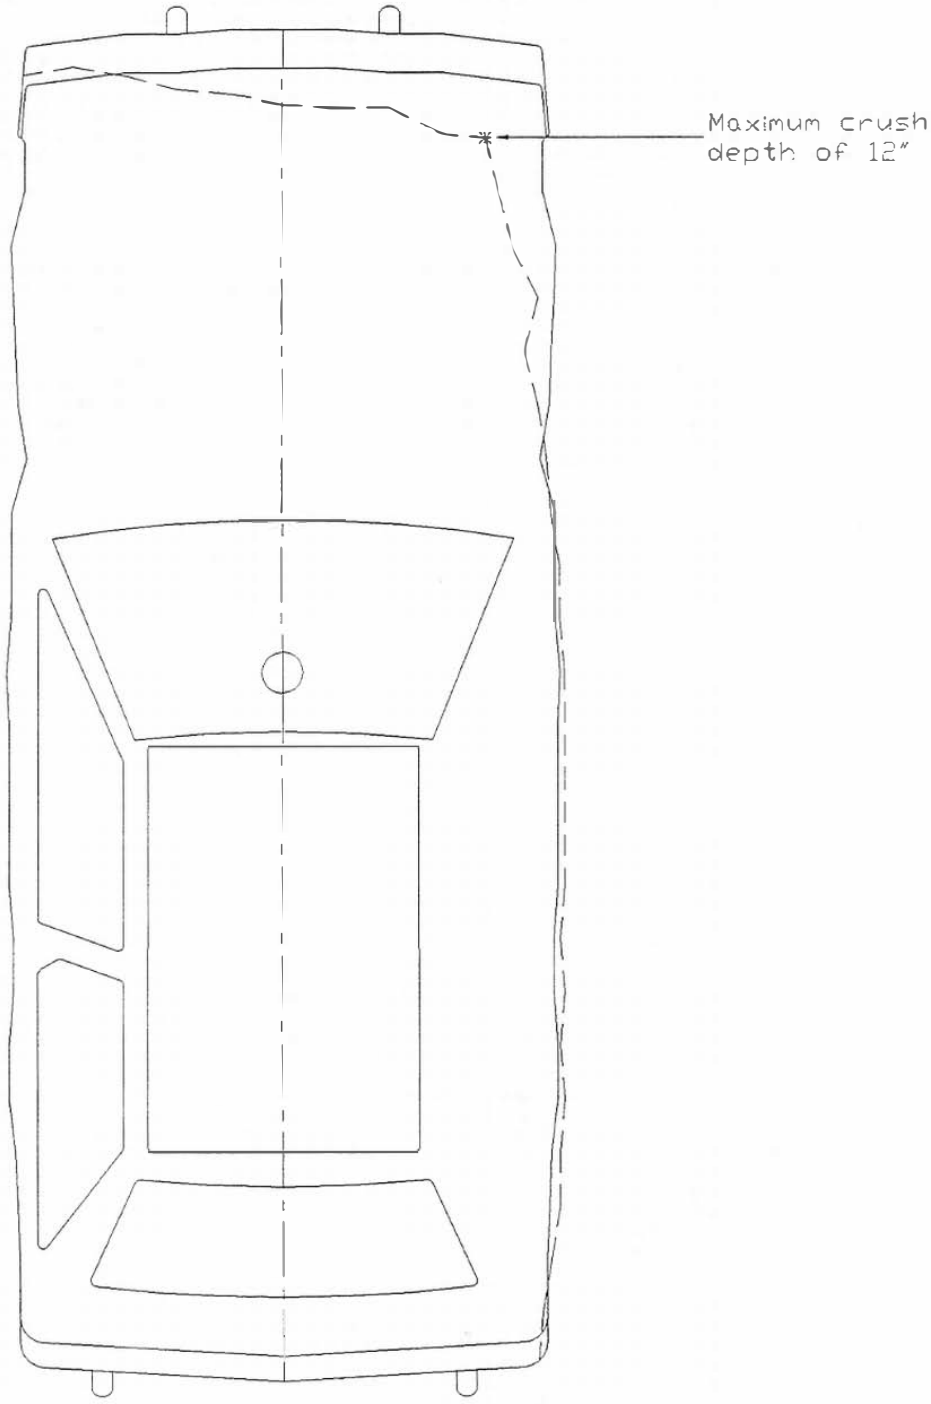
Figure 26. Vehicle Crush Measurements, Test GWMP-2.

crush deformation of 12 in. (30.5 cm) is shown in Figure 26.

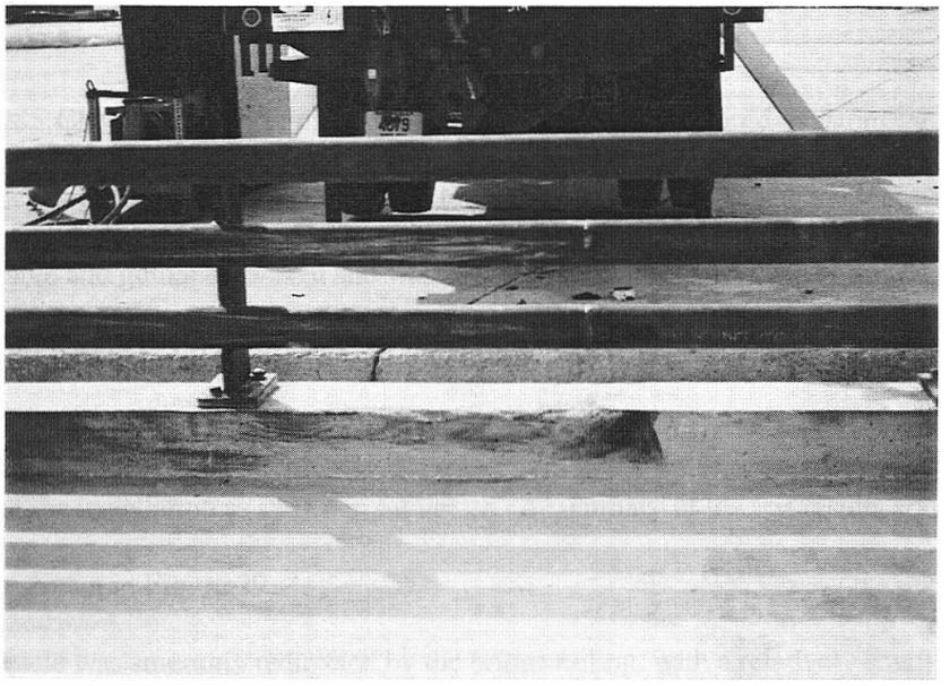
Figure 27. Bridge Rail Damage, Test GWMP-2.

As shown in Figure 27, the bridge rail and curb sustained minor scrapes in the area which the impact occurred. Contact with the middle and lower rail began at the midspan between posts 4 and 5, and continued to the midspan between posts 3 and 4.

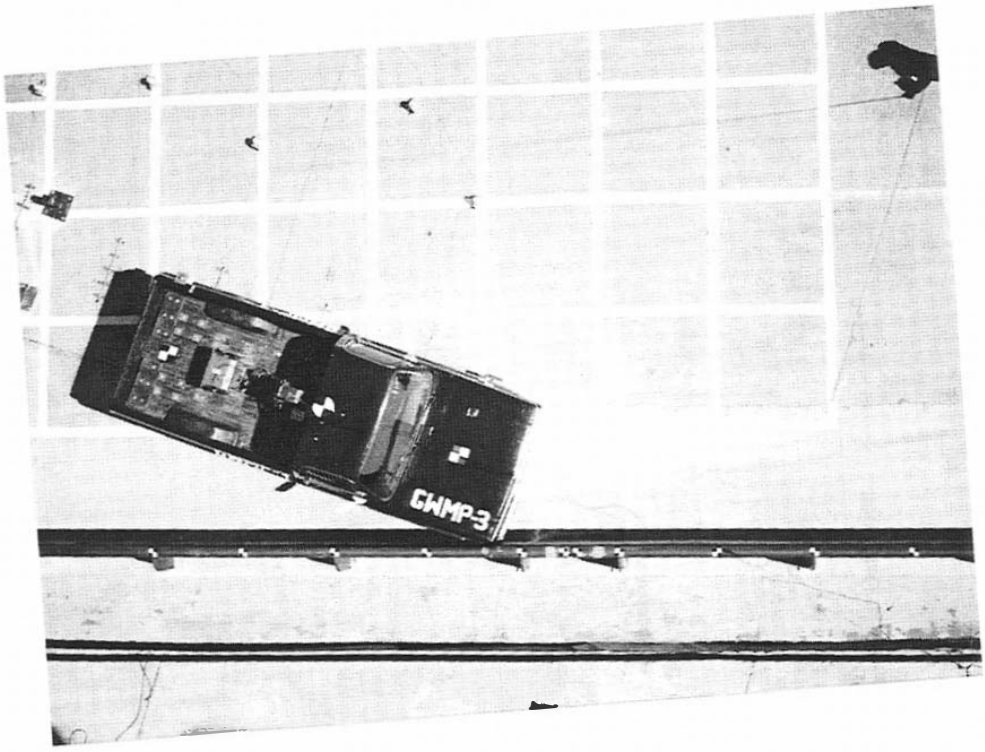
Figure 28. Impact Location, Test GWMP-3.

The 1985 Chevrolet 3/4 ton pickup was directed into the George Washington Memorial Parkway Bridge Rail using a reverse tow and cable guidance system (5). The vehicle was released from the tow cable and guidance system and was free wheeling at impact. The speed of the vehicle at impact was 46.6 mph (75.0 km/h) and the angle of impact was 22.7 degrees. The impact point was located 3 ft. - 3.5 in. (1.0 m) upstream of the expansion joint, just before post 6 from the upstream end of the installation as shown in Figure 28. A summary of the test results and sequential photographs is shown in Figure 29.

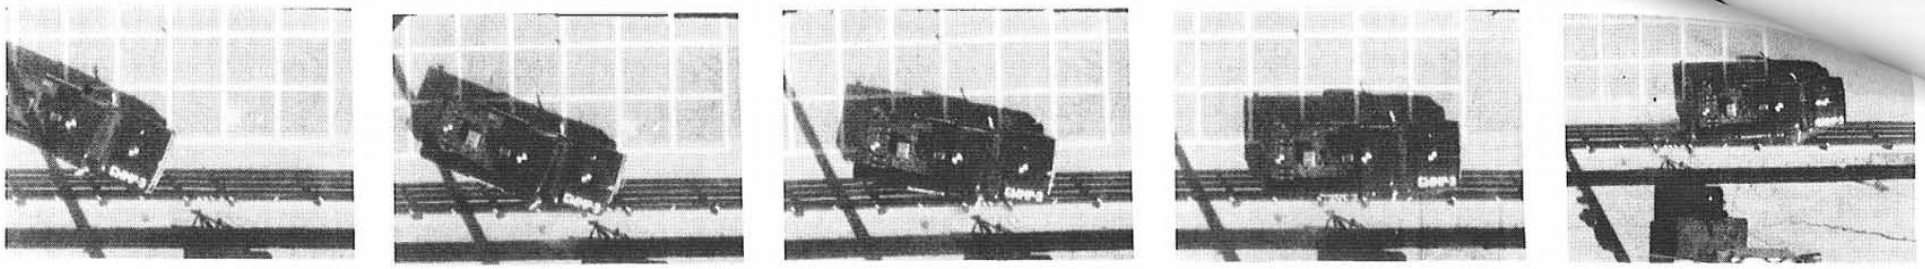
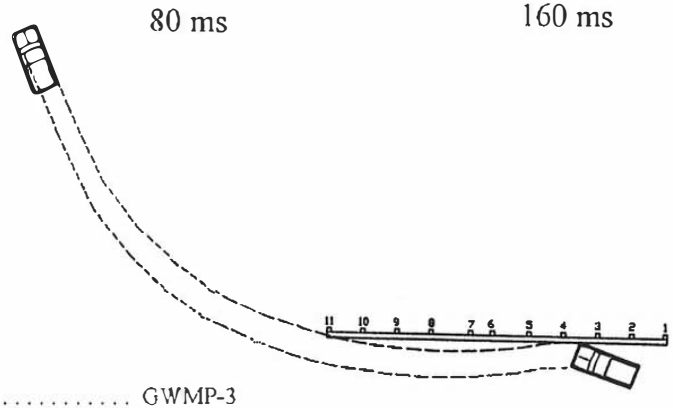
Figure 29. Summary of Test GWMP-3.

The longitudinal and lateral occupant impact velocities as determined from accelerometer data analysis were 9.6 fps (2.93 m/s) and 21.3 fps (6.49 m/s), respectively. The maximum occupant ridedown decelerations were 2.0 g's (longitudinal), and 8.0 g's (lateral). The results of this analysis are summarized in Figure 29 and Table 1.

Speed	
Impact	46.6 mph
Exit	38.2 mph
Angle	
Impact	22.7 deg
Exit	3.1 deg
Occupant Impact Velocity	
Longitudinal	9.6 fps
Lateral	21.3 fps
Occupant Ridedown Deceleration	
Longitudinal	2.0 g's
Lateral	5.0 g's
Vehicle Damage	
TAD	1-RF[illegible]-4
VDI	01RFES2
Vehicle Rebound Distance	3 ft. @ 40 ft.
Bridge Rail Damage	Minor
Maximum Permanent Set Deflection	0.25 in.

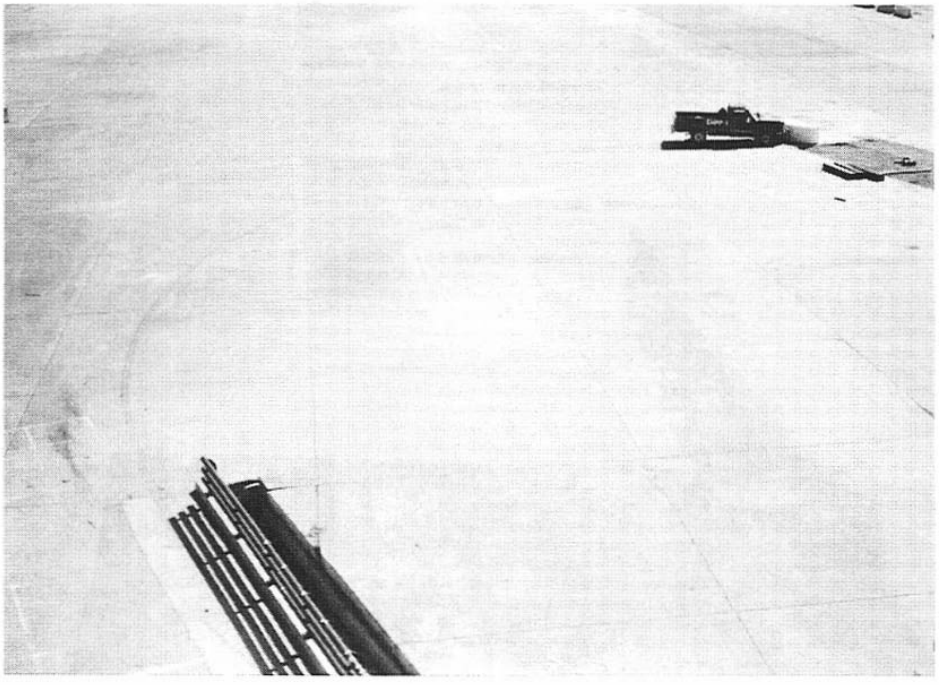
Figure 30. Vehicle Trajectory, Test GWMP-3.

The vehicle was smoothly redirected by the bridge railing, with a relatively small amount of damage to the vehicle. At 140 ms, tail slap occurred between the passenger side rear quarter panel of the vehicle and the rail. The tail slap caused cracking of the curb and deck at post 6. There was no snagging of the vehicle. There was a maximum permanent set deflection of 0.125 in. (0.32 cm) in the bridge rail. The vehicle came to rest 135 ft. (41.1 m) downstream and 110 ft. (33.5 m) to the back side of a line parallel with the front face of the bridge rail, as can be seen in Figure 30.

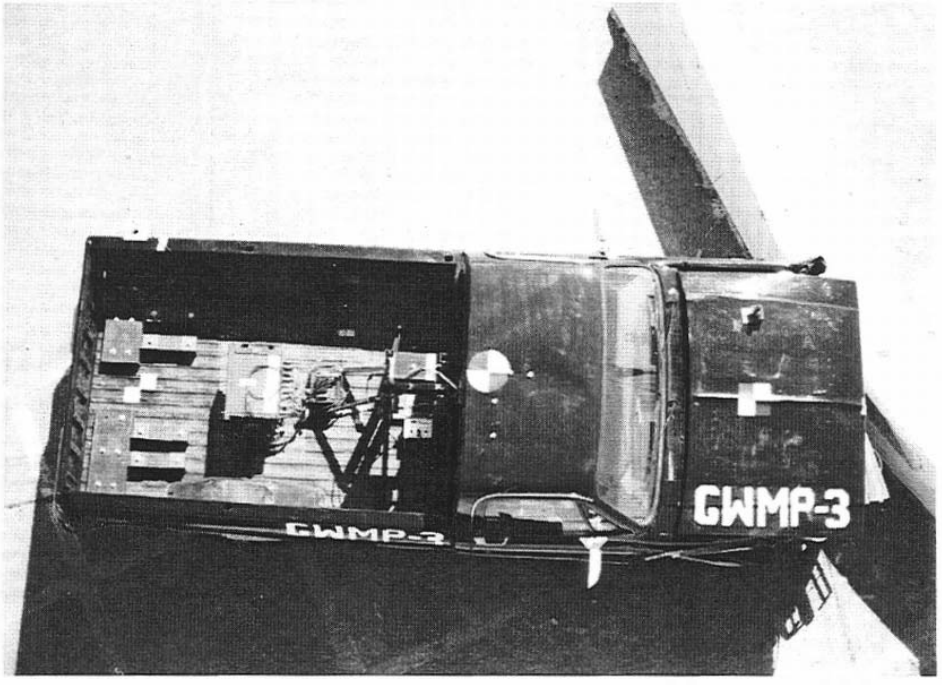
Figure 31. Vehicle Damage, Test GWMP-3..

The vehicle damage, shown in Figure 31, included the crushing of the right front corner of the vehicle, and scrapes and dents along the length of the passenger side. The right front tire was blown out and the rim was deformed. The maximum crush deformation of 9.75 in. (24.8 cm) is shown in Figure 32. All damage to the vehicle on the drivers side of the longitudinal centerline occured after impact with the bridge rail. During the vehicle's run out, it struck an obstacle on the testing grounds, which resulted in damage to the left front corner of the vehicle..

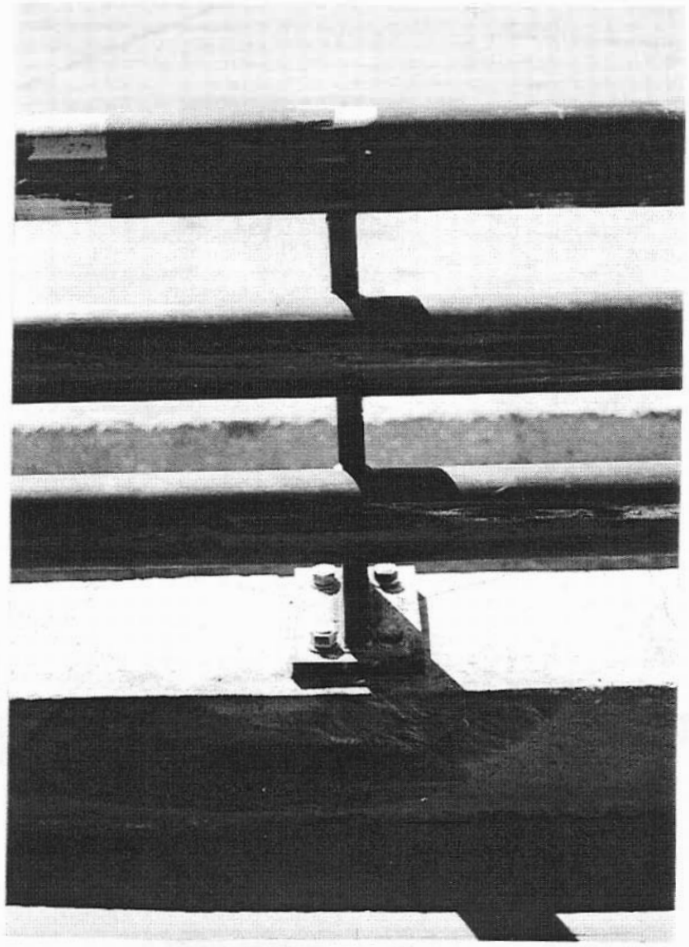
Figure 33. Bridge Rail Damage. Test GWMP-3.

The bridge rail sustained only minor cosmetic damage on each of the three rails as shown in Figure 33. Contact with each of the rails began 3 ft. - 5 in. (1.04 m) upstream of the expansion joint.

The vehicle remained in contact with the rail for 8 ft. - 0 in. (2.44 m) on the bottom rail, 8 ft. - 6 in. (2.59 m) on the middle rail, and 8 ft. - 2 in. (2.49 m) on the top rail.

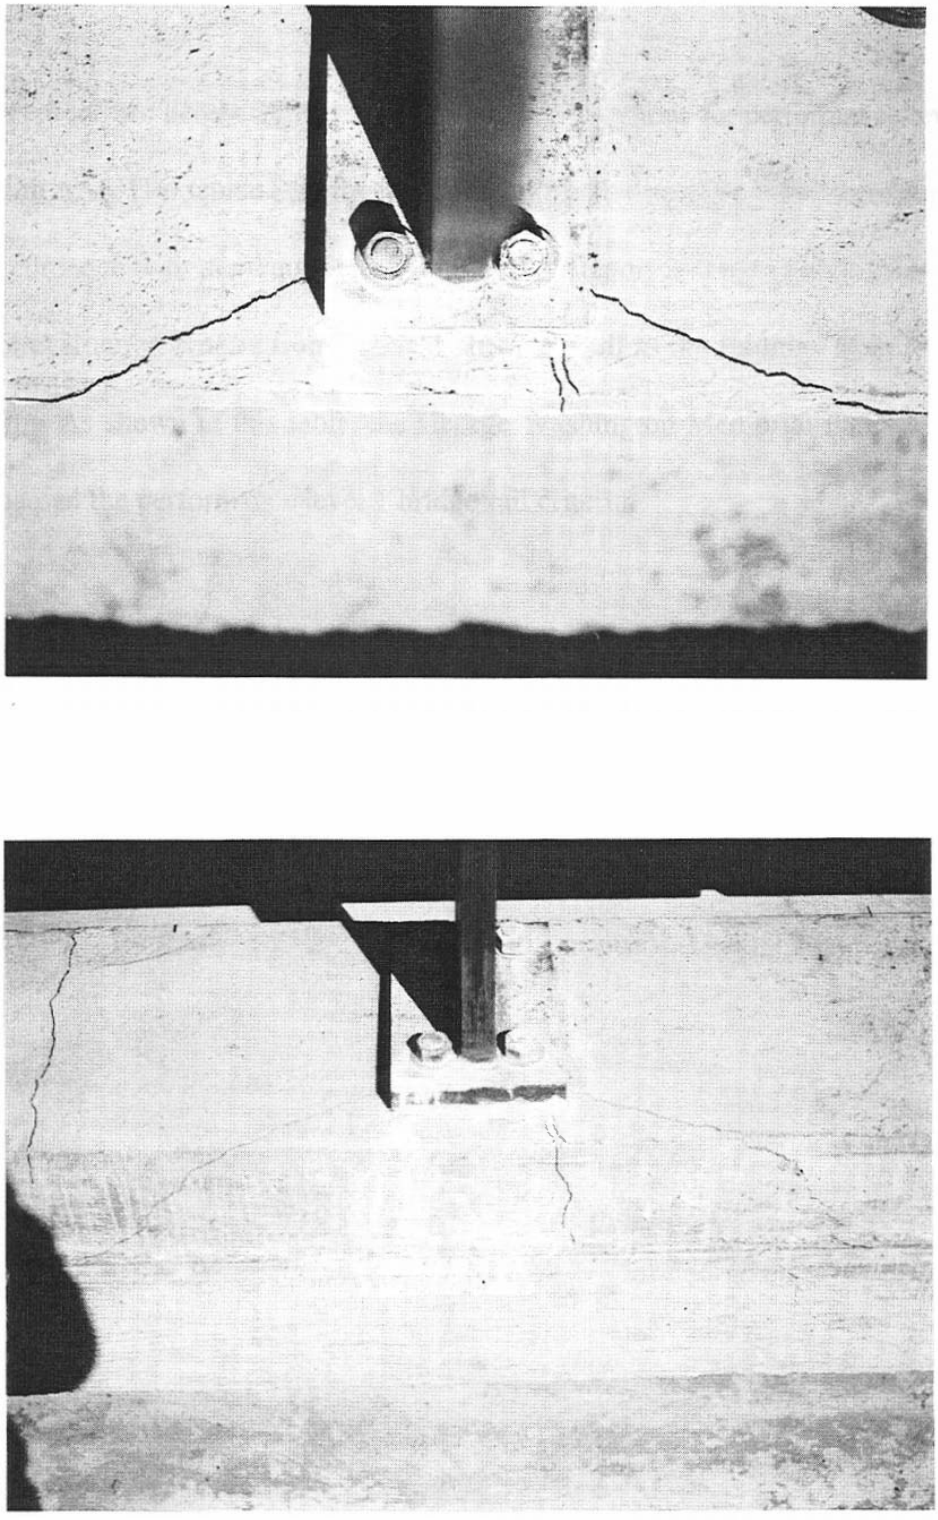
Figure 34. Curb Damage, Test GWMP-3.

Cracking occured in the curb and bridge deck at post number 6. On top of the curb, two cracks propagated outward from each of the rear post bolts, as shown in Figure 34. The length of cracks upstream and downstream of post 6 were 10 in. (25.4 cm) and 11 in. (27.9 cm) respectively.
