COMPLIANCE TESTING OF IOWA'S SKID-MOUNTED SIGN DEVICE

MwRSF Research Report No. TRP-03-86-99

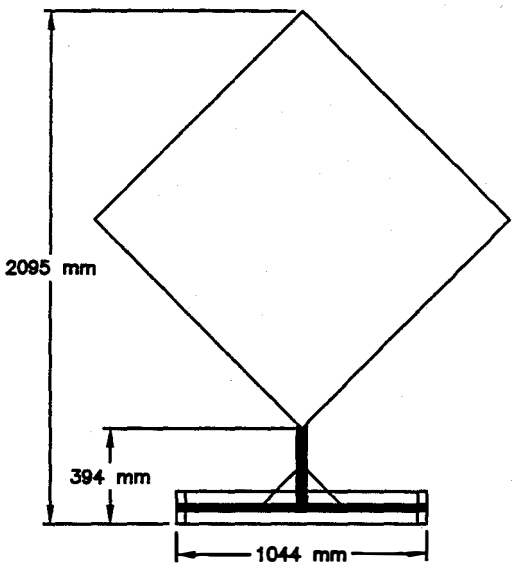
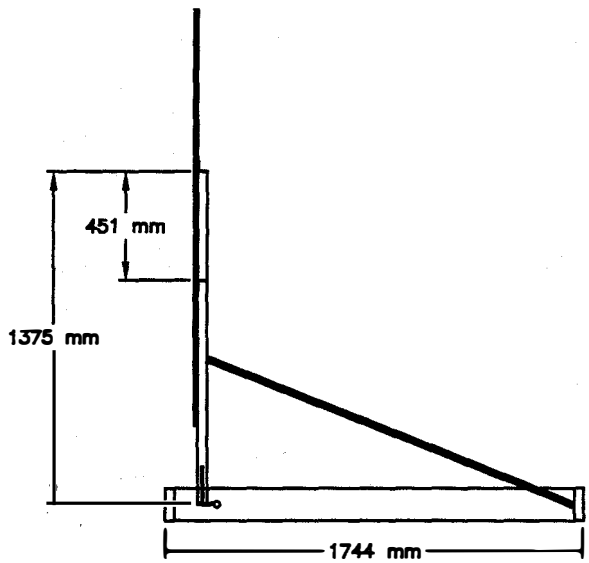
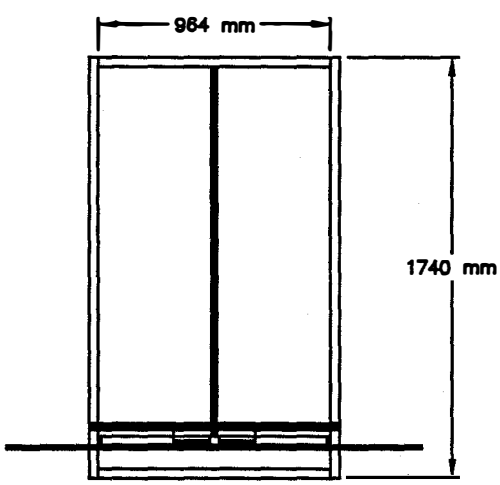
Figure 1. System Nos. 1 and 2 Sign Support Details, Tests I-1 and I-2

* Base – rectangular 135 mm wide x 38.35 mm thick treated wood
* Pipe Base – 27.28 mm sq. galvanized steel tube
* Support Rod – 21.52 mm dia. pipe

* Panel – Plywood with reflectve material, 1220 mm x 1220 mm
* Vertical Upright – 38.61 mm sq. x 1.52 mm wall x 1375 mm long galvanized steel
* Top Bracket – 2 pcs of 3.35 mm th. x 38.40 mm x 938 mm long galvanized steel welded together
* Bottom Bracket – 2 pcs of 3.35 mm th. x 38.40 mm x 450 mm long galvanized steel welded together

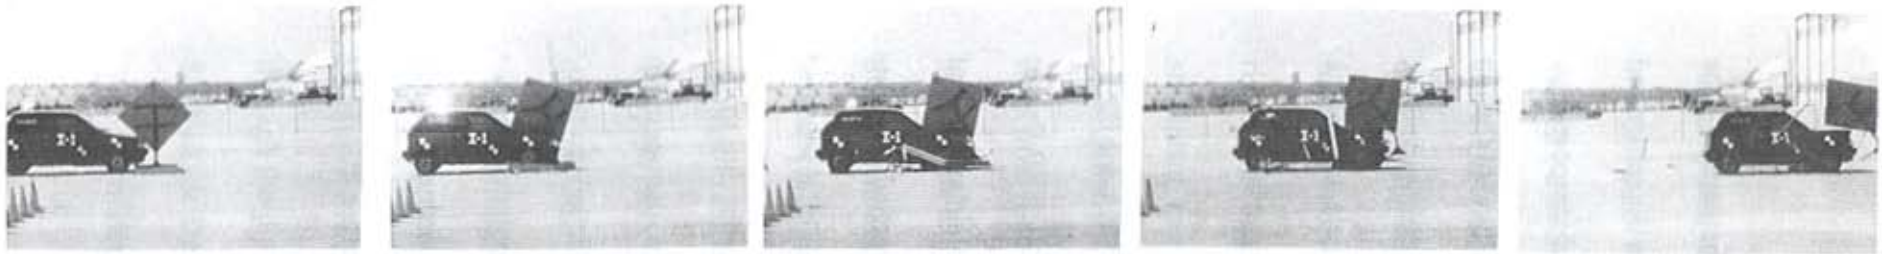
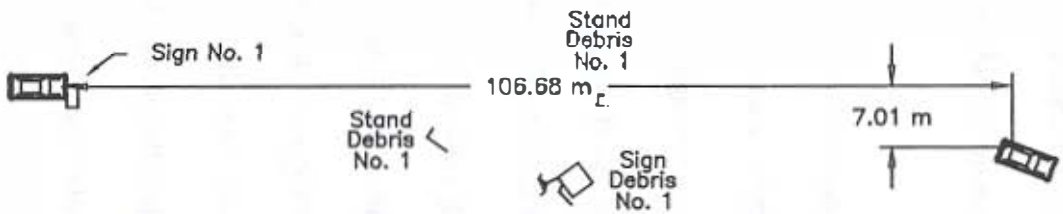
Figure 11. Summary of Test Results and Sequential Photographs, Test I-1

Note: The wooden base broke into two large pieces and many smaller pieces with a scatter pattern of 3.81 m left, 3.81 m right, and 24.38 m downstream from the original position of the sign.

- Lateral (not required) ..... NA
- Vehicle Damage ..... Windshield cracking & penetration, moderate hood indentation
  - TAD[12] 12-FR-1
  - SAE[13] 12-FRAN1

- Vehicle Stopping Distance ..... 106.68 m downstream 7.01 m right
- Barrier Damage ..... Moderate – Broke apart

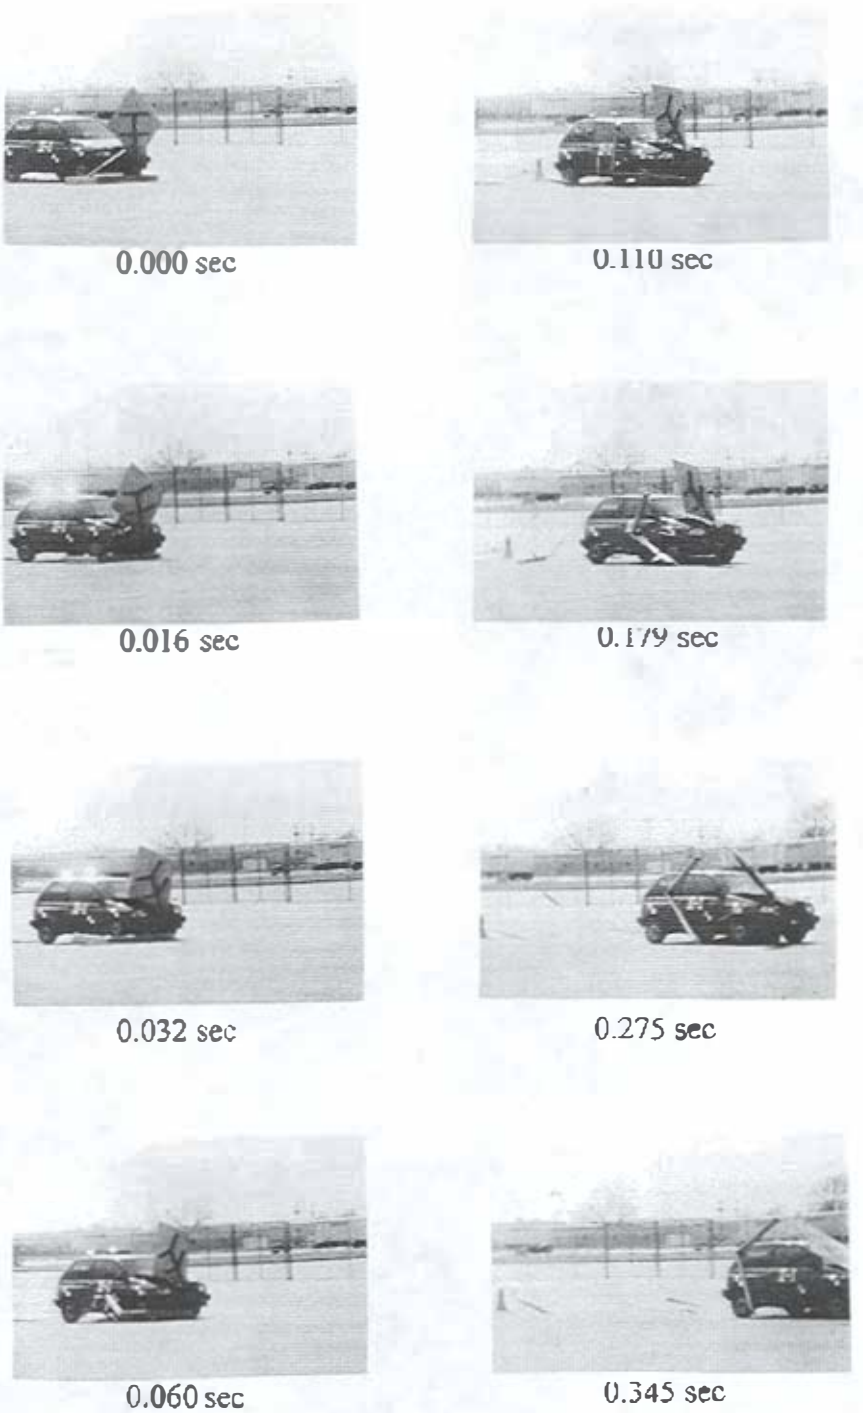
Figure 12. Additional Sequential Photographs, Test I-1

The test vehicle impacted System No. 1 with the centerline of the vehicle aligned with the centerline of the sign support, as shown in Figure 13. At 0.014 sec after impact, the hood was creased down the center and the outside edges buckled upward around the sign panel. At this same time, the vertical support deformed about the vehicle's bumper which caused the top of the sign panel to rotate toward the vehicle. After 0.030 sec, the corner of the sign panel closest to the vehicle impacted the lower-center of the windshield. At 0.032 sec, the vertical support ripped away from the wooden base as the vehicle began to travel over it. After 0.057 sec, the wooden base broke into several pieces. At this same time, the sign panel, with the vertical support still attached, was still in contact with the windshield and hood and continued to travel with the vehicle. At 0.107 sec, the sign panel, which was not in contact with the vehicle, traveled along in front of and at about the same speed as the vehicle. One of the larger pieces of the wooden base was along side the right-front side of the vehicle at 0.110 sec. At 0.179 sec, the sign panel and vertical support began to rotate counter-clockwise (CCW) in front and above the vehicle. At 0.220 sec, the sign panel was above the vehicle's hood and continuing to rotate CCW. At 0.275 sec, the large piece of the wooden base was near the right-side door, while the sign panel continued to rotate CCW.

After 0.345 sec, the sign panel rotated to a horizontal position above the vehicle. At this same time, the large piece of the wooden base was traveling at about the same speed as the vehicle, but without contact with the vehicle. The final position of one of the larger pieces of the wooden base was 41.15 m downstream and 6.10 m right from the original position. The other larger piece of the wooden base was located 60.05 m downstream and 1.52 m right from its initial position. There were smaller pieces of wooden base's debris were scattered along a path of 24.38 m downstream with a width of 3.81 m left and right of the original position. The pipe base, vertical tubing, mast, support rod, and sign panel, while still intact, came to rest 56.69 m downstream and 10.67 m right of the initial position. The vehicle subsequently came to rest 106.68 m downstream from the midpoint of the impact point and 7.01 m right from the centerline of the vehicle's original path. The final positions of the vehicle and the sign support are shown in Figure 11.

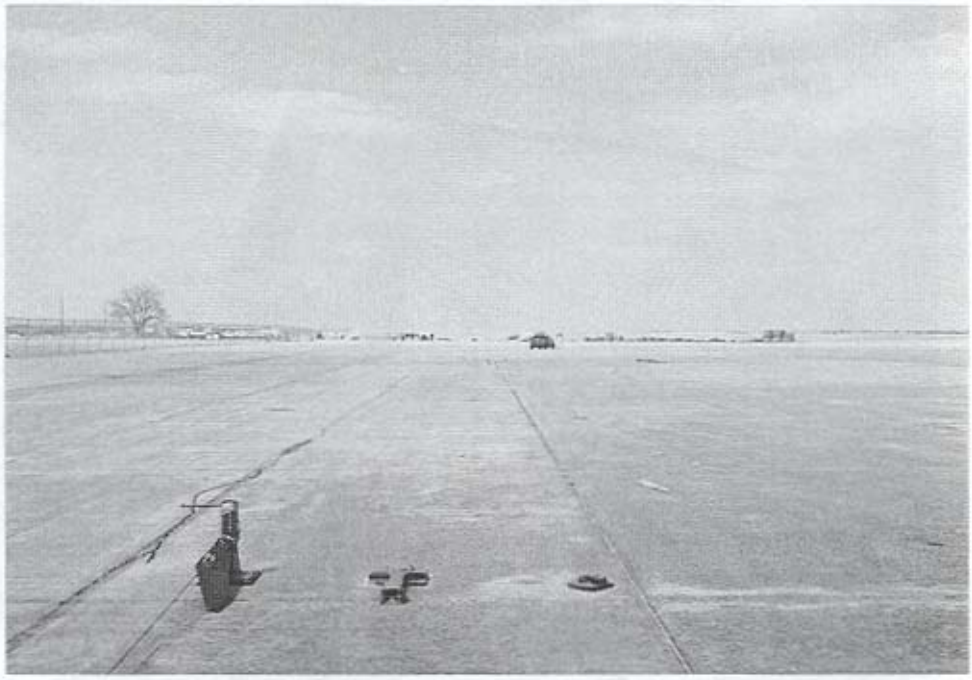
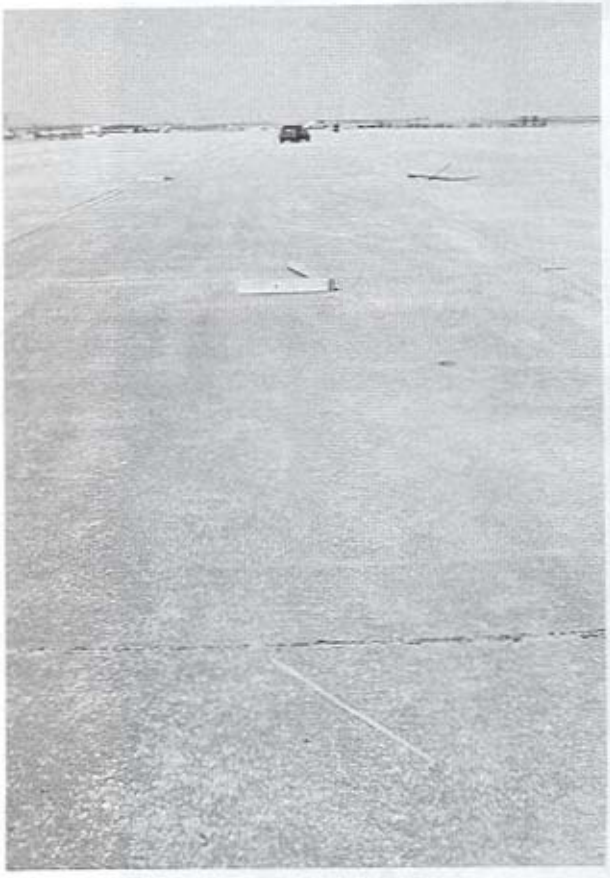
Figure 14. System No. 1 Overall Damage, Test I-1

Damage to System No. 1 is shown in Figures 14 and 15. System No. 1 encountered moderate damage to the sign support. The wooden base broke into two larger pieces and many smaller pieces. The pipe base, vertical tubing, mast, support rod, and sign panel all remained intact, but encountered deformations. Each leg of the pipe base bent to a 30 degree angle in opposite directions. The vertical tubing was bent in the shape of the nose of the vehicle. The support rod was bent into a 90 degree angle about the top third of the rod. The sign panel encountered scrape marks near the bottom front of the impacted side. The two bolts furthest away from the impact were slightly pulled through the plywood. No major damage was found to have occurred to the mast.

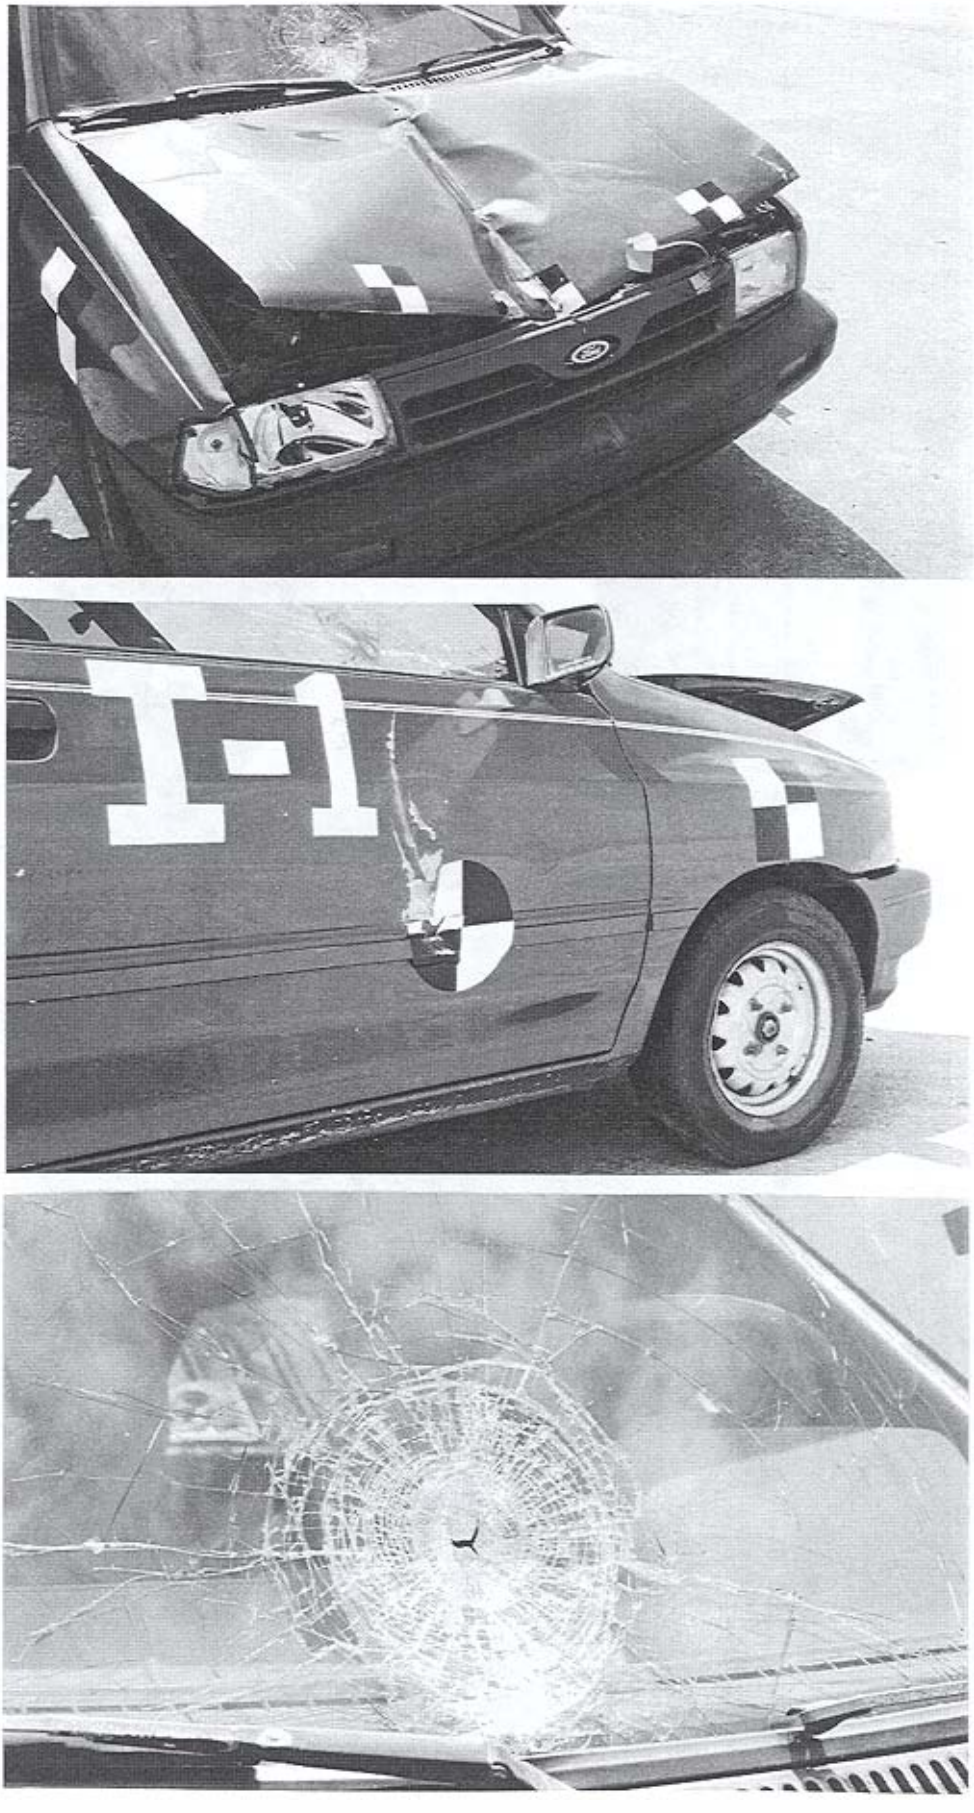
Figure 17. Vehicle and Windshield Damage, Test I-1

Exterior vehicle damage was moderate, as shown in Figures 16 and 17. A hole through the windshield was located 203 mm from the bottom and slightly to the right of the center. The windshield also had "spider web" cracking around the hole. The hood creased down the center and the edges of the hood folded upward. The left-front side of the hood also encountered scrape marks. The center point of the bumper cover had a slight indentation. A small crack was found at the top midpoint of the grill. Scrape marks and dents were found just above the target on the right-side door. The right-side headlight and blinker light were broken. No other damage to the vehicle was found. There were no interior occupant compartment deformations to the vehicle.

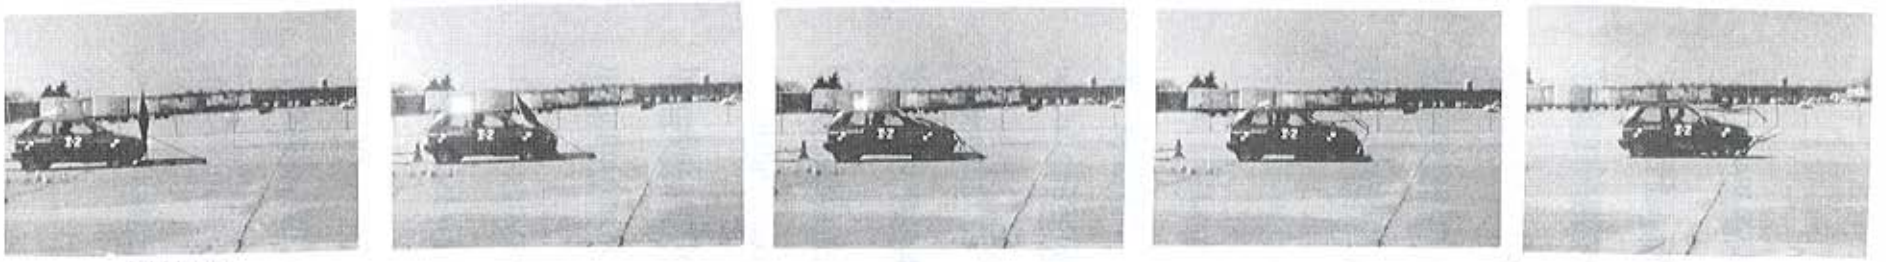
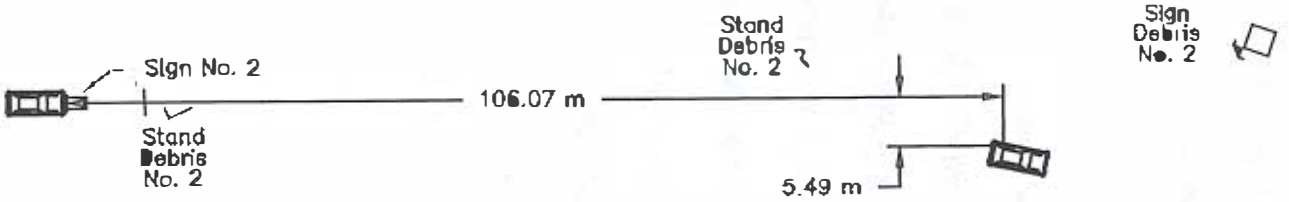
- Lateral (not required) ..... NA
- Vehicle Damage ..... Severe windshield cracking and major roof indentation
  - TAD[12] 12-FR-1
  - SAE[13] 12-FRAN1
- Vehicle Stopping Distance ..... 106.07 m downstream 5.49 m right

- Barrier Damage ..... Moderate – Broke apart

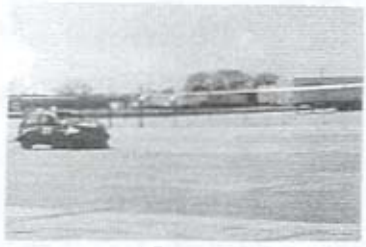
Figure 19. Additional Sequential Photographs, Test 1-2

The test vehicle impacted System No. 2 with the centerline of the vehicle aligned with the centerline of the sign support, as shown in Figure 20. At 0.016 sec, the top of the panel flexed away from the vehicle while the vertical support deformed around the front of the vehicle. After 0.028 sec, the vertical support separated from the wooden base and the support rod separated from the vertical support. At 0.042 sec, the top of the sign panel impacted the windshield. At 0.070 sec, the vertical support and horizontal sign angle brackets flexed away from the sign panel. At this same time, the sign panel was in contact with the windshield and the hood. After 0.127 sec, the sign panel and vertical support began to lose contact with the vehicle, and the wooden base was under the vehicle. At 0.147 sec, the sign panel and attached vertical support traveled above the vehicle's hood without any contact with the vehicle. At this same time, one piece of the wooden base was in front of the left side and one was under the middle of the vehicle. After 0.255 sec, one piece of the wooden base cleared the rear of the vehicle while the other larger piece of the wooden base was in front of the vehicle. At 0.279 sec, the sign panel, with attached vertical support, traveled above and in front of the vehicle at about the same speed as the vehicle. At 0.515 sec, the sign panel and vertical support impacted the hood and the ground, respectively, traveling along with the vehicle.

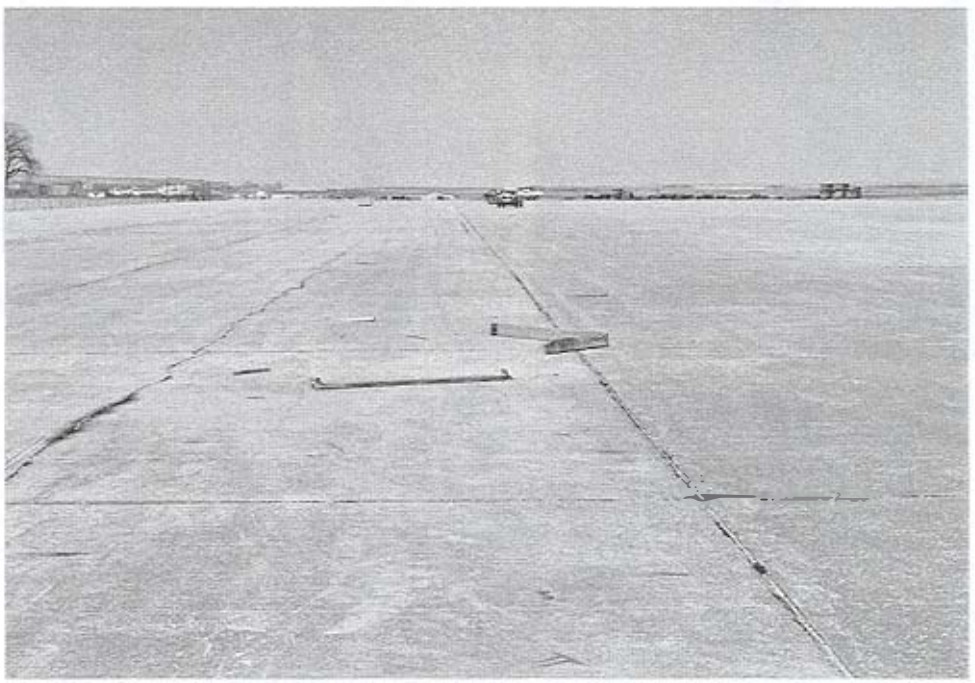
Figure 21. System No. 2 Overall Damage, Test I-2

Damage to System No. 2 is shown in Figures 21 through 23. System No. 2 has moderate damage to the sign support. The wooden base broke into three larger pieces and many smaller pieces. One of the larger pieces, the back piece with the support rod connected to it, was bent into a 120 degree angle about the rod's midpoint. The pipe base, vertical tubing, mast, and sign panel all remained intact but encountered deformations. Each leg of the pipe base bent evenly about the attached triangular gussett plate. The vertical tubing bent at 381 mm above the triangular gussett plate and was slightly dented at the support rod's connection point. Weld failures were found at the flat plate and gussett connection and the lower crossbrace and vertical tubing connection. The lower crossbrace was bowed slightly away from the sign panel. The sign panel was cracked on the left side near the lower crossbrace, and the bottom tip of the sign panel was also broken. No major damage was found to have occurred to the upper crossbrace.

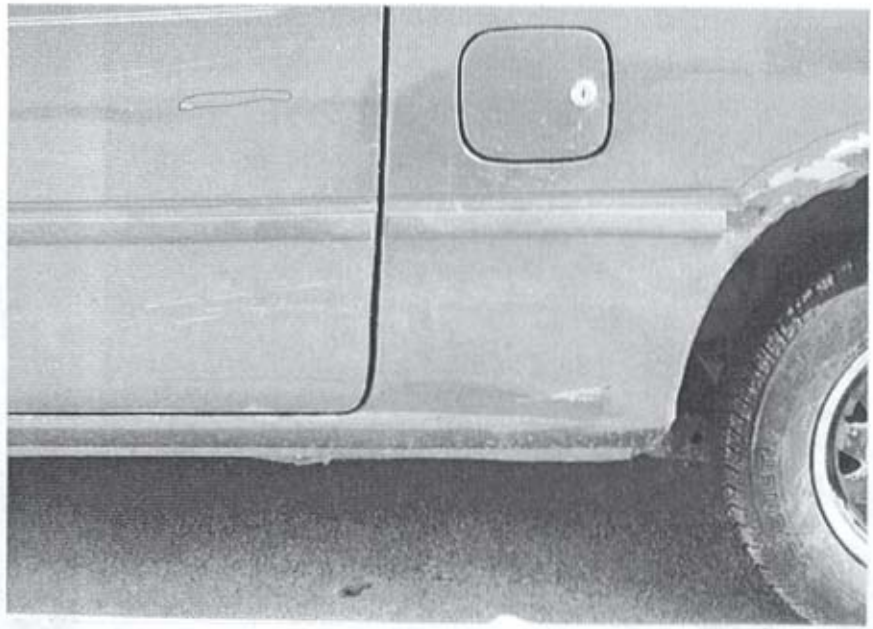
Figure 24. Vehicle Damage, Test I-2

Exterior vehicle damage is shown in Figures 24 and 25. Light scuff marks were found on the hood.

The center point of the bumper cover encountered a slight indentation. Scrape marks and small dents were found on the lower left-side door and the lower left-rear quarter panel. The windshield cracked due to contact with System No. 2. The windshield sustained major "spider web" cracking throughout, with both layers of the windshield being cracked. Most of the structural integritity of the windshield was lost. The roof at the top of the windshield was crushed downward toward the occupant compartment. The vehicle's right-side, back-end, headlights, fog lights, and parking lights were undamaged.
