CRASH TESTING OF MICHIGAN'S TYPE B (W-BEAM) GUARDRAIL SYSTEM – PHASE II

Michigan Department of Transportation
P.O. Box 30049
885 Ricks Road
Lansing, MI 48909

MwRSF Research Report No. TRP-03-104-00

December 13, 2000

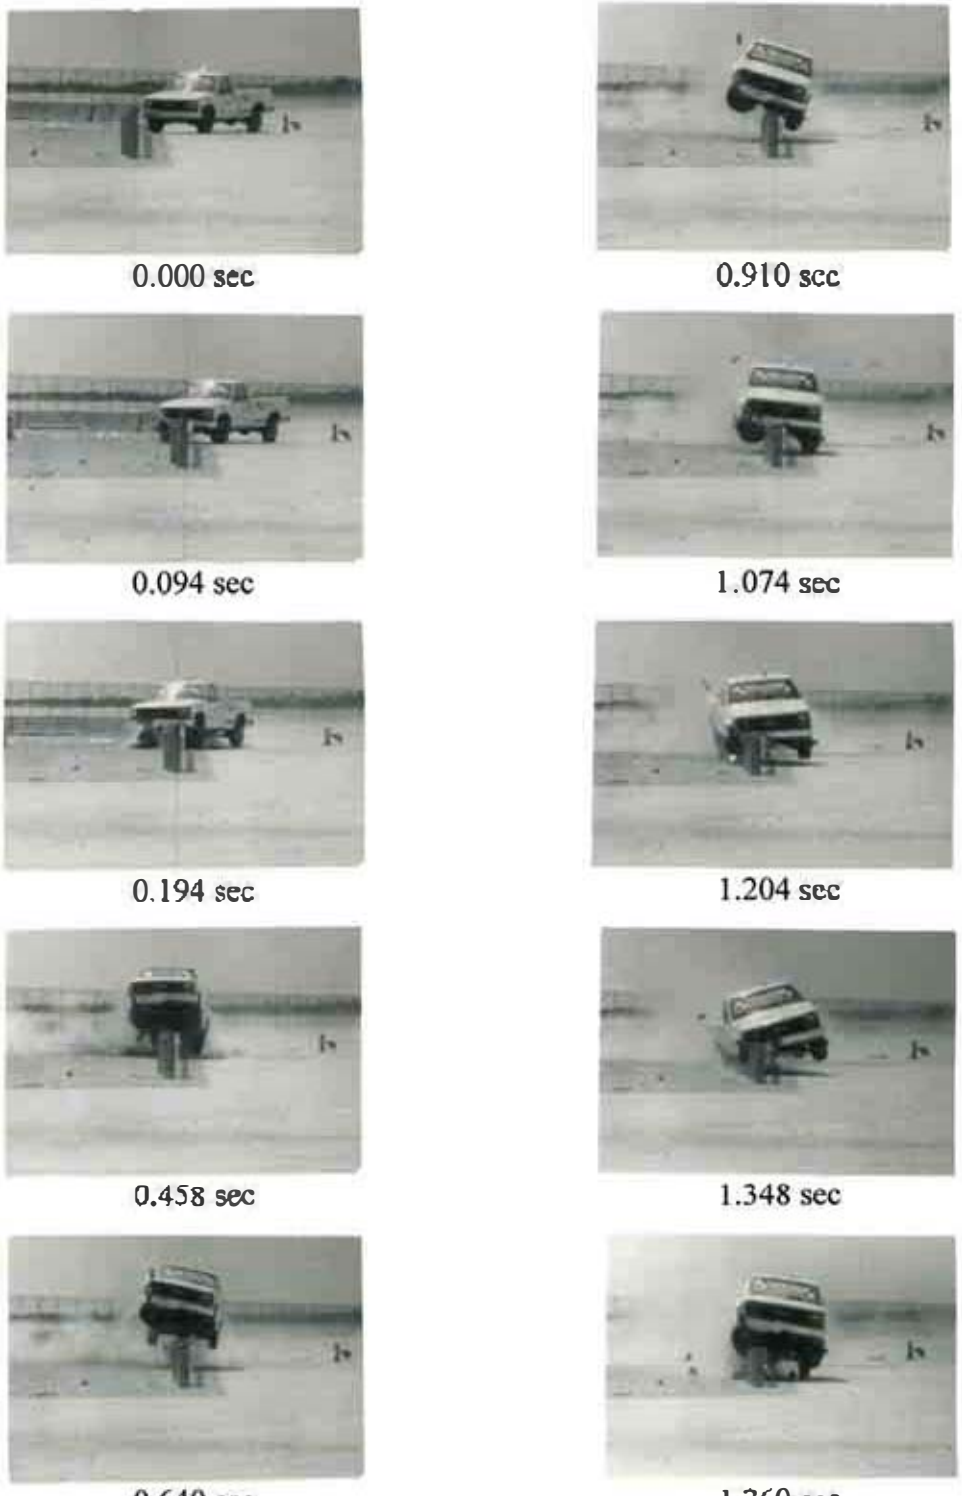
Figure 11. Additional Sequential Photographs, Test MIW-2

Damage to the barrier was moderate, as shown in Figures 17 through 25. Barrier damage consisted mostly of deformed W-beam, contact marks on a guardrail section, and deformed guardrail posts. The W-beam damage consisted of major deformation and flattening of the impacted section between post nos. 13 and 15. Contact marks were found on the guardrail between post nos. 13 and 17. The top ofthe W-beam rail, downstream of post no. 21, was damage from the truck riding along the rail. A 559-mm long cut was foundon the bottom peak starting 76-mm upstream of post no. 14.

Steel post nos. 3 through 13 and 17 through 19 moved backward slightly. Three steel posts, post nos. 14 through 16, rotated in the soil and bent toward the ground. A 406-mm long tire contact mark was found along the front face of post no. 14. The top of post no. 15 was also slightly

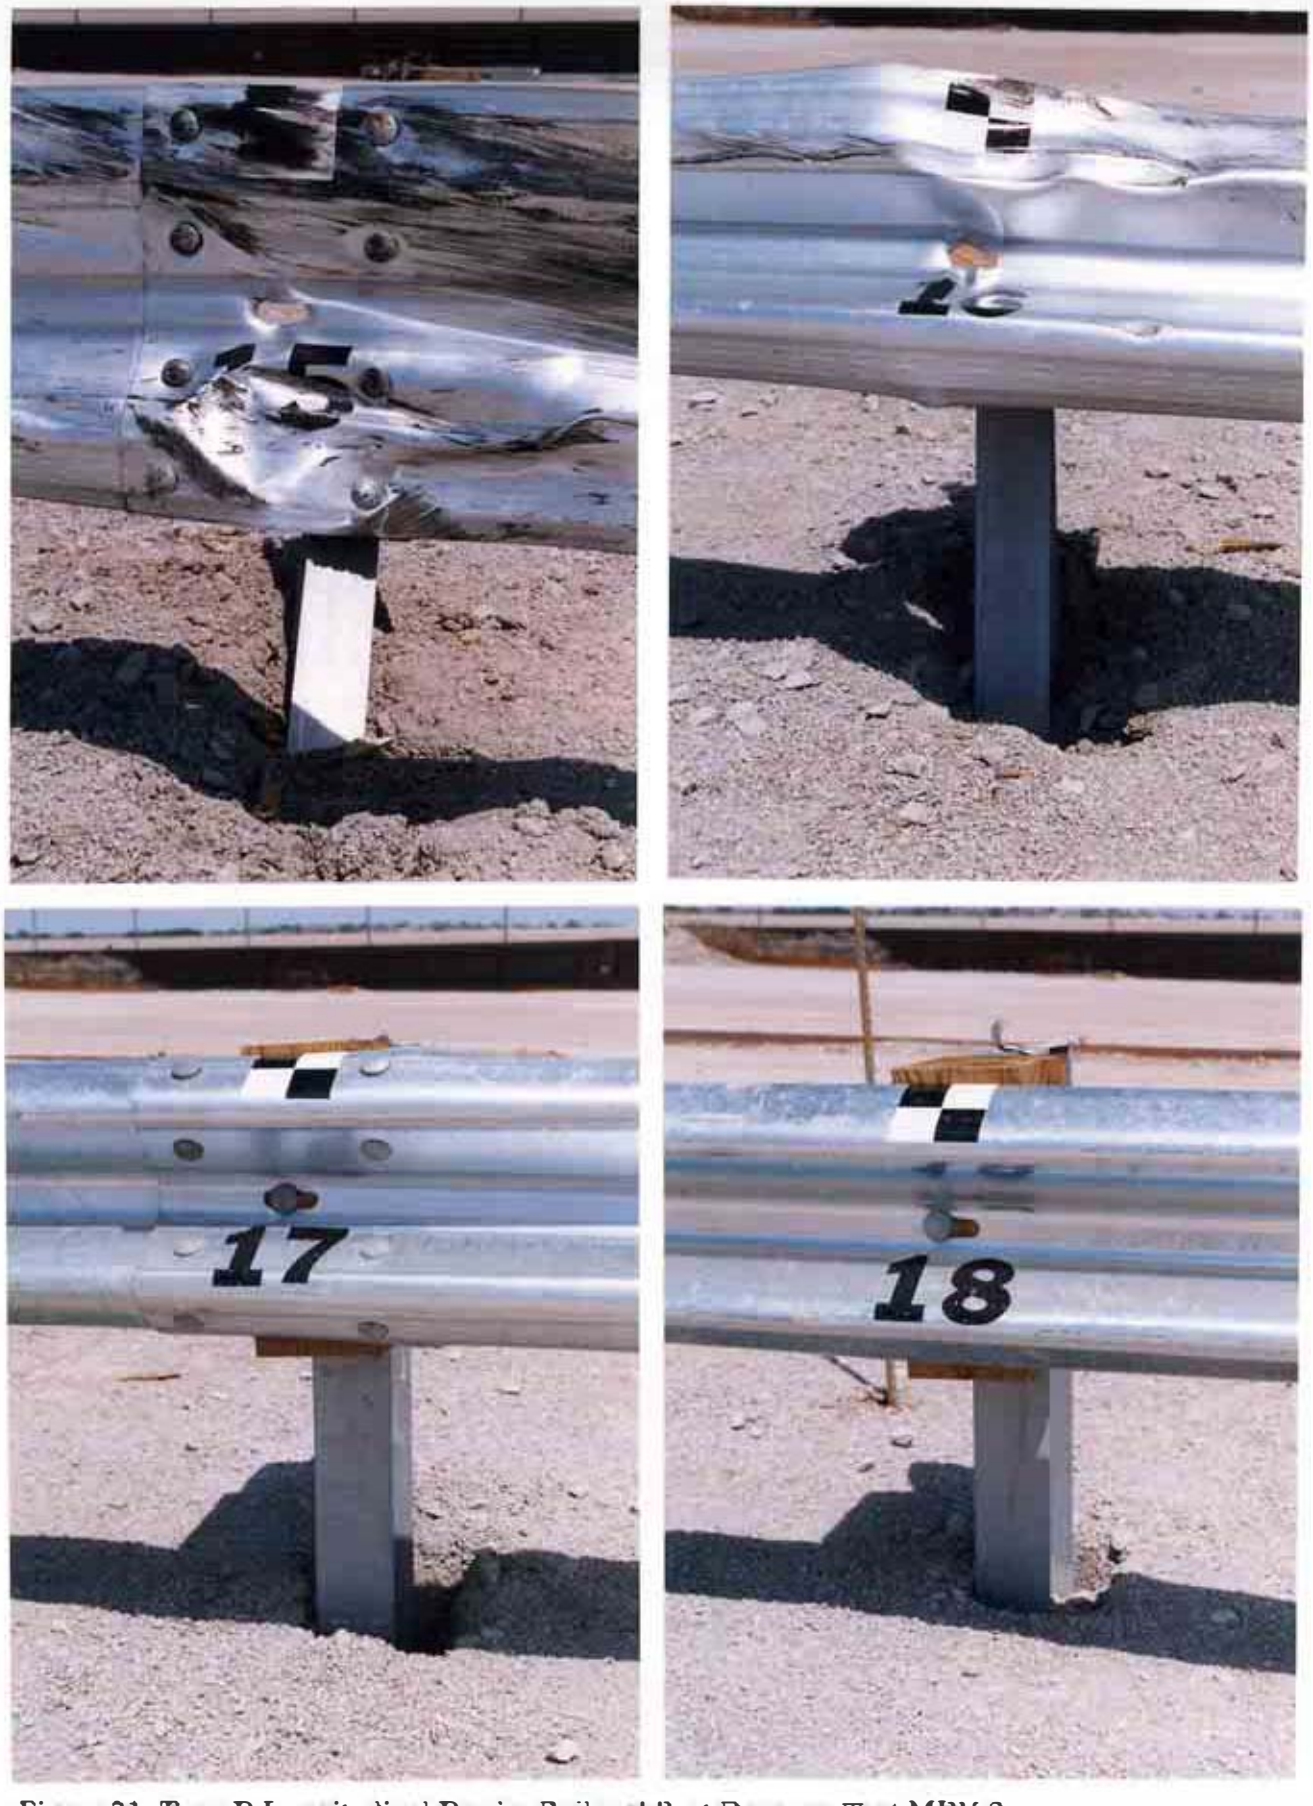
Figure 21. Type B Longitudinal Barrier Rail and Post Damage, Test MJW-2

damaged. The tops of steel post nos. 20 through 27 were contacted and damaged extensively by the vehicle. The wooden blockout at post no. 14 split down the middle but was still attached. Contact marks were found on the wooden blockout at post no. 15. A piece of the wooden blockout at post no. 16 was removed. Both the upstream and downstream anchorage systems move slightly, but the posts were not damaged, except for post no. 28 which was split along its length.

The cause of this unacceptable behavior is attributed to the failure of the W-beam to release quickly from the guardrail posts. The splice in the W-beam rail element remained attached to post

no. 15 until the right-front tire contacted the post. During this time, the post rotated downward approximately 250 mm. Although the blockout reduced the magnitude of the downward motion, this post attachment caused the W-beam to be pulled down during a period when it is normally lifted up to retain the impacting vehicle's front tire. As a result, the tire was forced out from under the guardrail when it struck post no. 15, and the wheel began to climb the barrier as the test vehicle progressed. This wheel climb lead to vehicle vaulting and the failure of the system to successfully redirect the test vehicle.

Careful inspection of the damaged guardrail system and photos of the barrier prior to impact revealed that the post bolts were installed near the downstream end of the slot in the rail element. Testing of the post bolt pullout strengths has shown that bolts installed near the end of the slot generate higher forces before being pulled through the rail. This installation detail may have helped prevent the post bolt from becoming detached from the rail element.
