PERFORMANCE EVALUATION OF THE PERMANENT NEW JERSEY SAFETY SHAPE BARRIER – UPDATE TO NCHRP 350 TEST NO. 4-12 (2214NJ-2)

MwRSF Research Report No. TRP-03-178-06

October 13, 2006

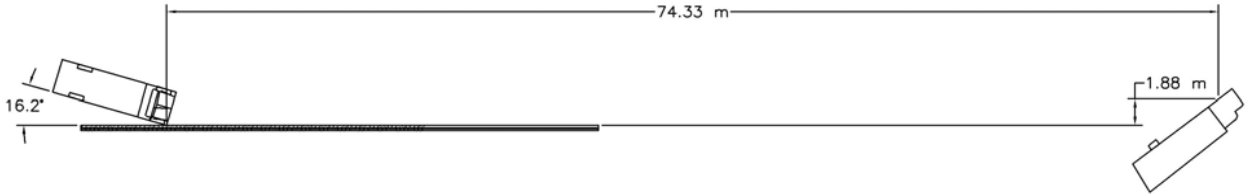
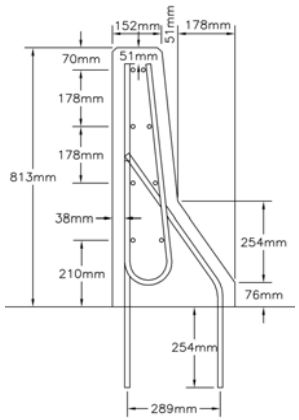
The analysis of the test results for test no. 2214NJ-2 showed that the permanent New Jersey safety shape concrete barrier system impacted with the 10000S vehicle of the Update to NCHRP Report No. 350 did not adequately contain the vehicle on the traffic-side face of the barrier system. It also did not safely redirect the vehicle since the vehicle did not remain upright after collision with the barrier. There were no detached elements nor fragments which showed potential for penetrating the occupant compartment nor presented undue hazard to other traffic. Deformations of, or intrusion into, the occupant compartment that could have caused serious injury did not occur. After collision, the vehicle did not exit the barrier as it rolled over the top of the barrier. Therefore, test no. 2214NJ-2 conducted on the permanent New Jersey safety shape concrete barrier system was determined to be unacceptable according to the TL-4 safety performance criteria found in Update to NCHRP Report No. 350 due to vehicle penetration and rollover the top of the barrier.

- Speed . . . . . 90.9 km/h
  - Angle . . . . . 16.2 degrees
  - Impact Location . . . . . 6.10 m downstream from upstream end
- Exit Conditions
  - Speed . . . . . NA

- Angle . . . . . NA
  - Exit Box Criterion . . . . . Fail
- Post-Impact Trajectory
  - Vehicle Stability . . . . . Unsatisfactory
  - Stopping Distance . . . . . 74.33 m downstream

- Working Width . . . . . NA
- Vehicle Damage . . . . . Extensive (rollover)
  - VDS[5] . . . . . 1-RFQ-5 & 1-RD-6
  - CDC[6] 1-RDAS9
  - Maximum Deformation . . . . . NA

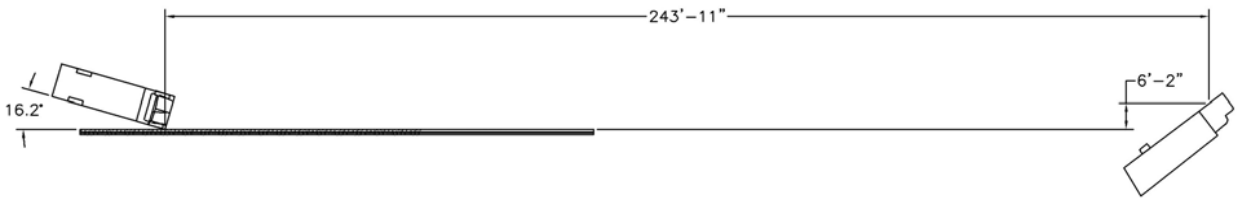
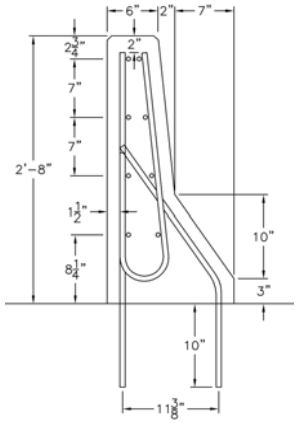
Figure B-1. Summary of Test Results and Sequential Photographs (English), Test 2214NJ-2

- Speed . . . . . 56.5 mph
  - Angle . . . . . 16.2 degrees
  - Impact Location . . . . . 20 ft downstream from upstream end
- Exit Conditions
  - Speed . . . . . NA

- Angle . . . . . NA
  - Exit Box Criterion . . . . . Fail
- Post-Impact Trajectory
  - Vehicle Stability . . . . . Unsatisfactory
  - Stopping Distance . . . . . 243 ft - 11 in. downstream
    6 ft - 2 in. laterally behind

- Test Article Damage . . . . . Minimal
- Test Article Deflections
  - Permanent Set . . . . . NA
  - Dynamic . . . . . NA
  - Working Width . . . . . NA
- Vehicle Damage . . . . . Extensive (rollover)
