# PERFORMANCE EVALUATION OF THE MIDWEST GUARDRAIL SYSTEM – UPDATE TO NCHRP 350 TEST NO. 3-11 WITH 28" C.G. HEIGHT (2214MG-2)

MwRSF Research Report No. TRP-03-171-06

October 11, 2006

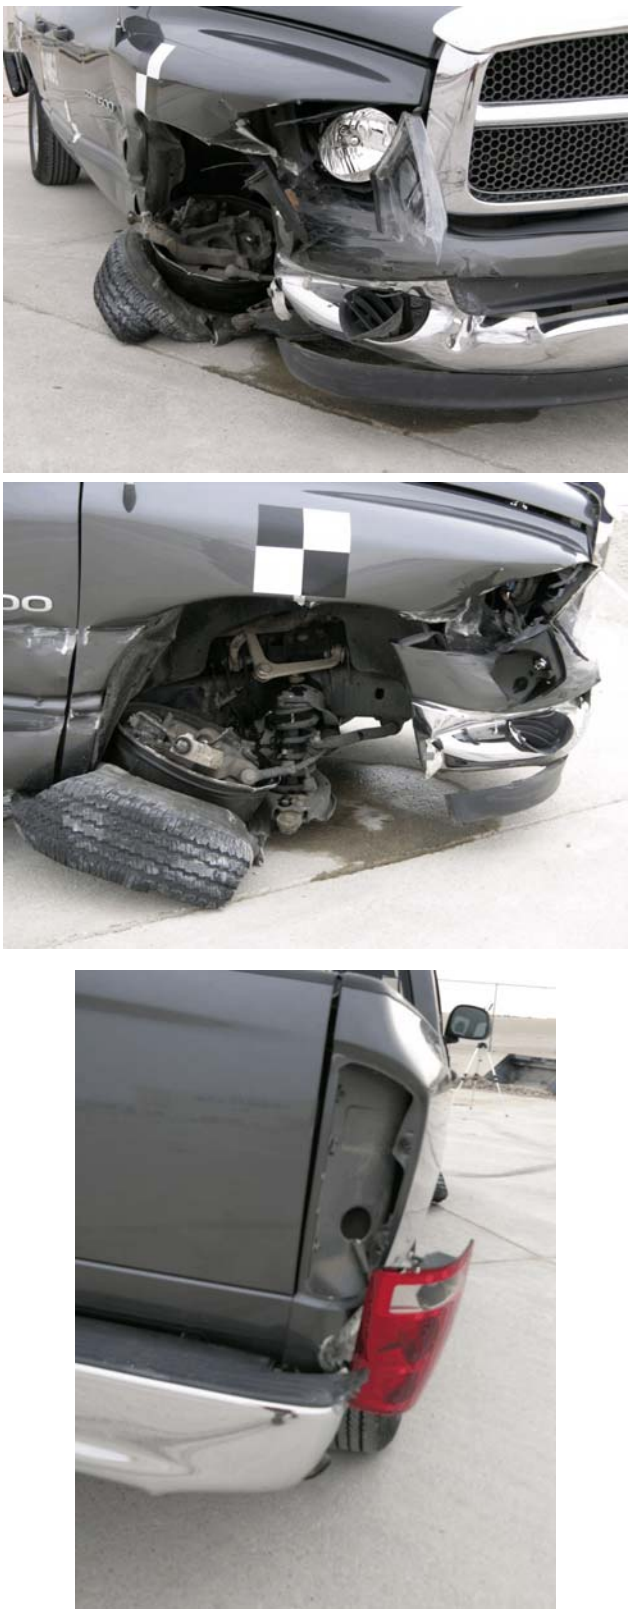
Figure 27. Vehicle Damage, Test 2214MG-2

Exterior vehicle damage was moderate, as shown in Figures 26 and 27. Occupant compartment deformations to the right side and center of the floorboard were judged insufficient to

cause serious injury to the vehicle occupants. Maximum longitudinal deflections of 19 mm (0.75 in.) were located near the center of the right-side floor pan. Maximum lateral deflections of 6 mm (0.25 in.) were located throughout the right-side floor pan. Maximum vertical deflections of 13 mm (0.5 in.) were located near the center of the right side. Complete occupant compartment deformations and the corresponding locations are provided in Appendix C.

Damage was concentrated on the right-front corner of the vehicle. The right-front quarter panel was deformed inward toward the engine compartment. The right side of the front bumper was flattened and bent back toward the engine compartment. A major gouge along the right side of the vehicle spanned from the front wheel well to the rear of the vehicle. A dent was found in the right-side door. The right-side door shifted and the top of it was ajar. The right corner of the rear bumper encountered minor scratches and dents. The right-front wheel assembly deformed and crushed inward toward the engine compartment. The right-side lower and upper ball joints were fractured. The right-side steering linkage remained attached but was bent around the sway bar to lower control arm connection. The upper control arm was bent. Minor dents were found on the right-front steel rim. The right-front tire was deformed under the vehicle. The sidewall of the right-front tire was torn, and the tire deflated. The right-side headlight, park light, and tail light fractured, and the park light disengaged from the vehicle. Minor deformations were found on the grill and plastic bumper. All window glass remained undamaged. The left-side and rear of the vehicle remained undamaged.
