# **Pavement Quality Indicators Study**

## **Five Year Report**

**Construction Management Department  
University of Nebraska  
Lincoln, NE 68588-0500**

**Researcher: Cody Kluver  
Advisor: Wayne Jensen**

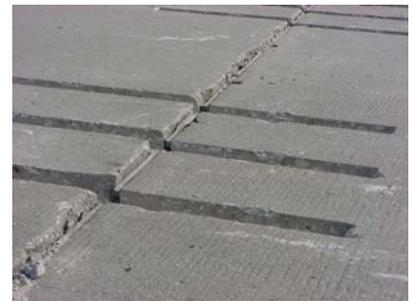
Picture 1.1: Removed pavement for new dowel bars.

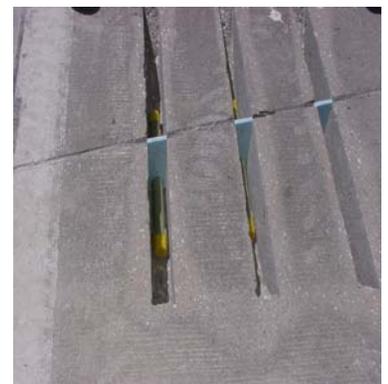
Picture 1.2: Placement of dowel bar chairs, dowel bars, and expansion joint.

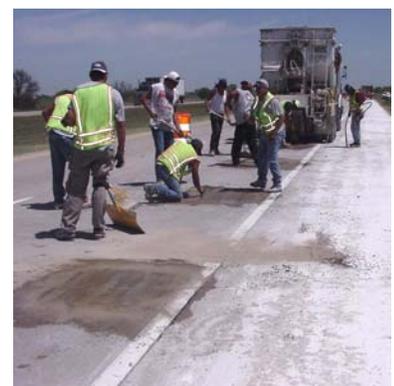
Picture 1.3: Placement of high strength grout.

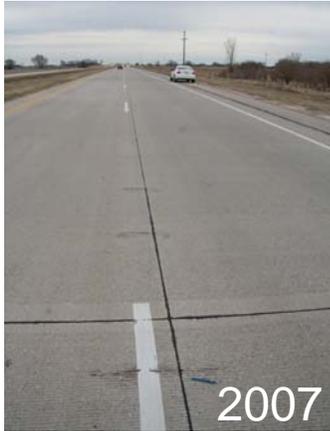
**Location:** MM 168.5

- Placement of tie bars too close to pavement surface across longitudinal joint caused surface cracking shown in photo at left.

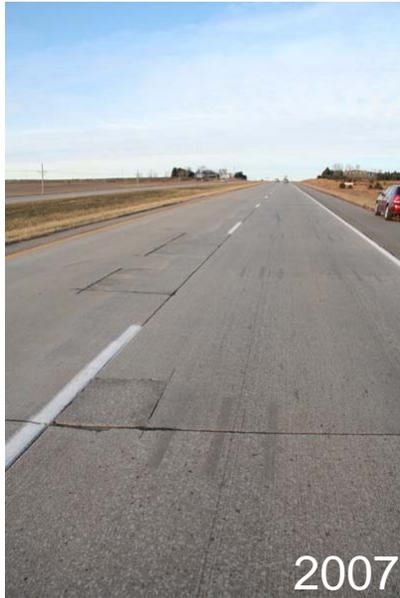
**Location:** MM 268

- Saw cut patches showing disintegration of concrete.
- Grout patches from dowel bar retrofit are also visible.

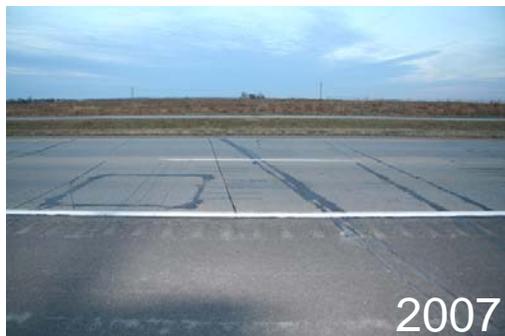
**Location:** MM 253

- Cracks forming where roadway was undermined during utility work.

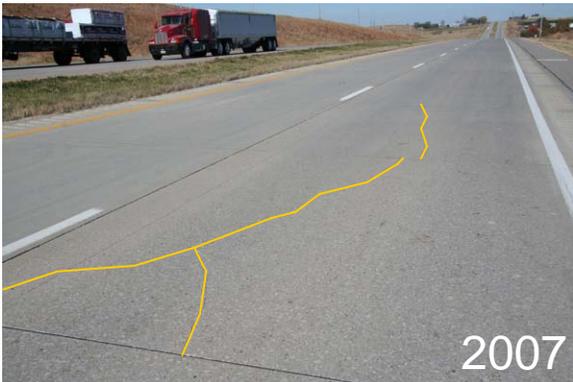
**Location:** MM 43.8

- High slab cracking.
- Concave road surface for three sections.
- Standing water in shoulder joints.

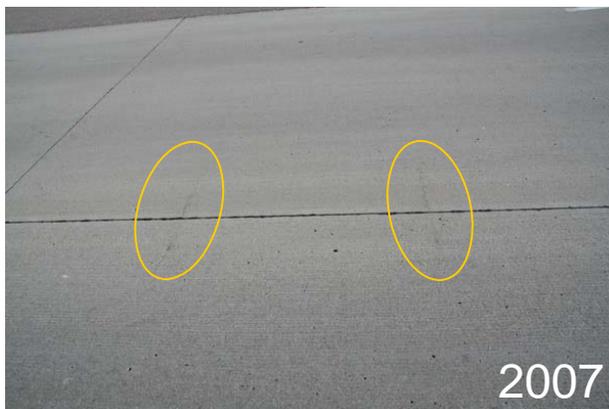
**NEBRASKA CITY INTERCHANGE**

Faulting 6mm or greater.  
Severity of faulting varies with changes in temperature and soil moisture content.  
Image from 2005 shows more severe level of faulting.

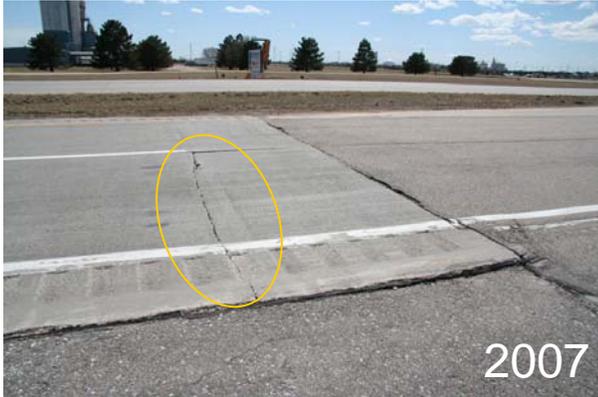
**Location:** MM 384.35

- Transverse cracking near the end of the study section.
- Faulting greater than 3 mm.

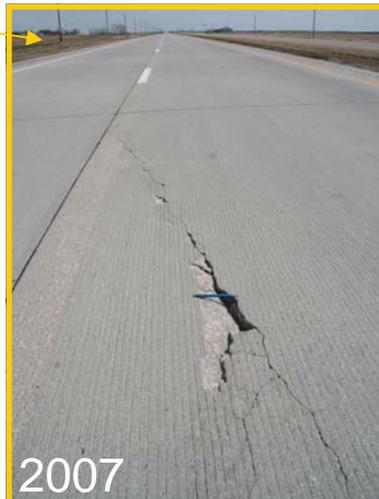
**Location:** MM 190.8

- Longitudinal cracking.
- Extends three panels i(~50 feet) in length.
- Longitudinal cracking is not typical of this section.

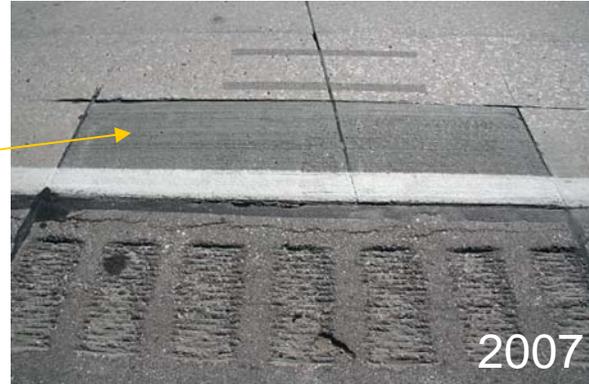
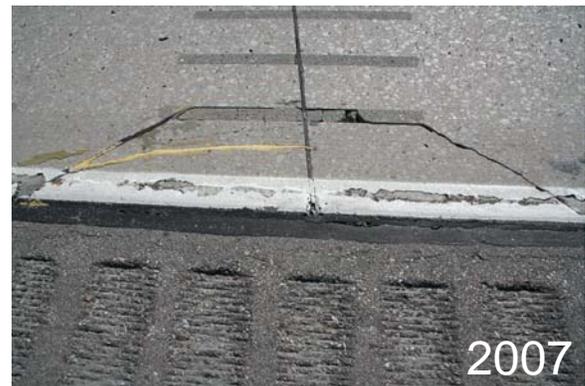
**Location:** MM 115.9

This graph shows how Columbus NW section reacted to a dowel bar retrofit in year seven. Since the retrofit, there has been a significant decrease in the Nebraska Serviceability Index (NSI). This decrease is caused by placing the retrofitted dowel bars too close to the shoulders, thereby causing cracking of pavement along the shoulders. This problem is visible in the pictures of the Columbus NW section.

- Cracking along shoulder where dowel bars were retrofitted is common throughout the study section.
- Euroteck foam was used to prevent additional settling and to raise cracked panels.
- Retrofitted dowel bars placed too close to edge of pavement caused the cracking.
- Retrofitted dowel bars are now placed 6” closer to the centerline to prevent cracking of this type.

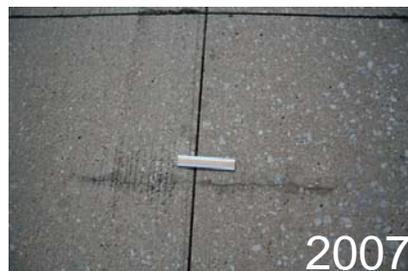
- Surface cracking extending through 11 to 12 panels along longitudinal joint.
- 2'8" cracks above tie bars across longitudinal joints.

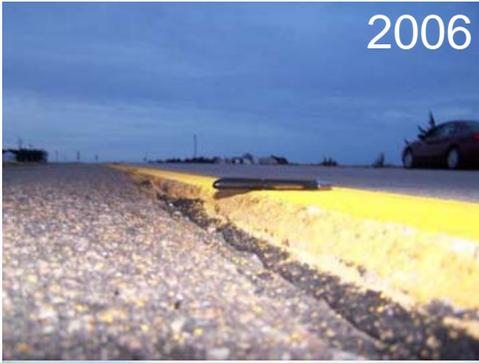
**Location:** MM 17

- Shoulder drop off.

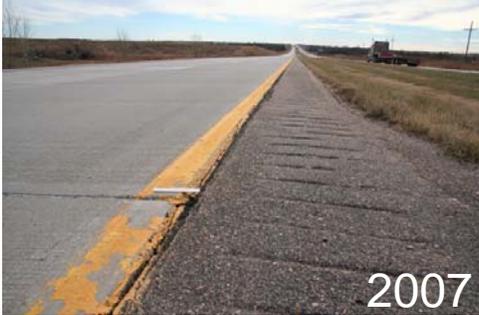
- Magnitude of drop off has not increased from previous years.

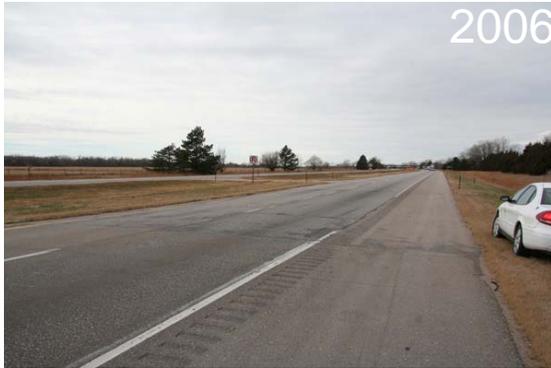
**Location:** MM 290.96

- Surface distress near end of study section.
- Longitudinal and transverse cracking.

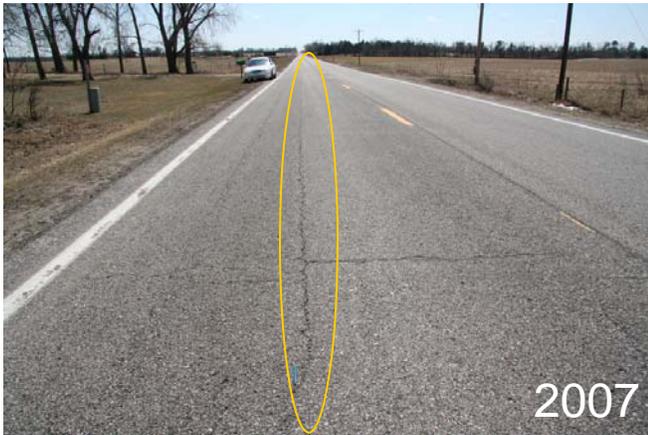
**Location:** MM 171.3

- Longitudinal crack ~ 100' in length.

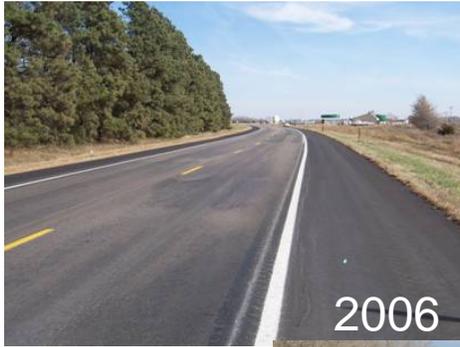
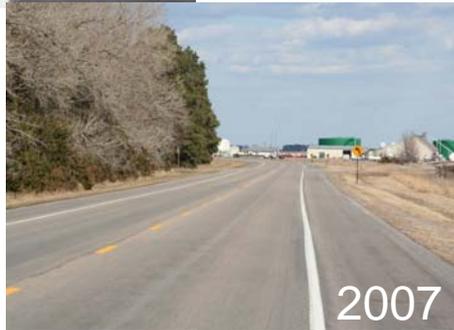
**Location:** MM 341.9

- Pavement rehabilitation in 2006.
- Some surface wear was already visible in 2007.

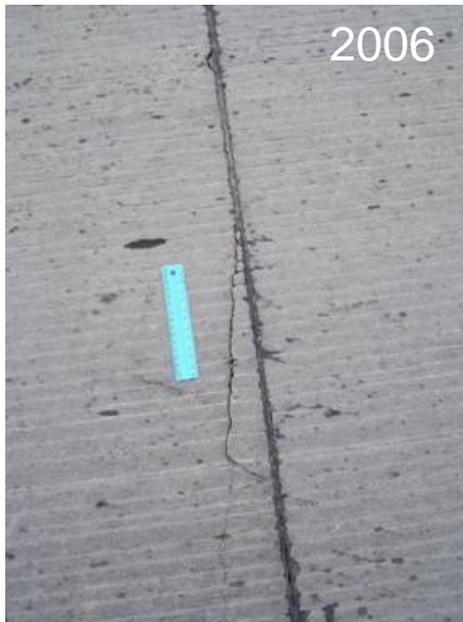
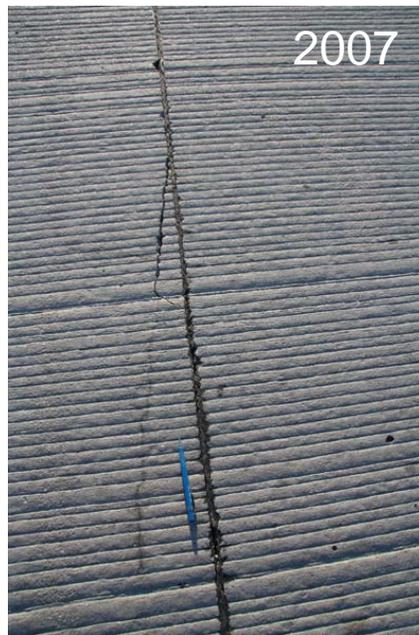
**Location:** MM 293.9

- 1.5' diagonal slab cracking.
- Between 2006 and 2007 hairline cracks advanced about six inches.

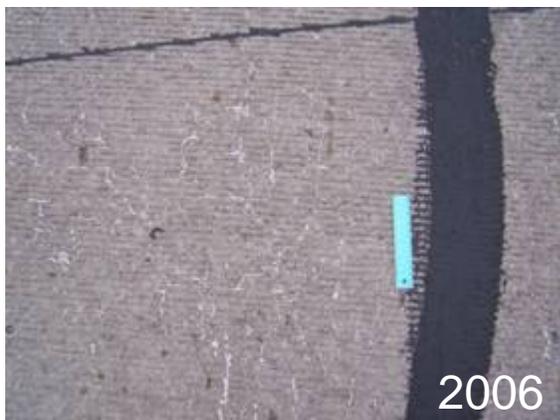
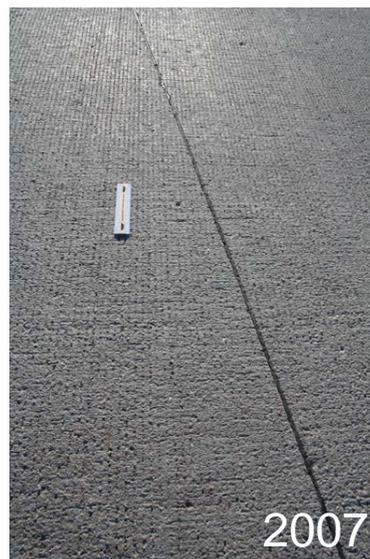
- High severity longitudinal cracking.
- Low pavement wear in wheel paths.
- ASR cracking at joints and cracks was less visible in 2007 than in 2006.

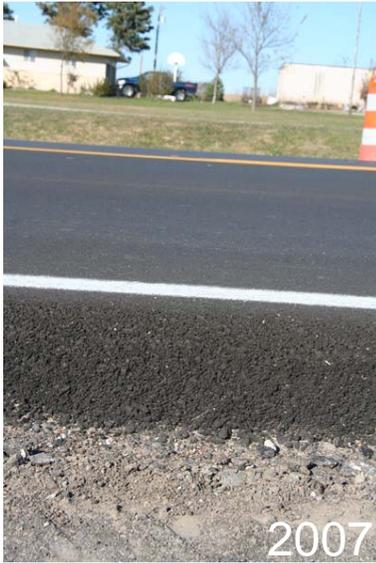
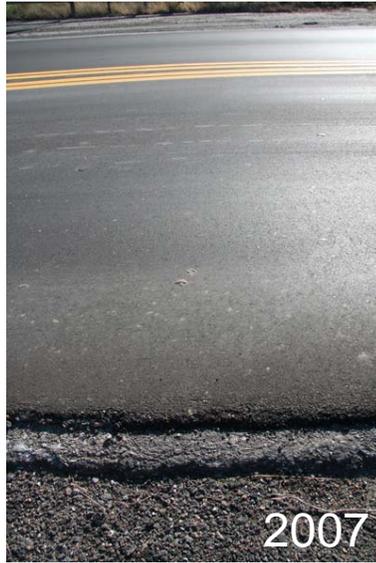
### Plattsmouth West

- Contractor was finishing construction during site visit in fall of 2007.
- Pictures show highway approaching a cable guard rail location.

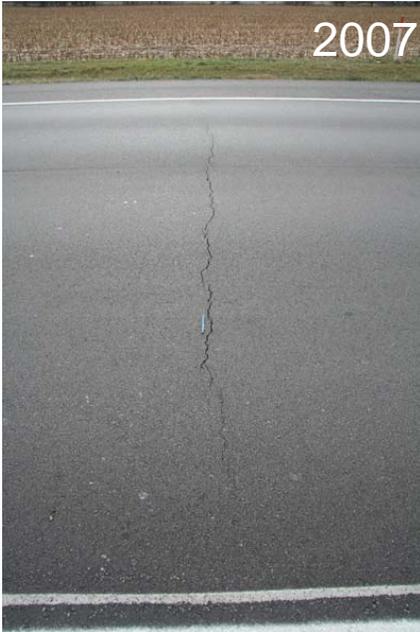
**Location:** MM 442 +20

- Thin transverse cracking.
- Roadway appears in excellent condition, but it is possible to see thin transverse cracks when walking the section.
- Cracking is surprising because this section is less than one year old.
