**Report SPR-P1 (09) P320**

# **Inspector's Manual for Mechanically Stabilized Earth Walls**

Nebraska Department of Roads

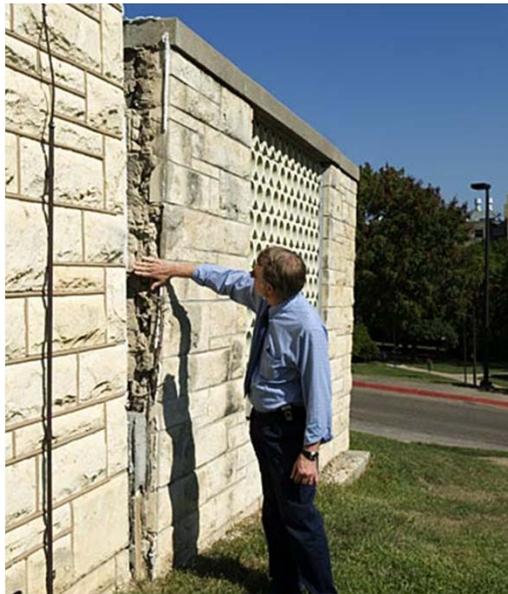
# Wall Tilting

A panel wall showing a positive tilt.

Inclination of the wall face from vertical or from its original inclination.

- ❖0– A section of or the entire wall has failed due to tilting.
- ❖1 – A section of or the entire wall is inclined to the extent that separation of panels is beginning to occur in the wall face.
- ❖3 – A section of or the entire wall is inclined outward at  $10^\circ$  (2 inches Horizontal: 12 inches Vertical) to  $15^\circ$  (3 inches Horizontal: 12 inches Vertical).
- ❖5 – A section of or the entire wall is inclined outward at  $5^\circ$  (1 inch Horizontal: 12 inches Vertical) to  $10^\circ$  (2 inches Horizontal: 12 inches Vertical).
- ❖7 – A section of or the entire wall is inclined outward at  $0^\circ$ - $5^\circ$  (1 inch Horizontal: 12 inches Vertical).
- ❖9 – There is no change in wall inclination from construction specifications.

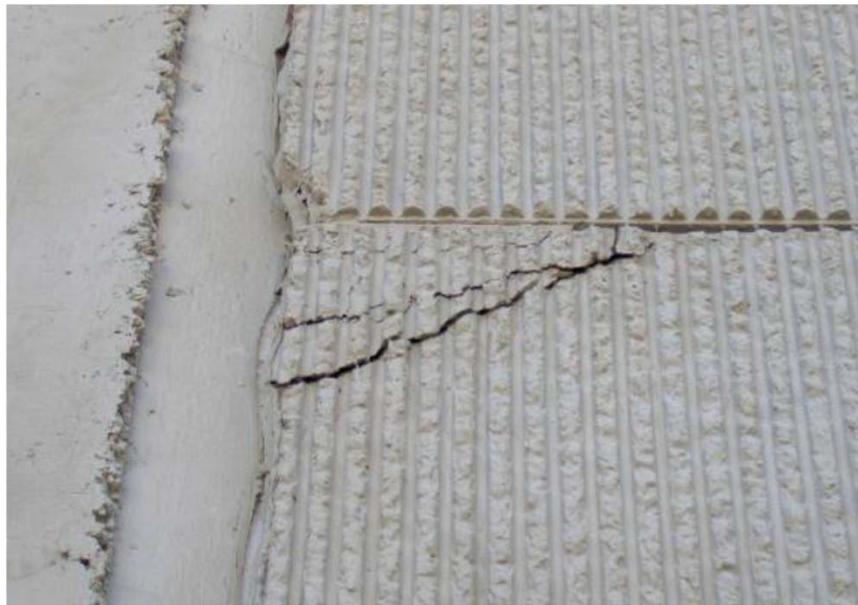
# Structural Cracking

Separation of the corner of a precast panel as a result of structural cracking.

Structural cracking is characterized by a separation which penetrates through the entire depth of the wall face. A crack which does not extend through the entire thickness of the wall face should be characterized as facial deterioration.

- ❖0 - More than 50% of wall area shows structural cracking.
- ❖1 - Between 33 - 50% of wall area shows structural cracking.
- ❖3 – Between 20 - 33% of wall area shows structural cracking.
- ❖5 – Between 10- 20% of wall area shows structural cracking.
- ❖7 - Less than 10% of wall area shows structural cracking.
- ❖9 - None or only an insignificantly small wall area shows structural cracking.

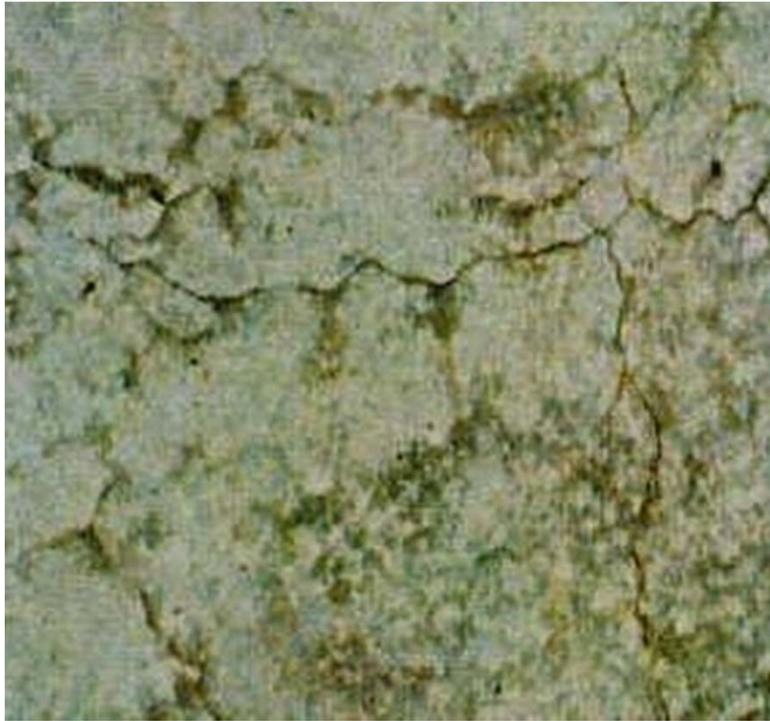
# Facial Deterioration

Nonstructural cracking with discoloration is documented as facial deterioration.

Impairment of the quality, appearance or function of a wall face. Facial deterioration can be characterized by spalling, nonstructural cracking, deterioration of facing materials, discoloration or other phenomena. Cracks which do not extend through the total depth of the wall face should also be characterized as facial deterioration.

- ❖0 - More than 50% of the wall area shows facial deterioration.
- ❖3 – Between 50% and 25% of the wall area shows deterioration.
- ❖6 – Less than 25% of the wall area shows deterioration.
- ❖9 - None or only an insignificantly small area of the wall shows facial deterioration.

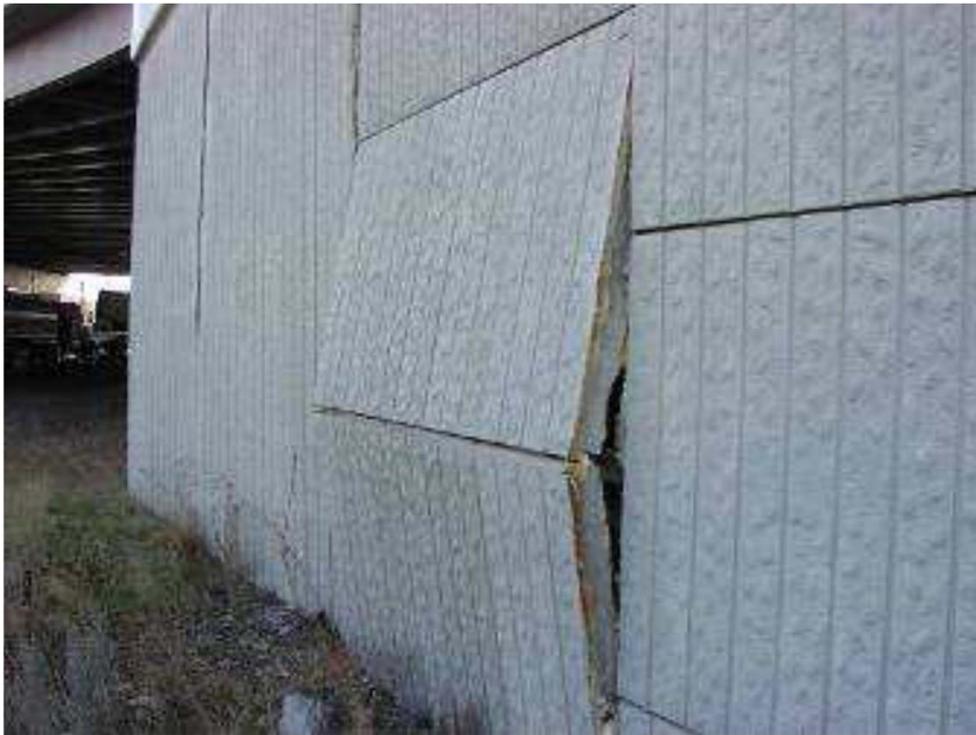
# Bowing of the Wall

Bowing caused by failure of reinforcement connections.

An outward bend or curve in the horizontal or vertical direction (or both) along a wall face. Bowing results from embedment pullout or broken connections between reinforcement and facing materials on adjacent panels.

- ❖0 – Wall panels have bowed outward to the point where backfill loss is actively occurring through joints.
- ❖3 – Wall panels have bowed outward to the point where filter fabric is visible at the joints; connectors between adjacent panels have broken.
- ❖5 – Wall panels have bowed outward to where connectors between adjacent panels are visible and being deformed.
- ❖7 – Wall panels have bowed outward to the point where bowing is visible standing directly in front of the wall.
- ❖9 – No indication of bowing on the wall face.

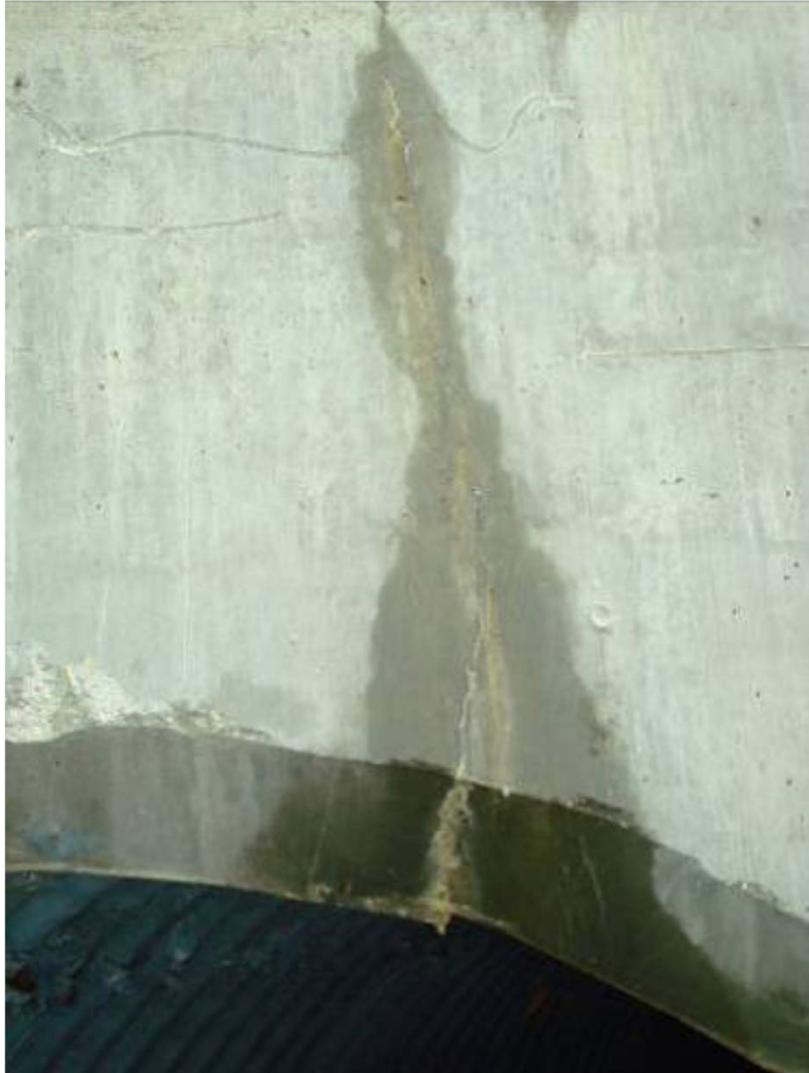
# Panel Staining

Discoloration of a wall face due to water moving through cracks.

A discoloration or change in the appearance of the surface of one or more panels or blocks. Staining is caused by water containing minerals moving through wall joints or cracks.

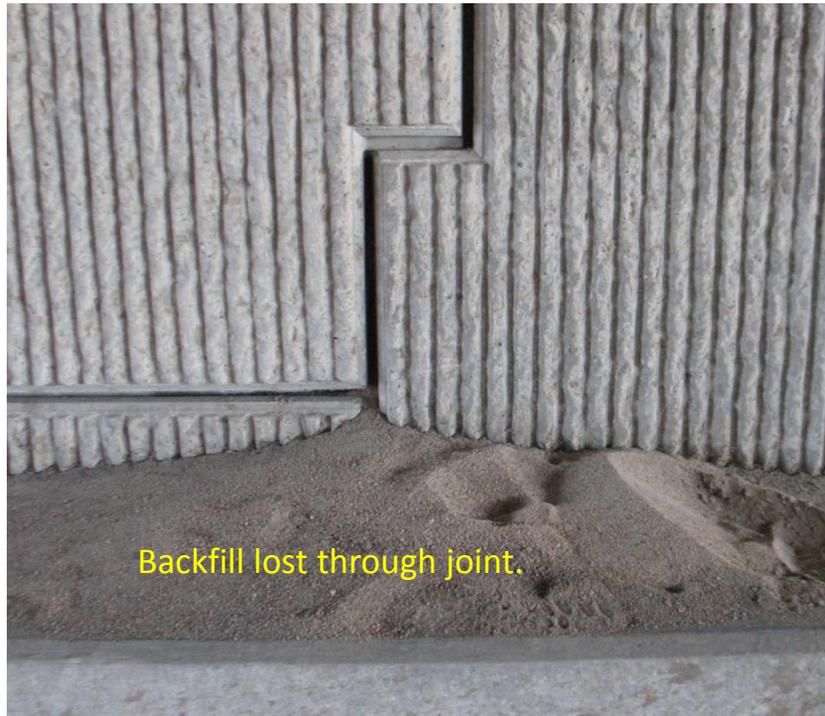
# Loss of Backfill

The material shown above is select backfill which has moved from behind the wall, through panel joints, to accumulate in front of the wall.

Backfill moving from its original location down the wall's back slope or outward through wall joints.

- ❖0 - Backfill loss has resulted in significant settlement of the v-ditch or roadway or has affected wall inclination or alignment.
- ❖3 – Significant areas/quantities of backfill loss are visible.
- ❖6 – Backfill loss is occurring, but only minor areas/quantities of backfill loss are visible.
- ❖9 - No visible evidence of backfill loss.

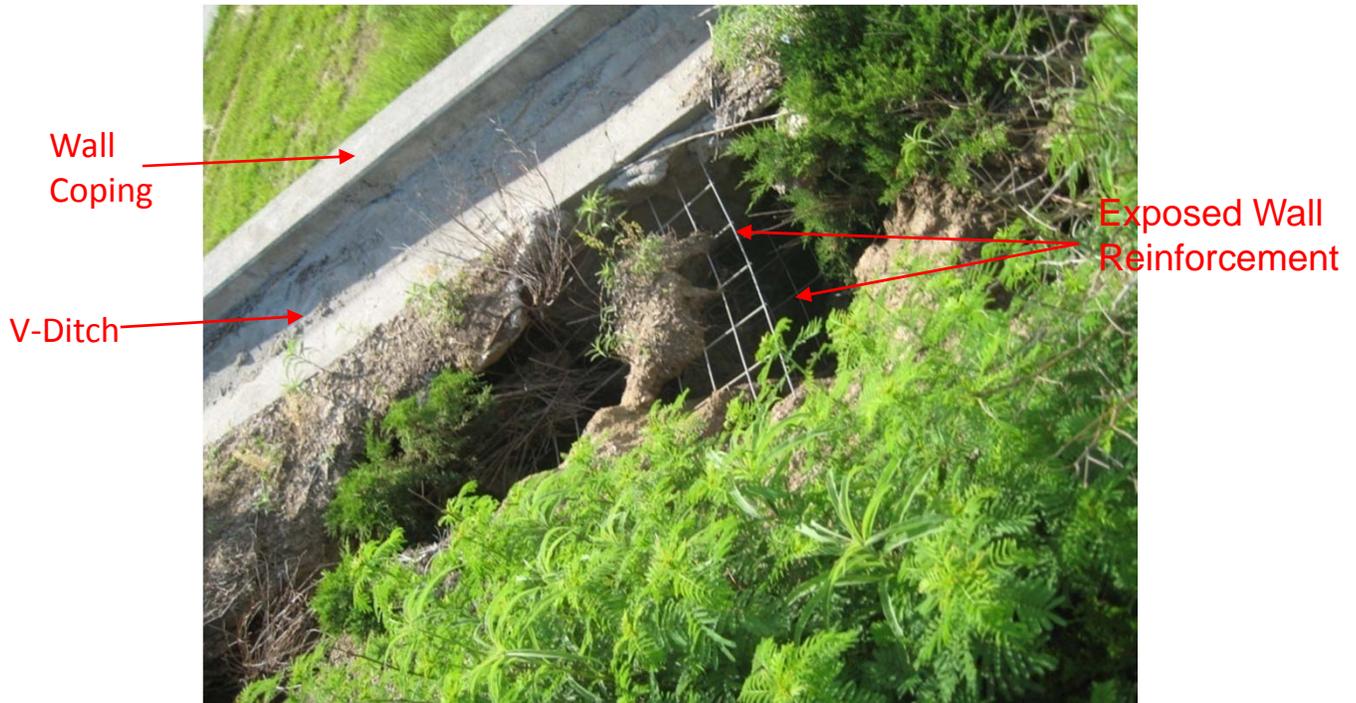
# Erosion- Back of Wall

Washout (showing wall reinforcement exposed).

Loss of backfill material through erosion behind the wall face. Severe erosion of backfill is indicated by significant washouts and exposure of wall reinforcement.

- ❖0 - Wall reinforcement is visible in several locations.
- ❖3 - Wall reinforcement is being exposed at two or more locations.
- ❖5 - Effects of erosion are visible but no wall reinforcement has been exposed.
- ❖7 - Minor effects of erosion are visible; plant roots may be exposed or higher original soil levels on concrete structures may be indicative of erosion.
- ❖9 - There is no visual evidence that erosion is occurring behind the wall.

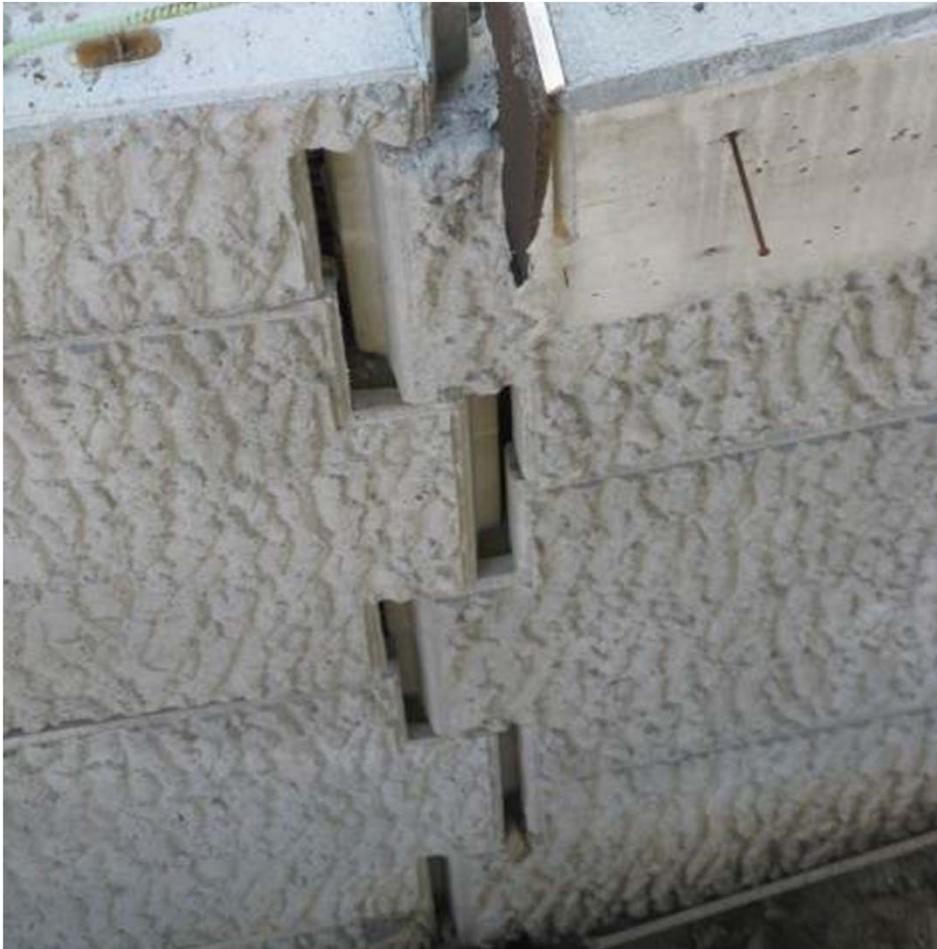
# Joint Spacing

Two adjacent sections of this wall are bowing outward, causing excessive joint spacing between two adjacent panels.

Even spacing between panels or blocks is desirable for wall function and for esthetic considerations. Vertical and horizontal joints should be consistent and of uniform size across the entire wall face.

- ❖ NA – Wall is not a panel wall; wall has no joints.
- ❖ 0 – Joint width appears almost totally irregular and random.
- ❖ 3 - Joint width varies widely across the wall face.
- ❖ 5 - Joint width appears marginally regular, but considerable variation exists in different areas or at different heights along the wall.
- ❖ 7 – Joint width appears generally uniform with the exception of some discrepancies in localized areas.
- ❖ 9 - Joint width appears generally uniform across the entire wall.

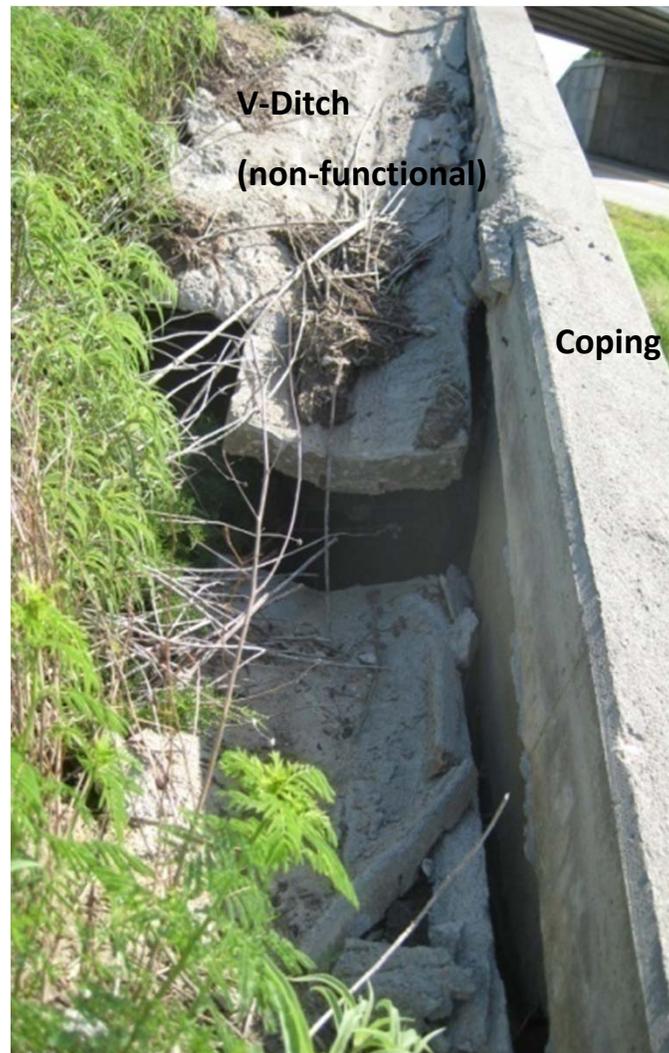
# Condition of V-Ditch

Loss of backfill has caused a complete break along the V-Ditch as well as its separation from the wall.

The V-Ditch is a continuous structure that intercepts runoff and transports it away from the wall. Where the V-Ditch has failed, runoff may cascade downward over the wall's face or drain downward through the wall along its back face.

- ❖ NA – The wall has no V-Ditch.
- ❖ 0 - The V-Ditch is nonfunctional due to backfill movement, cracking, etc.
- ❖ 3 - The V-Ditch has separated from the wall face; extensive cracking or breakup of the V-Ditch has rendered it almost nonfunctional.
- ❖ 5 - The V-Ditch is still attached to wall, but large cracks are developing in the V-ditch at several locations. The V-Ditch can transport less water than intended.
- ❖ 7 - The V-Ditch is still attached to the wall, but minor cracks are developing; ability of V-Ditch to transport water has not been affected.
- ❖ 9 - No cracks in the V-Ditch; no separation of the V-Ditch from the wall. The V-Ditch is functioning as intended.

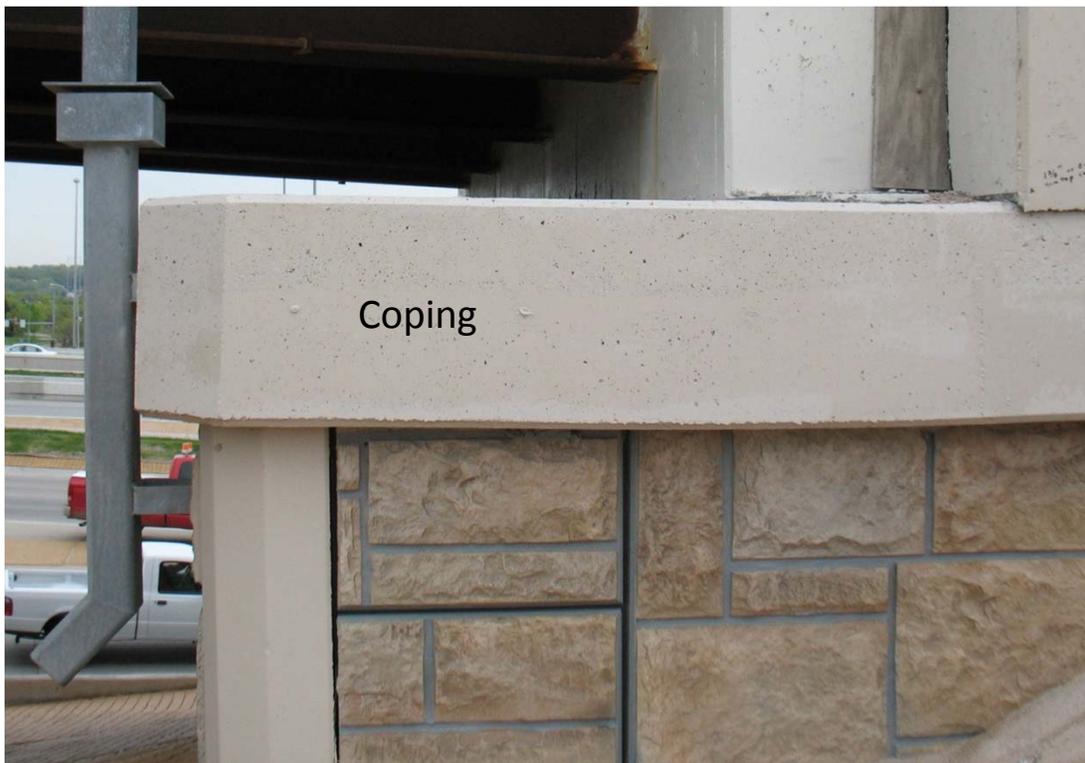
# Coping Deterioration

The coping covering the top of this wall is in excellent condition.

Coping is the cap (often concrete) that covers the top panels along a wall face. Coping should not be confused with railing, which serves as a safety mechanism for vehicles.

- ❖ NA – This wall has no coping.
- ❖ 0 - More than 25% of the coping shows signs of severe cracking, has become detached or is spalling.
- ❖ 5 – Less than 25% of the coping shows signs of severe cracking, has become detached or is spalling.
- ❖ 9 – There are no signs of coping deterioration.

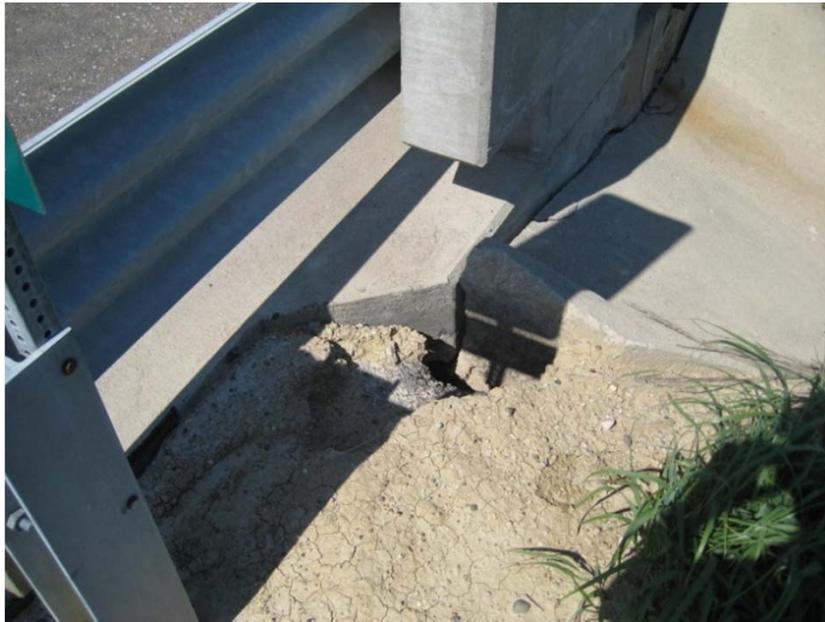
# Drainage Runoff

Improper drainage runoff from the roadway caused undermining of this road and displacement of the flume.

Drainage pathways should move runoff from the upper road surface away from the wall without adversely affecting the wall function or traffic movement. Indicators of problems include and are not limited to: misalignment or tilting of guardrails, erosion beneath guardrails or erosion along the sides of the road in either direction.

- ❖ NA- No structure above wall to cause drainage runoff.
- ❖ 0 - Erosion runoff is actively moving significant quantities of backfill material from its original location.
- ❖ 3 - Indications of erosion runoff are present; quantity of backfill material being moved appears significant.
- ❖ 6 - Indications of erosion runoff are present but there is no indication that the quantity of backfill material being moved is significant.
- ❖ 9 - No signs of erosion due to drainage runoff.

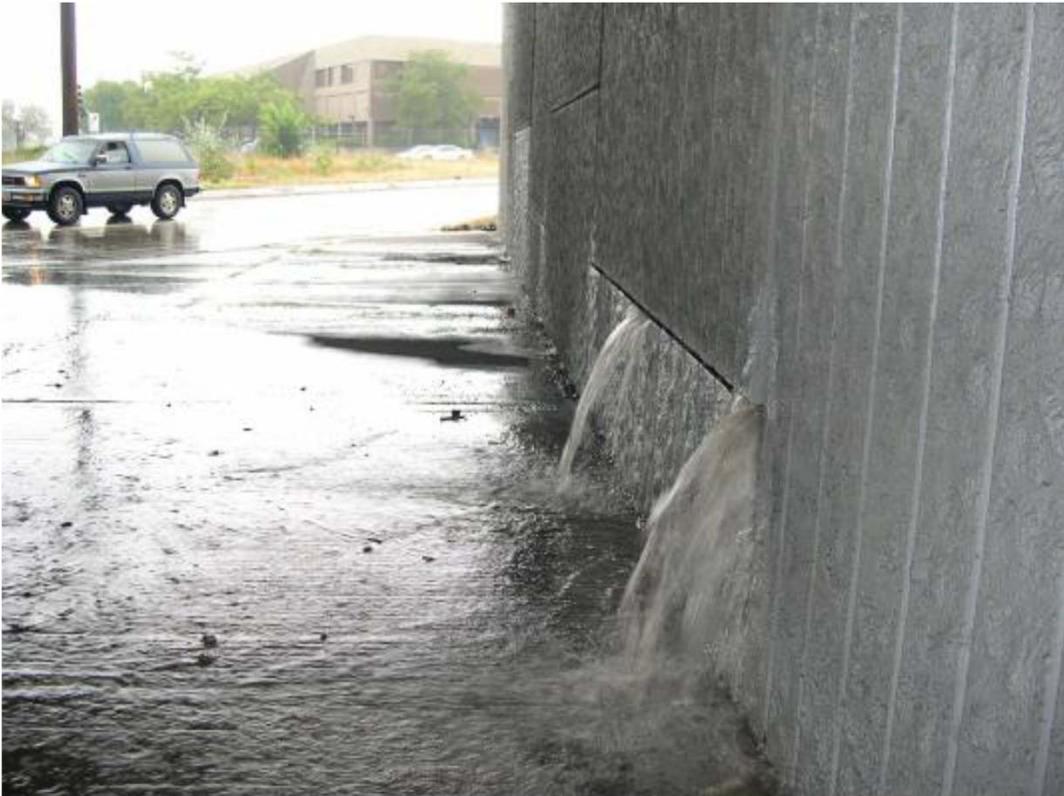
# Drainage at the Front of the Wall

Problematic drainage is causing ponding at the front of this wall.

- ❖ 0 – Signs of water ponding consistently in front of the wall (Cattails growing, stain lines left from standing water on the wall, etc.).
- ❖ 5 – Water ponds in front of the wall infrequently or only during periods of intense precipitation.
- ❖ 9 - Front of the wall is well drained; no ponding occurs.
