**EFFECTIVENESS OF AVIAN COLLISION AVERTERS IN PREVENTING
MIGRATORY BIRD MORTALITY FROM POWERLINE STRIKES IN THE
CENTRAL PLATTE RIVER, NEBRASKA**

2008 - 2009 Final Report

30 September 2009

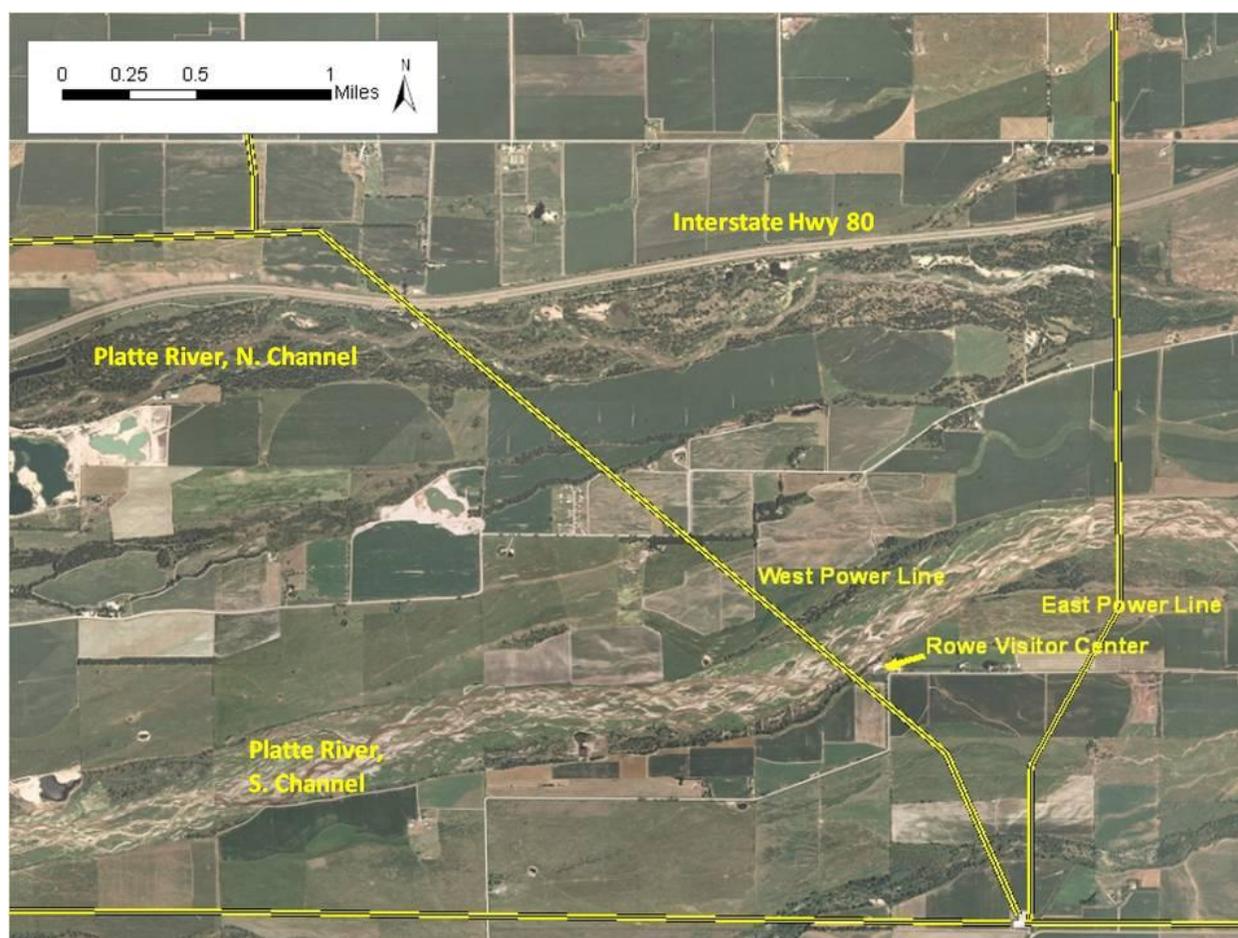
Two 69-kV powerlines cross the Platte River at the National Audubon Society's Lillian Rowe Sanctuary in Buffalo County, south central Nebraska. During spring 2008 and 2009, over-river spans of each were the focus of intensive study of powerline collisions by sandhill cranes that roost on the river. The area also is used by whooping cranes.

Two 69-kV powerline arrays stretch across the Platte River within the sanctuary, one about 0.1 km (about 100 yards) west of Rowe’s visitor center and the other about 1.8 km (about 1.1 miles) east. Each array has two nonelectrified “static” wires suspended about 15 m (50 feet) above the ground and three transmission “conductor” wires about 5 m (17 feet) below these, all supported by wood, H-frame pole structures (powerlines of 69 kV or greater commonly are called transmission lines, while smaller arrays commonly are called distribution lines). The western powerline includes a support structure amid the river channel. The eastern powerline has a support structure on either river bank, but none in the river channel. Bank-to-bank spans of the western and eastern powerlines are 301 m (about 1000 feet) and 283 m (about 935 feet), respectively.

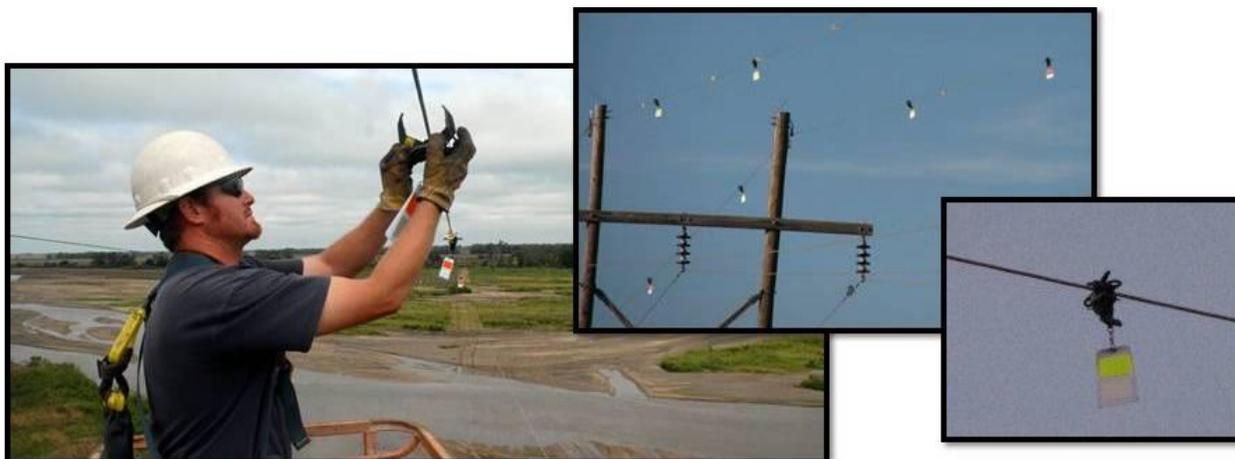
During spring 2008 and 2009, static wires of both powerlines at Rowe were marked with “FireFly” devices (FireFly Diverters LLC, Grantsville, Utah) in an attempt to make powerlines more conspicuous to birds and thus reduce collisions by birds with the wires.

The over-river span of each powerline was equipped with a spinning model of the FireFly on its static wires in September 2007. The FireFly’s main component is an acrylic plastic tag that measures 9 x 15 cm (3.5 x 6 inches), is 3 mm (0.13 inches) thick, and is covered with yellow and orange reflective tape and photo-reactive coatings that luminesce up to 8 to 10 hours after sunset. FireFlies were attached at 12-m (40-foot) intervals on each static wire by means of

spring-loaded clamps. Attachment points alternated between wires such that a FireFly occurred on one or the other line every 6 m (20 feet). FireFlies were suspended by swivels so they would spin in any wind. By winter 2009, about one-third of the FireFlies broke, typically at the swivel, and fell from the powerlines; these were replaced by a non-spinning model just before migrant cranes began to arrive in the area in February 2009.

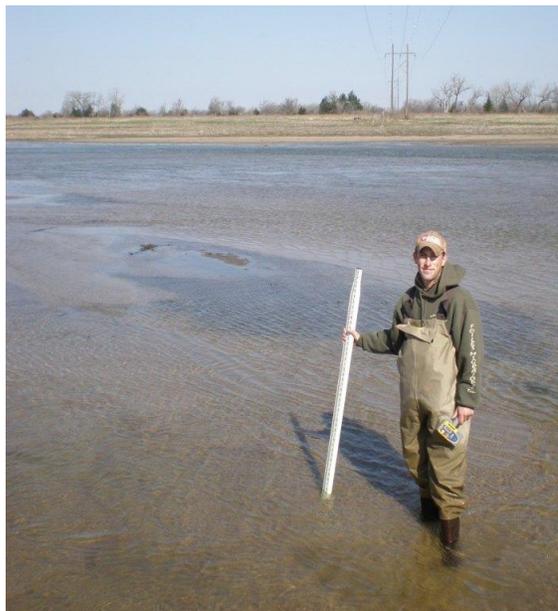
Some crane carcasses likely were swept downstream, away from powerlines, before being detected by investigators. Following methods in a recent study at Rowe (Wright et al. 2009), this potential bias was estimated by measuring the proportion of the river channel with water deep enough for carcasses to float, both at maximum and minimum flows for the season.

To estimate the number of carcasses swept downstream prior to detection, we calculated the proportion of the width of the channel at each powerline array covered by deep water, i.e., the mean depth needed to float complete carcasses of sandhill cranes downstream (12.5 cm [5 inches]; Wright et al. 2009). We used a laser level and a GPS to determine widths of channel segments that equaled or exceeded this depth at the highest and lowest flow levels observed during our survey period. We multiplied the inverse of the proportion of channel covered by deep water by the number of estimated mortalities corrected for both carcass detection rates and scavenger removal rates (Wright et al. 2009; see Table 1 in RESULTS, page 12). We used measurements from 2008 for both years because maximum and minimum widths of deep water were similar.

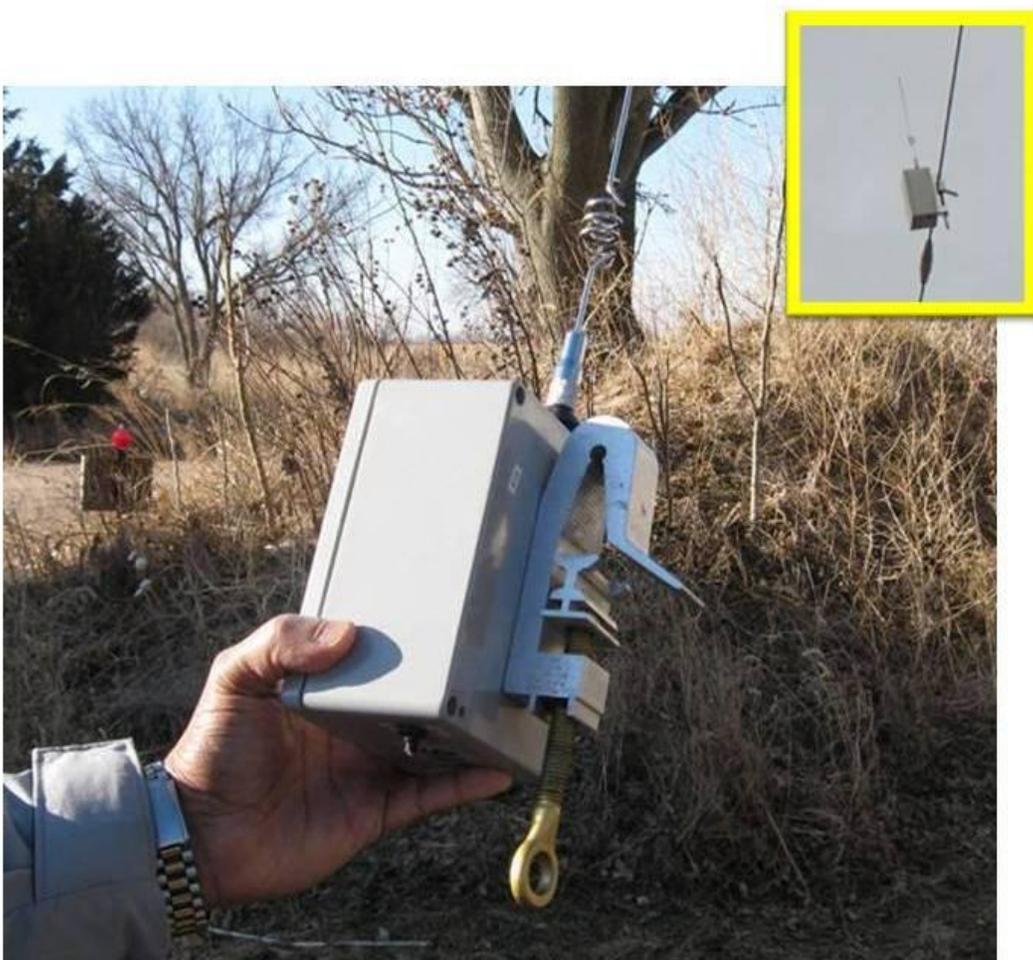
Bird Strike Indicators (EDM International, Inc., Ft. Collins, Colorado) were mounted on wires of the eastern powerline at Rowe during spring 2009 to record collisions by birds especially during hours when the powerline was not being directly observed.

Bird strike indicators (BSIs; EDM International, Fort Collins, Colorado) were attached to wires of the eastern powerline at Rowe in 2009. A relatively new technology, the BSI is an impulse-based, vibration sensing tool that, when mounted on a powerline wire, records bird collisions as unique signatures. A BSI was attached to each static and each transmission wire, roughly: 1) 90-95 m north, 2) 180-185 m north, and 3) 90 m south of the H-frame support

structure on the south bank of the river. Thus, a total of 15 BSIs were used. BSIs were distributed at intervals of about one-third of the powerline span to maximize their sensitivity to vibrations caused by bird collisions. Records of collisions were transmitted to a computer base station at Rowe headquarters. To validate BSI records of collisions, we compared the timing and total number of collisions of birds that we observed directly to those recorded by BSIs during each evening observation period. We used correlation to assess the strength of the relationship between the two sources of data then used BSI records to explore the incidence of collisions by birds during each 24-hour diel period.

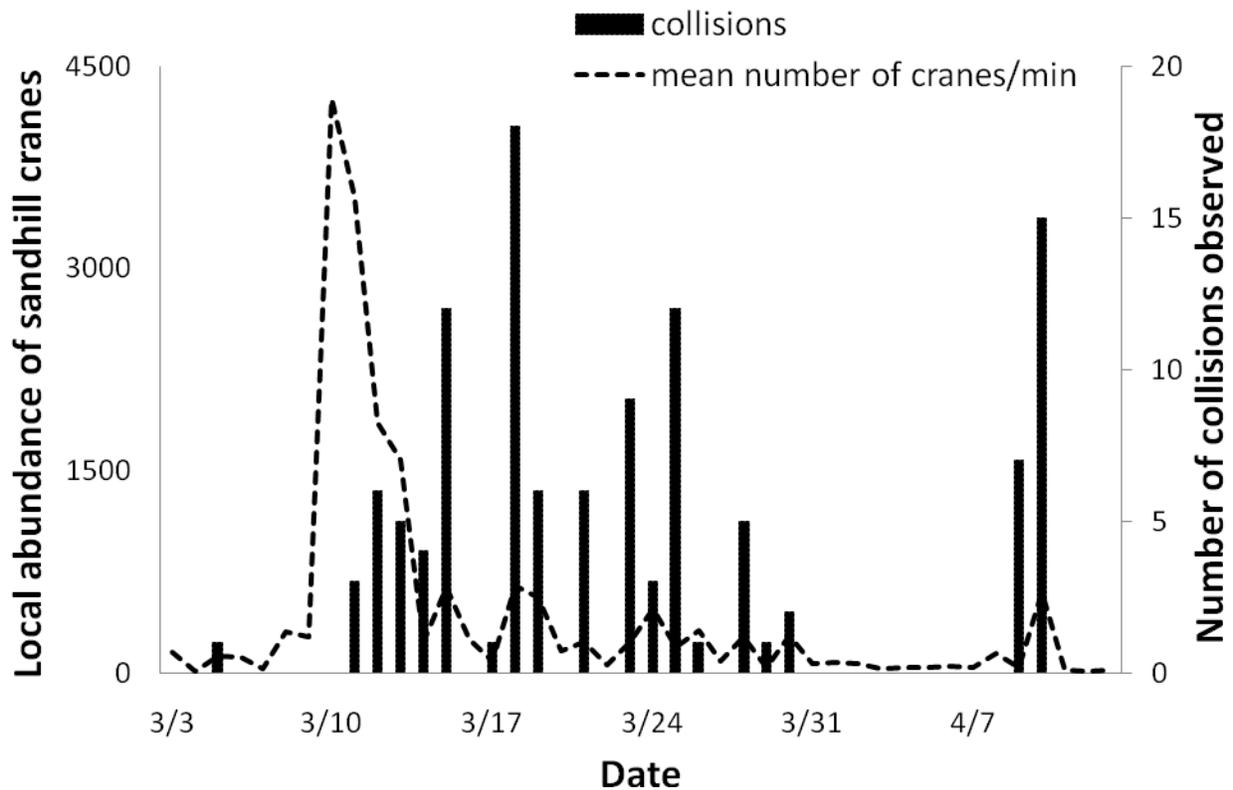
Figure 1. Relationship between the observed number of collisions by sandhill cranes with the eastern powerline over the Platte River at Rowe Sanctuary in Buffalo County, Nebraska, and local abundance of cranes defined as the mean number observed flying past the powerline per minute during evenings (i.e., about 0.5 hours before sunset until 2 hours after sunset), 3 March to 13 April 2009. Data were based on 30-second counts every 5 minutes.

At the peak of staging by sandhill cranes in the area in mid-March, we typically observed an average of about 500 cranes/minute pass through the over-river span of the eastern powerline (2009 data, Fig. 1). However, we detected no relationship between local abundance of cranes and number of collisions by cranes through spring ($r = 0.13$, $P = 0.41$). After a week of almost no collisions at the end of each migration season in April, we noted an abrupt increase in collisions (e.g., 9 to 10 April 2009, in Fig. 1).

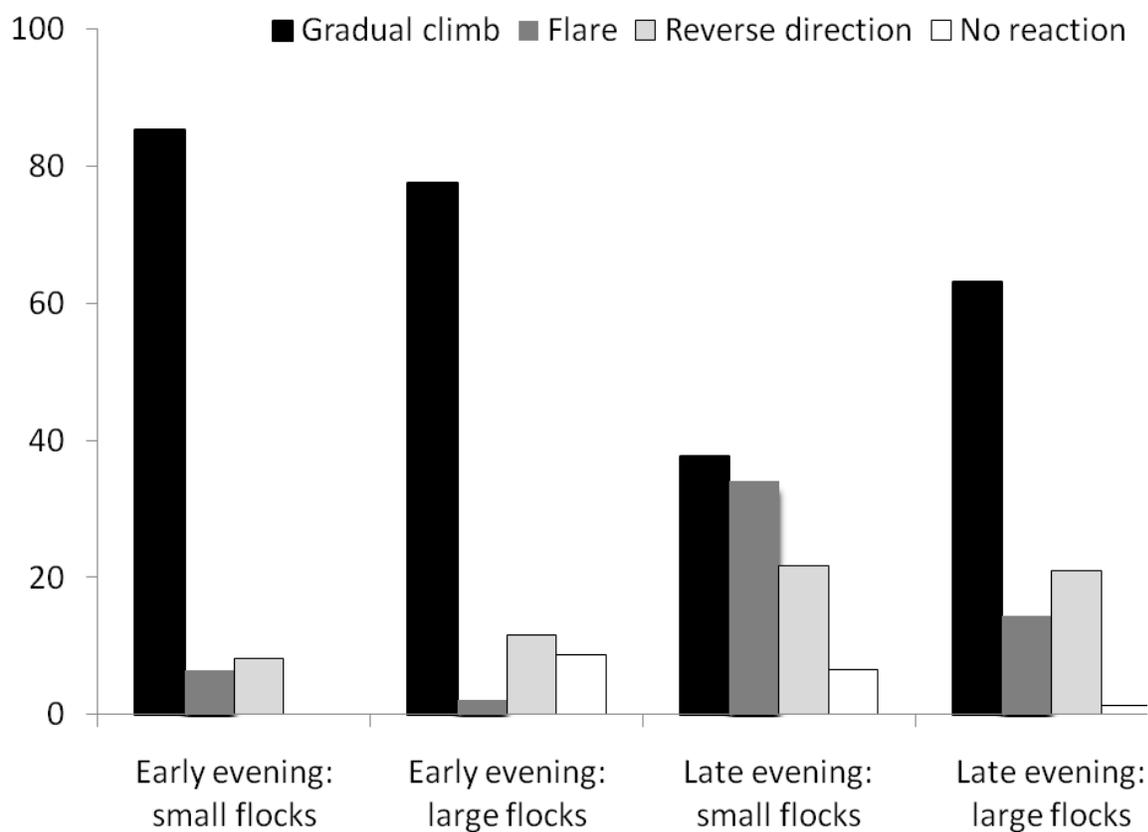
Figure 2. Behavioral reactions of flighted sandhill cranes to a 69-kV powerline over a night roosting area for the cranes on the Platte River at Audubon’s Lillian Rowe Sanctuary in south central Nebraska, as determined by direct observation, 3 March to 13 April 2009. Small flocks included one to three individuals and large flocks included more than three individuals. The first flock in each 5-minute interval was included in the sample. Numbers of reaction observations are in parentheses. Data were collected from about 0.5 hours before sunset until 2 hours after sunset; early evening was up to 45 minutes after sunset and late evening was more than 45 minutes after sunset. Flare was defined as a sudden increase in altitude as cranes flapped quickly to rise above the powerline.

We recorded 474 reactions of sandhill crane flocks to the eastern powerline at Rowe in 2009. The proportion of reaction types differed with time (early versus late evening, flock sizes combined: $X^2 = 70.9$, 3 df, $P < 0.001$). During early evening, cranes typically avoided the powerline by climbing gradually as they approached (Fig. 2). In late evening, however, cranes were less likely to climb gradually. This was especially true for small flocks, which in late evening were almost equally likely to flare or reverse direction as they were to climb gradually. Cranes that did not react (7.8% of large flocks during day, 6.4% of small flocks during late evening) generally were in flocks that passed 5-10 m above the static wires, although during late evening, some small flocks passed between static and transmission wires or beneath transmission wires without appearing to react to the wires.

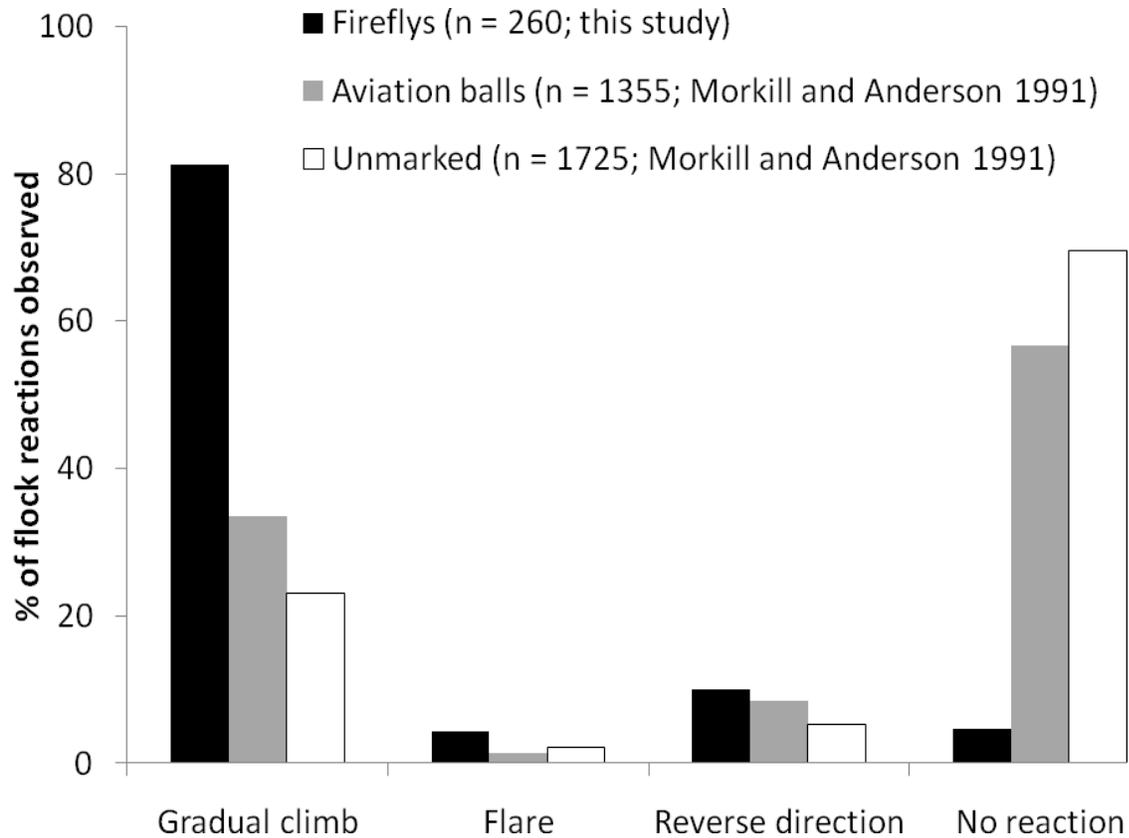
Figure 3. Behavioral responses of flighted sandhill cranes to a 69-kV powerline marked with Firefly avian flight diverters over the Platte River in south-central Nebraska during spring 2009, and of reactions of sandhill cranes to unmarked powerline spans and powerline spans marked with 30-cm diameter aviation marker balls over croplands in south-central Nebraska during spring 1988-1990, based on data in Morkill and Anderson (1991). Sample sizes (i.e., number of flock reactions observed) are in parentheses.

Sandhill cranes we observed reacted more often to the powerline marked with FireFlies and did so more by gradually climbing as they approached, compared to reactions of cranes to powerlines marked with yellow aviation balls or to unmarked powerlines in Morkill and Anderson (1991; $X^2 = 230$ and 384 ; both, $df = 3$, $P < 0.001$; Fig. 3). Last, the cranes we observed reacted sooner to the powerline with FireFlies than they did to powerlines with aviation balls or to unmarked powerlines ($X^2 = 230$ and 384 ; both, $df = 3$, $P < 0.001$; Fig. 4).

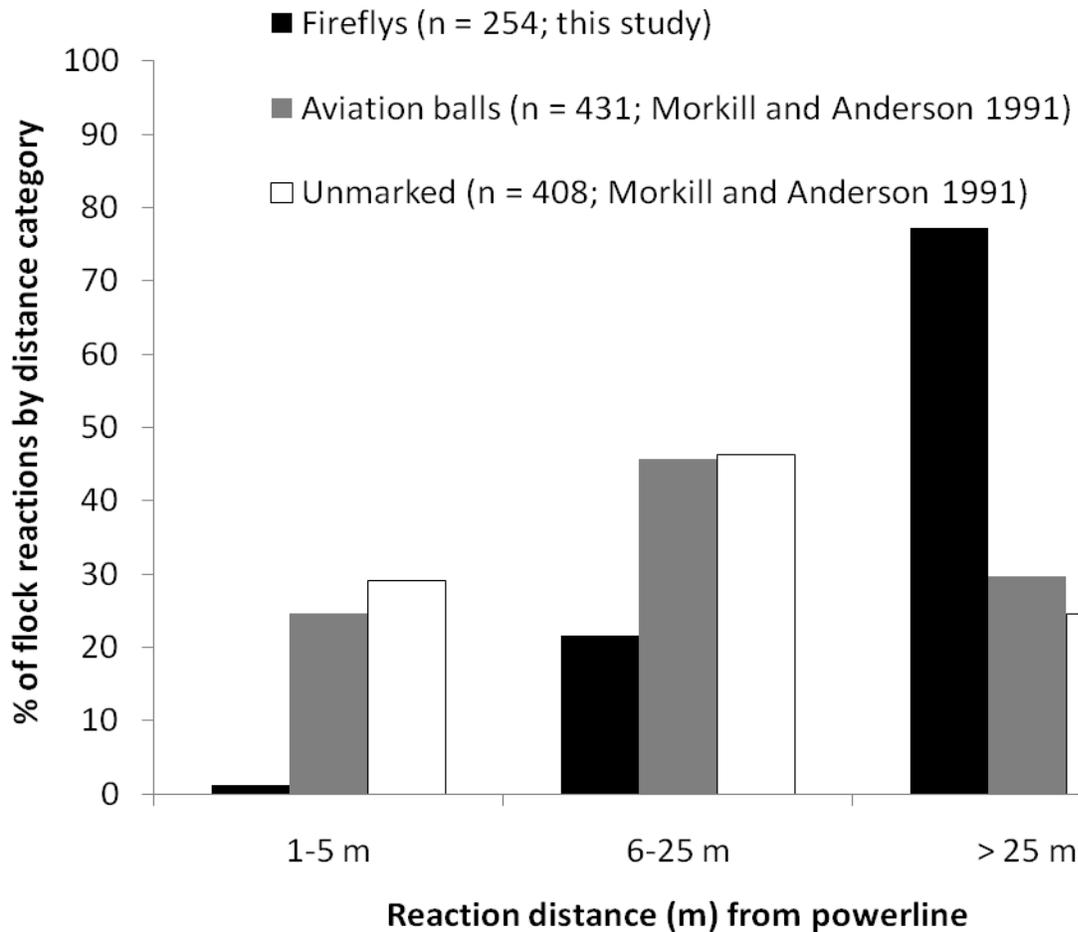
Figure 4. Frequency distribution of distances of initial reactions of flighted sandhill cranes to a 69-kV powerline marked with Firefly avian flight diverters over the Platte River in south-central Nebraska during spring 2009, and of reactions of sandhill cranes to powerline spans marked with 30-cm diameter aviation marker balls and to unmarked spans over croplands in south-central Nebraska during spring 1988-1990, based on data in Morkill and Anderson (1991). Sample sizes (i.e., number of flock reactions observed) are in parentheses.

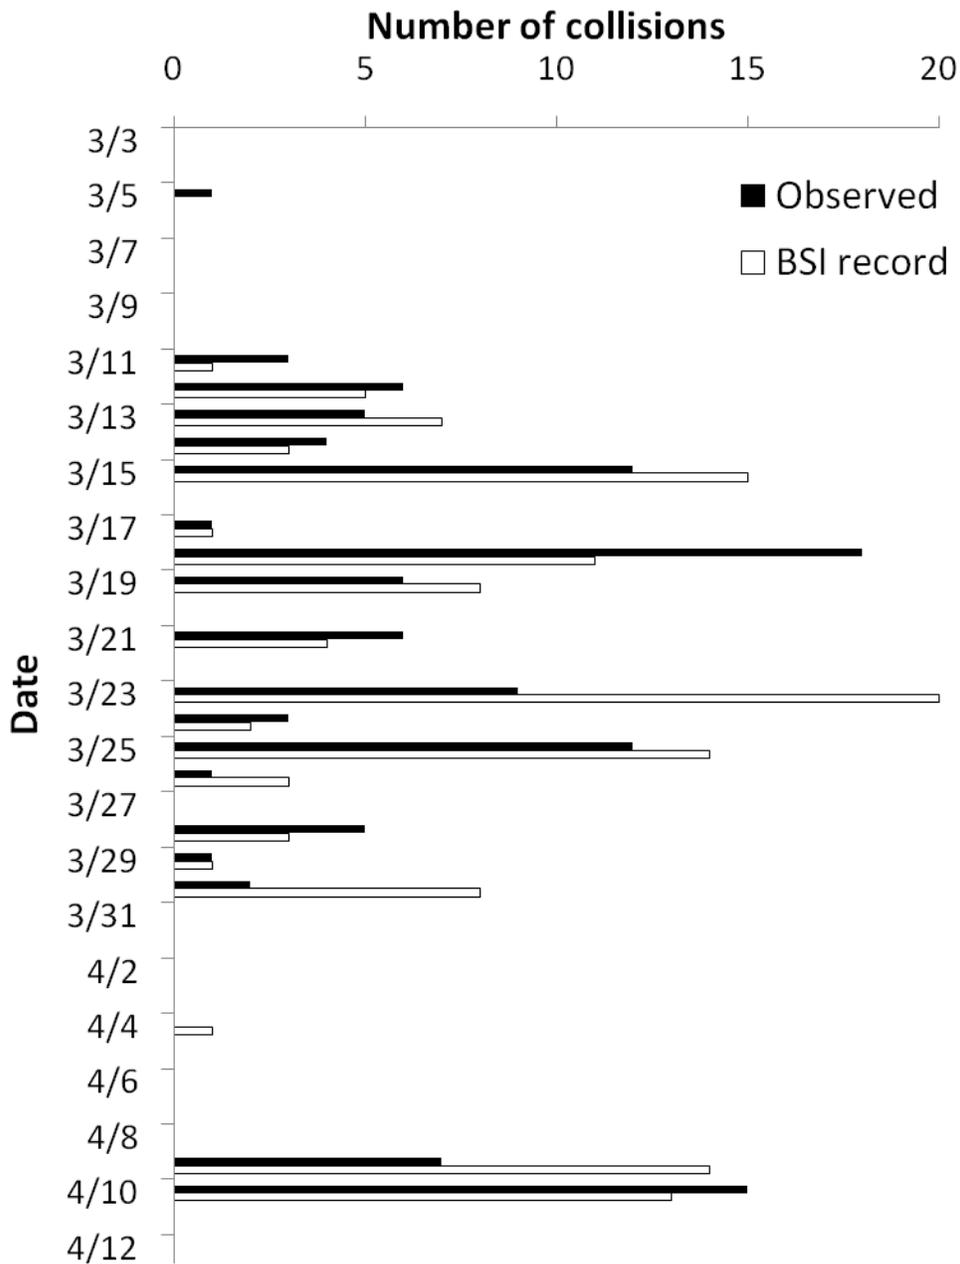
Figure 5. Number of collisions by birds with the eastern powerline over the Platte River at National Audubon Society's Lillian Rowe Sanctuary in south central Nebraska, as recorded by direct observation and by electronic bird strike indicators (BSIs; EDM International, Fort Collins, Colorado) during evenings, 3 March to 13 April 2009. All collisions directly observed were of sandhill cranes, while those recorded by BSIs were of relatively large birds of unknown species. No BSI data were collected on 3 March.

The number of collisions by birds recorded by BSIs each evening correlated closely with the number of collisions by sandhill cranes we directly observed during the same time ($r = 0.86$, $P < 0.001$; Fig. 5). Several BSI records suggested double collisions (i.e., two birds striking a wire simultaneously), while several others suggested collisions that involved two wires (i.e., a bird striking one wire then immediately another). Stemming from this validation of reliability of BSIs, there were 358 collisions, presumably all by birds, with the eastern powerline on 55 days between 11 February and 15 April 2009. Collision incidence indicated by BSIs was distributed unevenly through night and day ($X^2 = 463$; $df = 7$, $P < 0.001$), with about one-half occurring during evening and nearly all others during the remaining night hours (Fig. 6).

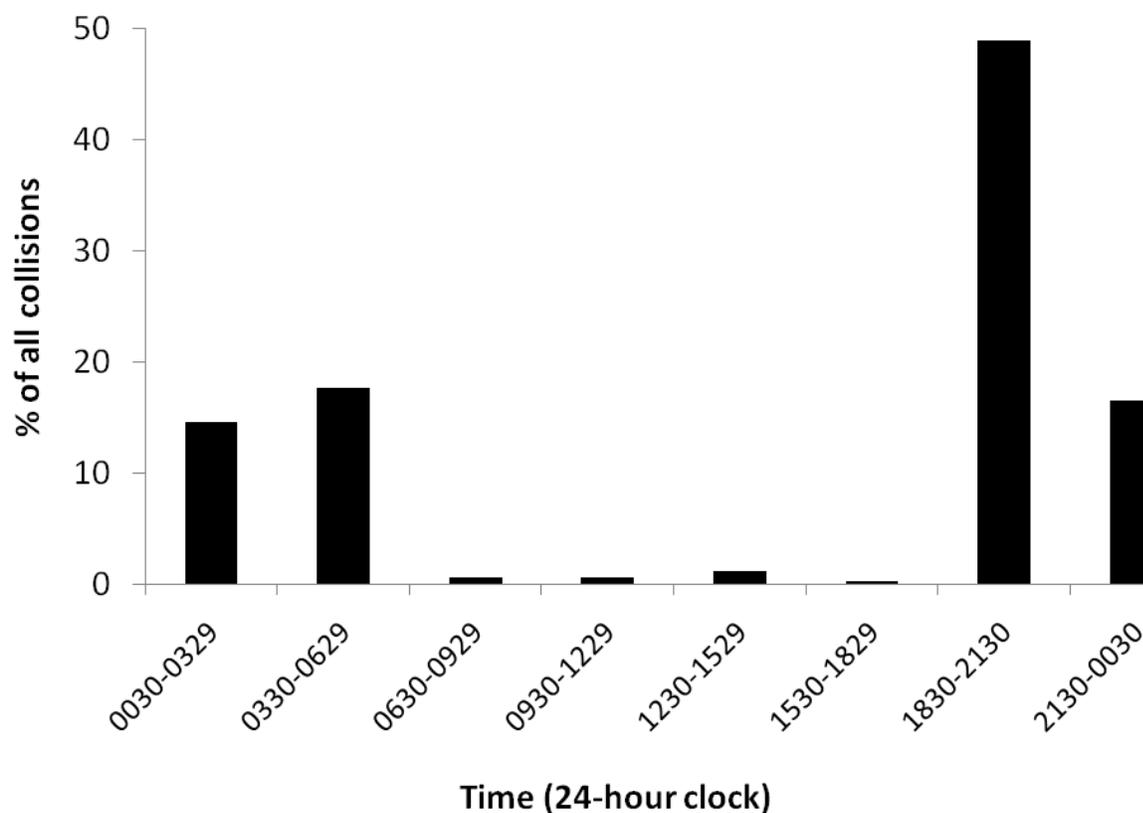
Figure 6. Diel timing of collisions by birds with the eastern powerline at National Audubon Society's Lillian Rowe Sanctuary in south central Nebraska, as detected by electronic bird strike indicators (EDM International, Fort Collins, Colorado) during 11 February to 15 April 2009. Data are presented as percentage of total collisions recorded (n = 358).

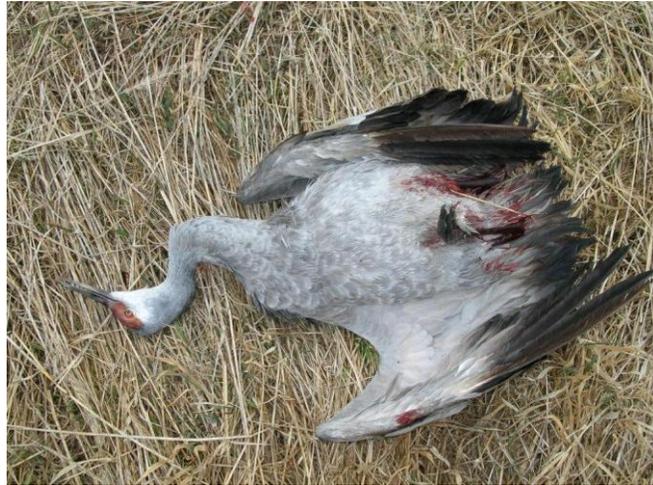
Fresh carcass of sandhill crane beneath the western powerline at Rowe in March 2008, with evidence of blunt trauma to the legs, abdomen, and right wing.

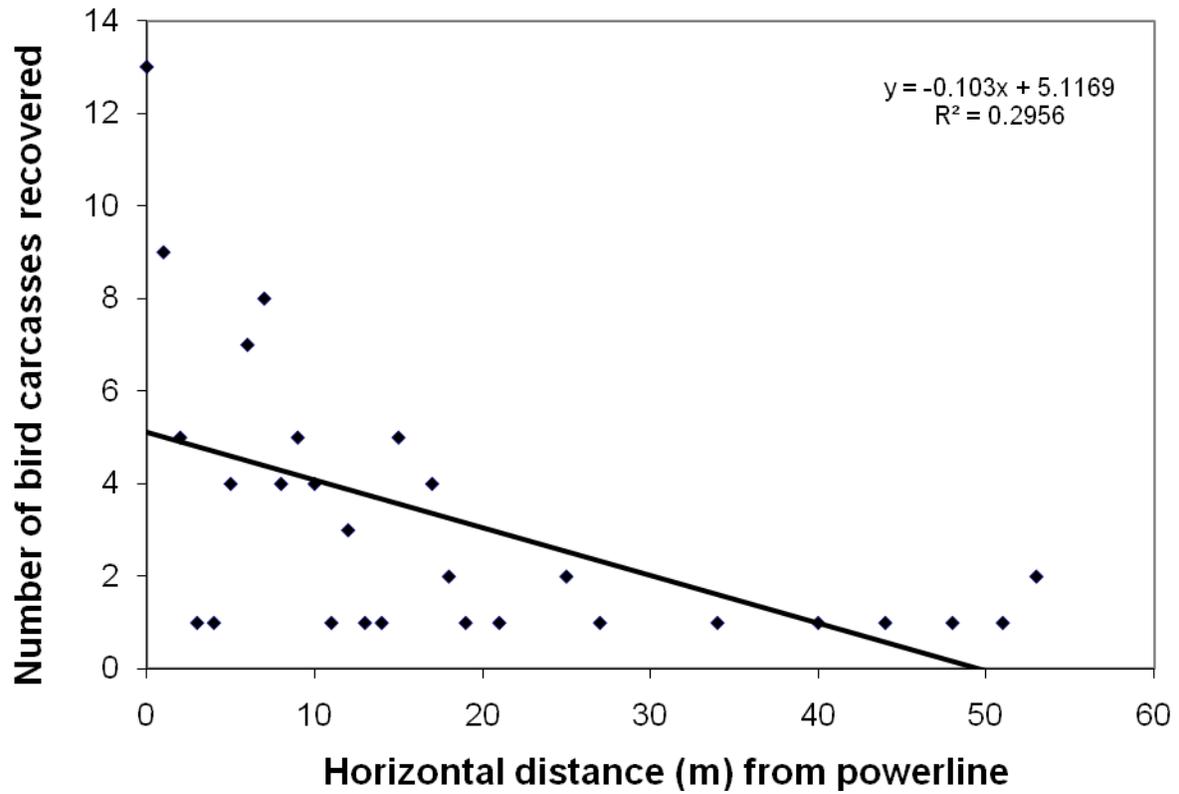
Appendix A. Distribution of distances at which bird carcasses were discovered from powerlines at Rowe, spring 2007 (R. Murphy and T. Smith, University of Nebraska-Kearney, unpublished data).
